NAVIGATIONAL RISK ASSESSMENT WORKING GROUP 47

13 September 2013

Final Report into the Review of Multiple Contact Incidents at Northfleet Hope Container Terminal (NHCT)

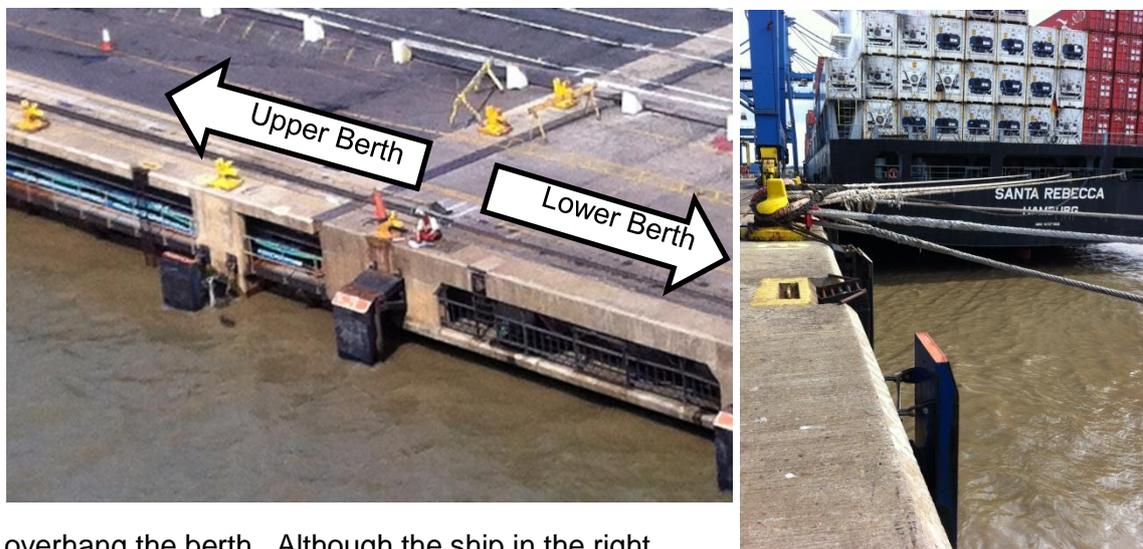
5. Light ship/fenders – the combination of less laden ships (and so higher out of the water) and berthing at or near HW will render a ship with a cutaway stern or bow more likely to

overhang the berth. Although the ship in the right hand photo carries its beam width all the way aft and so rests her stern squarely on the fenders, many modern ships become finer towards the bow and stern and so overhang the berth if too close. Looking at the left-hand photograph above, the fenders on the

upper berth are approximately 0.5 metres lower than those on the lower berth, so that if the ship is only slightly off the line of the berth it will overhang the fendering and could then land on the un-fendered concrete edge. It is interesting to note that the fenders at London Gateway come higher out of the water than even those on the lower berth shown here. Following publication of the interim report the Port of Tilbury have already investigated with external consultants whether or not the fenders could be extended in height or whether the coping edge could be fendered with a 'half-round' rubber fendering. Early findings indicate that fender improvements will not easily or quickly be achieved and so with the current fender arrangements at NHCT, pilots must take great care to berth the ship squarely aligned with the line of the berth.

- c. Notwithstanding the issues identified in the analysis above, it is clear that fenders extending in height to the same height as the coping edge (or higher, such as those at London Gateway) would prevent much of the damage experienced. It is recommended that the port of Tilbury continue with their review of the fendering arrangements.

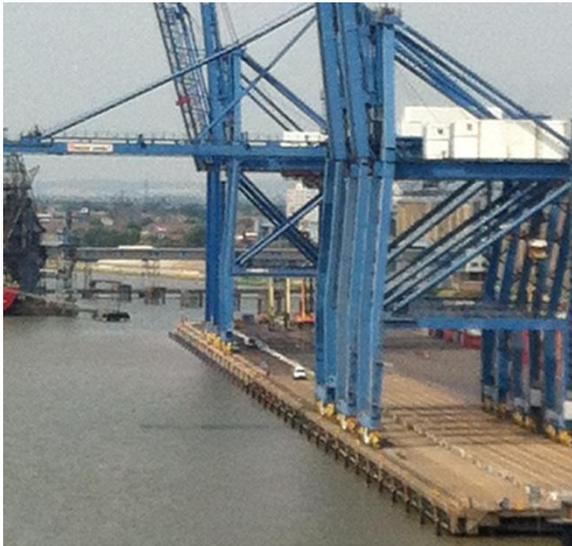
6. Crane Booms – From early analysis of the MAERSK NIENBURG incident, it is clear that

the quayside cranes should be positioned as close to the middle of the ship being berthed, **not** the middle of the berth; the crane booms must be raised. If for some reason the boom must be left down, the pilot should be warned of the situation through London VTS, as a lowered boom makes it more difficult to line up with the line of the berth. Interestingly, when the PLA Chief Harbour Master accompanied a pilot on 23 Jul, the boom on the upper crane on the lower berth was down and he was surprised by how close the end of the boom was to the bridge of the ship. In one reported near-miss event with the SANTA ROSA, in order to manoeuvre past the lowered boom and overcome the effect of

the 'vicious' set into the berth, on this occasion exacerbated by a south-westerly wind, the pilot needed to maintain way on the ship using dead slow ahead. As a result, at 4 knots, the ship was going faster than the pilot wished, requiring half astern to bring way off the ship in time.

- s. Quayside cranes on the berth being approached should be positioned adjacent to where the middle of the ship will be with crane booms in the upright position; if this is not possible the pilot is to be warned in good time.
