NOTICE TO AGENTS, BERTH AND SHIP OPERATORS No.3 of 2016

CONFIRMATION OF STABILITY

SAFETY FLYER

Hoegh Osaka: Listing, flooding and grounding on 3 January 2015

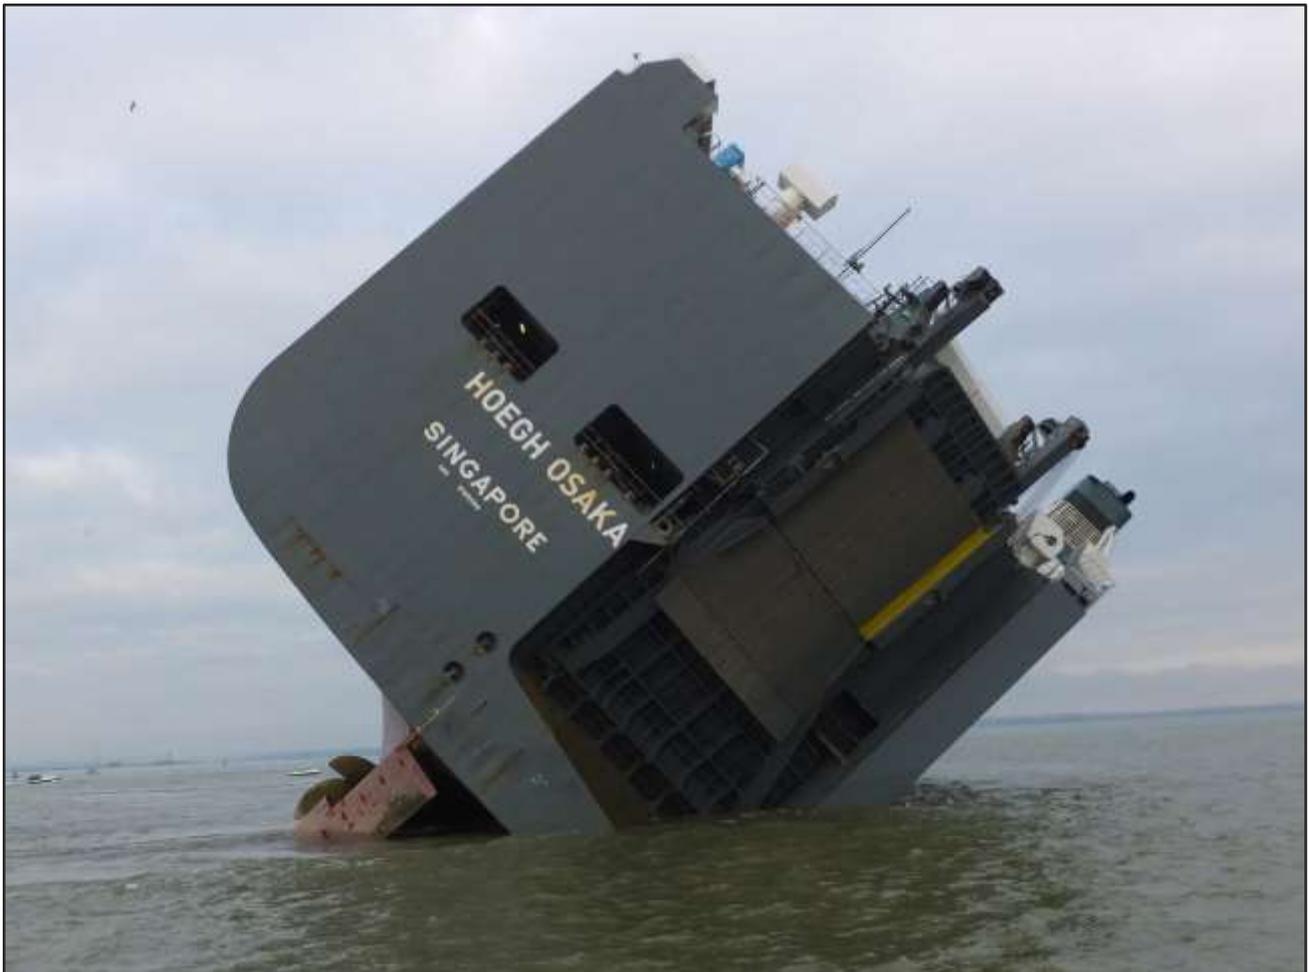
Hoegh Osaka

At 2109 (UTC) on 3 January 2015, the pure car and truck carrier (PCTC) *Hoegh Osaka* was departing Southampton, UK, and turning to port around the Bramble Bank when the vessel developed a significant starboard list. As the list increased in excess of 40° the ship lost steerage and propulsion, and subsequently drifted aground on Bramble Bank. A cargo shift as the vessel listed resulted in breaches to the hull and consequent flooding. All crew were safely evacuated from the ship and surrounding waters. There was no resulting pollution, and the ship was later successfully salvaged.

Stability modelling and analysis following the accident show that *Hoegh Osaka* heeled heavily to starboard while turning as a result of having departed port with inadequate stability. Cargo distribution was such that the upper vehicle decks were full while the lower vehicle decks were lightly loaded. *Hoegh Osaka* was low on bunker fuel oil, which was stored low down in the ship, and the ship's overall vertical centre of gravity (VCG) was relatively high.

Hoegh Osaka's inadequate stability had not been identified prior to departure. The figures in the pre-stowage plan were significantly different to the final cargo tally; the estimated weight of many items of cargo was less than their actual weight; and no allowance was made for the VCG of the cargo loaded being above deck level. Finally, it was onboard practice to alter the ballast tank quantity readings on the loading computer so its output would match the observed draught readings. It would have been possible to embark additional ballast prior to departure to reduce the ship's VCG as necessary, but as the shortcoming in stability had not been identified this was not done.

- Assessing a ship has adequate stability for its intended voyage on completion of cargo operations and before it sails is a fundamental principle of seamanship that must not be neglected. Sufficient time must be made before departure for an accurate stability calculation to be completed.
- A loading computer is an effective and useful tool for the safe running of a ship. However, its output can only be as accurate as the information entered into it.
- The master has ultimate responsibility for the safety of his/her ship. This responsibility cannot be delegated to shore-based managers or charterers' representatives.
