Condition Survey Report 2021/2

The PLA has commissioned a condition survey of the mechanical and civil structures at Richmond Lock and Weir. The last full survey was undertaken in the late 1980s prior to the major refurbishments in the early 1990s.

STRUCTURAL SURVEY SUB & SUPERSTRUCTURE CONDITION ASSESSMENT

CLIENT			Houlder Ltd			
PROJECT TITLE			Richmond Lock & Weir			
SUBJECT			Structural Survey			
DOCUMENT TITLE			Sub & Superstructure Condition Assessment			
DOCUMENT REF			2144-BRL-01-XX-RP-C-1000			
REVISION RECORD						
REV	STATUS	DATE	SUMMARY OF CHANGES	PREP	CHK	APP
P01	S2 – Suitable for Information	11/03/22		GG	-	TKHB
P02	S2 – Suitable for Information	25/03/22		GG	MB	TKHB

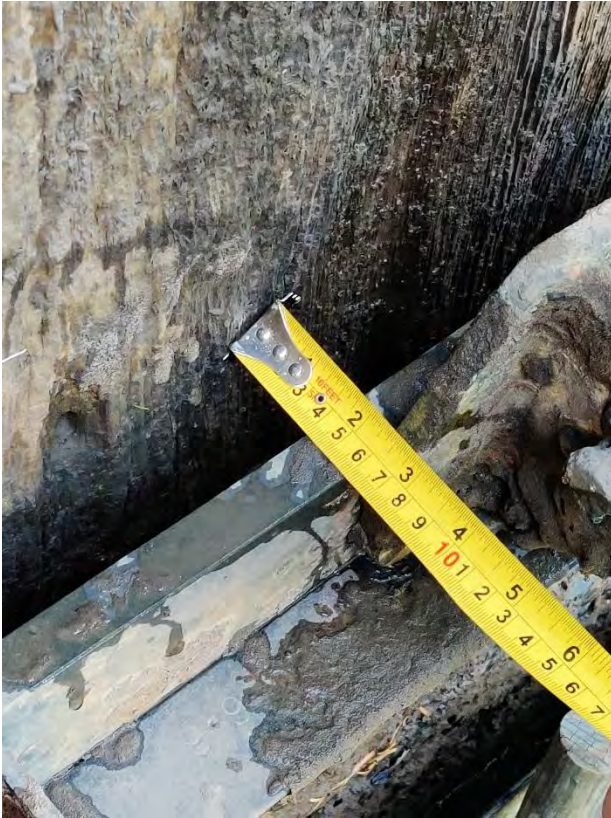
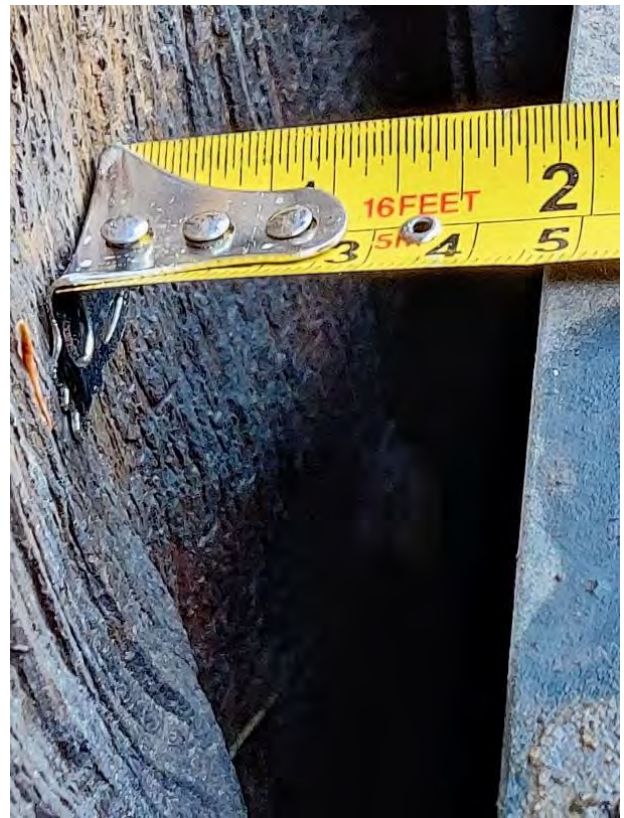
There are large gaps behind the penstocks which allow water to pass through the gates. If the loss of water is of concern these could be blocked off.

Photos 3 & 4: Upstream gates 40 - 50mm gaps behind penstocks

Reference section	Issue	Proposal
Lock Gates	2.1.1	Leakage through penstocks	Fill in the gap along the top of the penstock housings to reduce the water flow if this is considered a problem

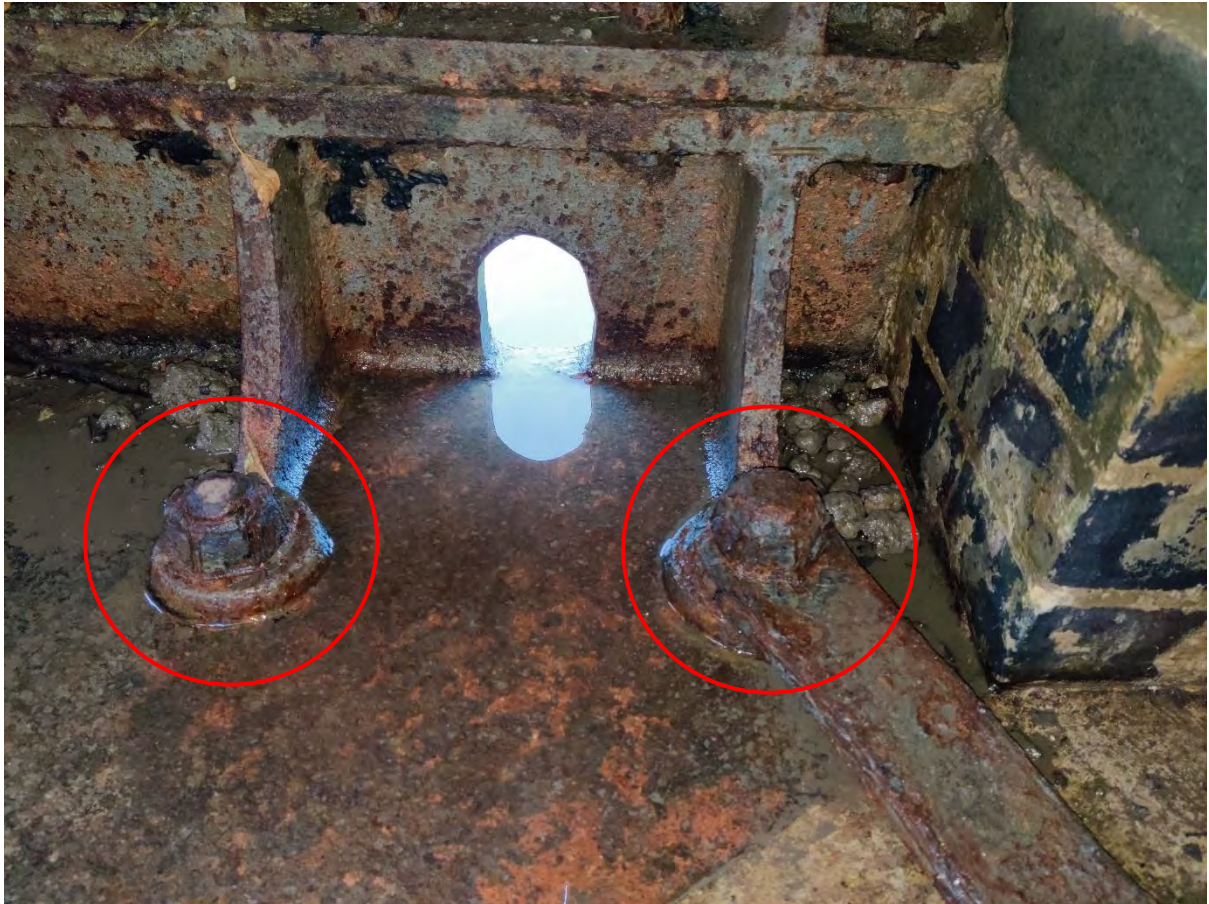
The nuts bolting the seating to the concrete foundation are heavily rusted in numerous locations. There are minimal remaining coatings on the seatings and nuts. The nuts need to be removed and replaced with galvanised ones and both upper and lower seatings recoated.

Photo 17: Downstream Middlesex

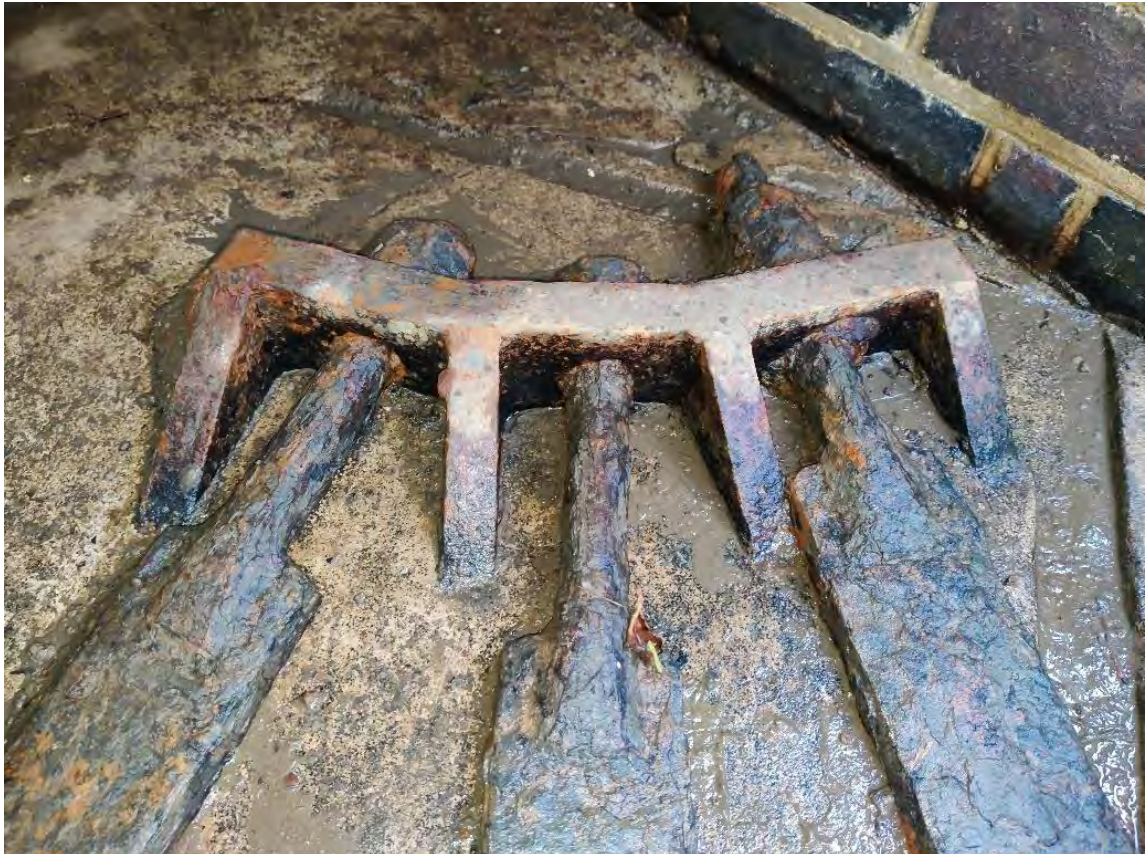
The 3 restraint straps on each gate are heavily rusted together with the threaded ends and nuts. There is minimal coating remaining. It is proposed that these are removed and replaced with new galvanised straps.

The ground anchors are rusty but their thickness is substantial so these should just be recoated.

Photo 18: Typical Ground Anchor and top bearing restraint straps

3.1.2	Strap nut condition	Remove and replace with galvanised nuts
	3.1.3	Strap deterioration	Remove and replace with new galvanised straps or re-galvanise existing straps

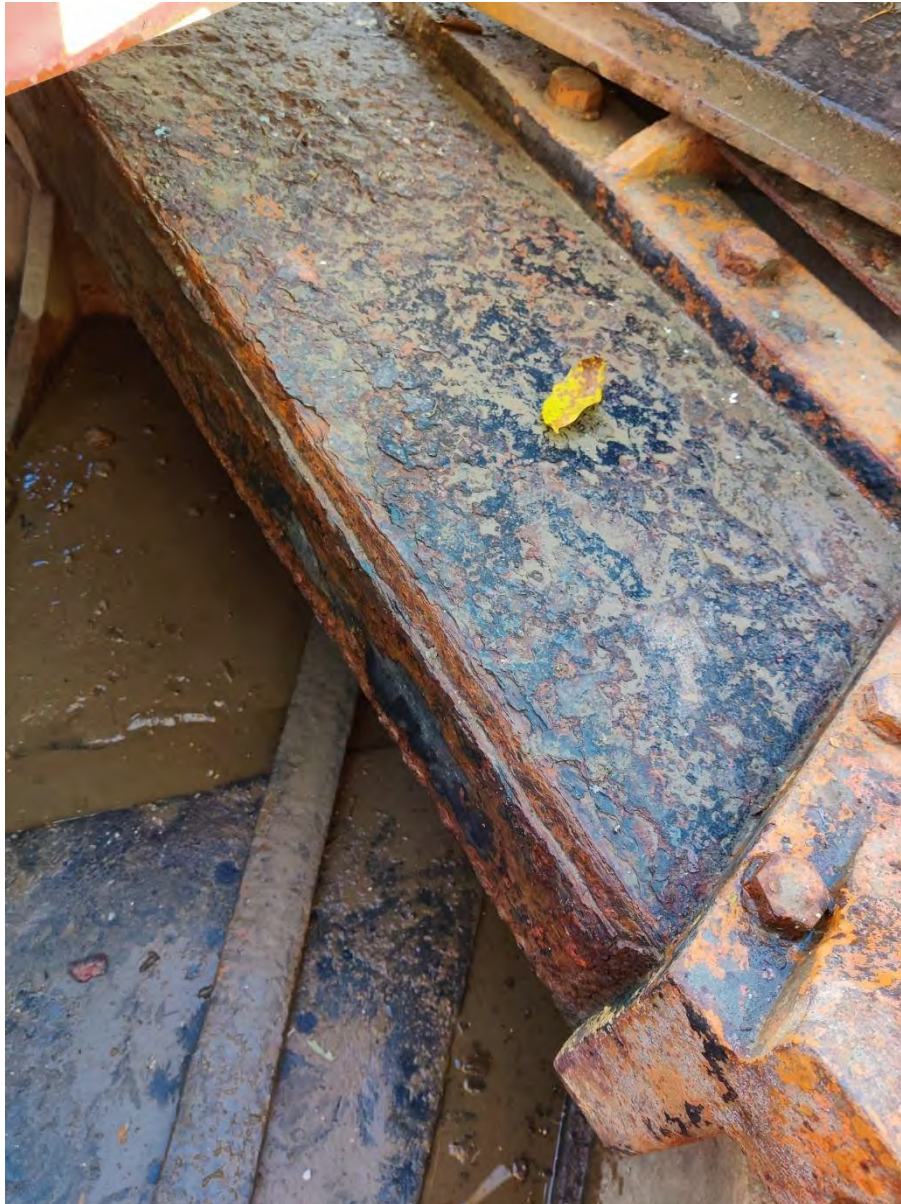
There is heavy rust on all the gate quadrants as shown below. There is considerable thickness remaining, but recoating is required to prevent further loss.

Photo 19: Heavy pitting - Downstream Middlesex

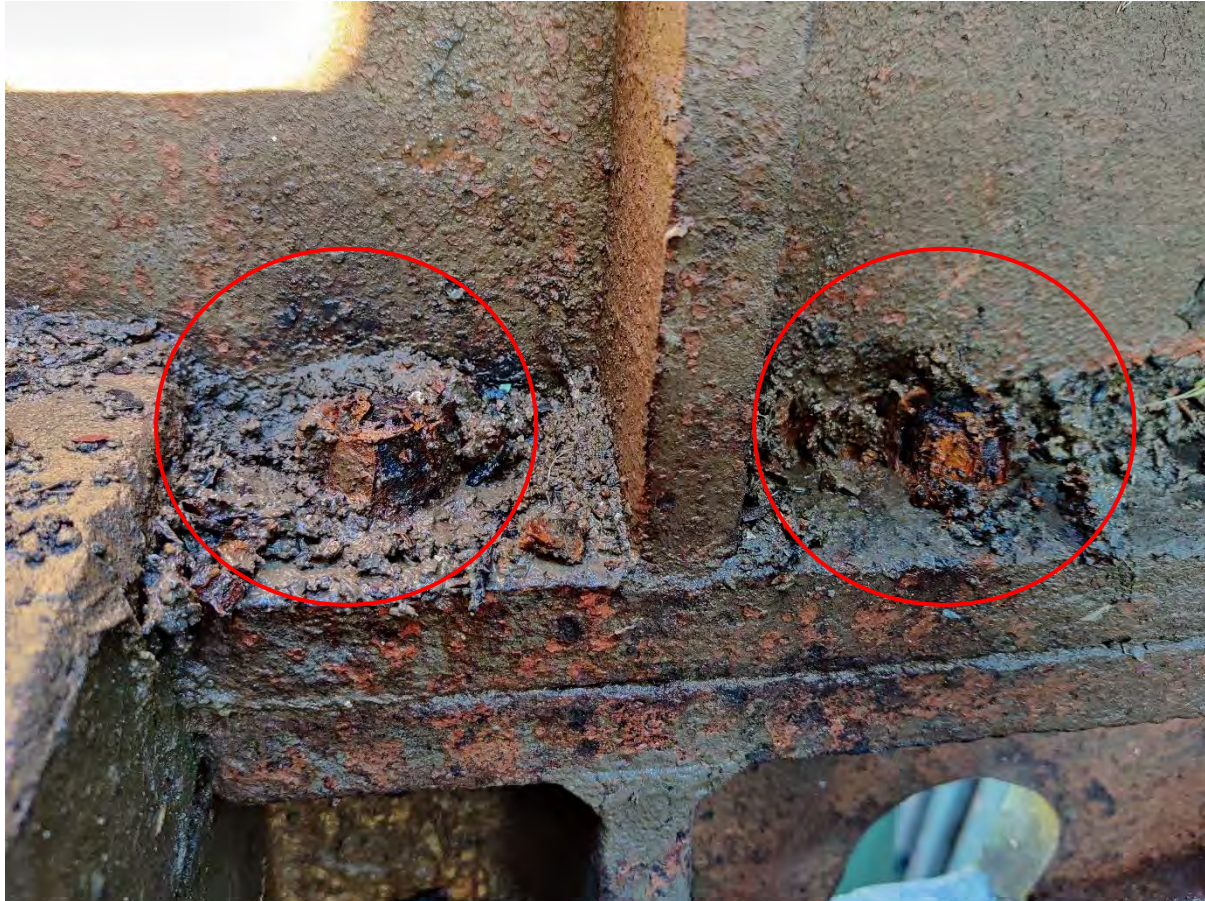
The bolts connecting the upper and lower seatings are very rusty. In some cases, the heads have disintegrated as shown below.

Photo 20: Typical example - Downstream Middlesex

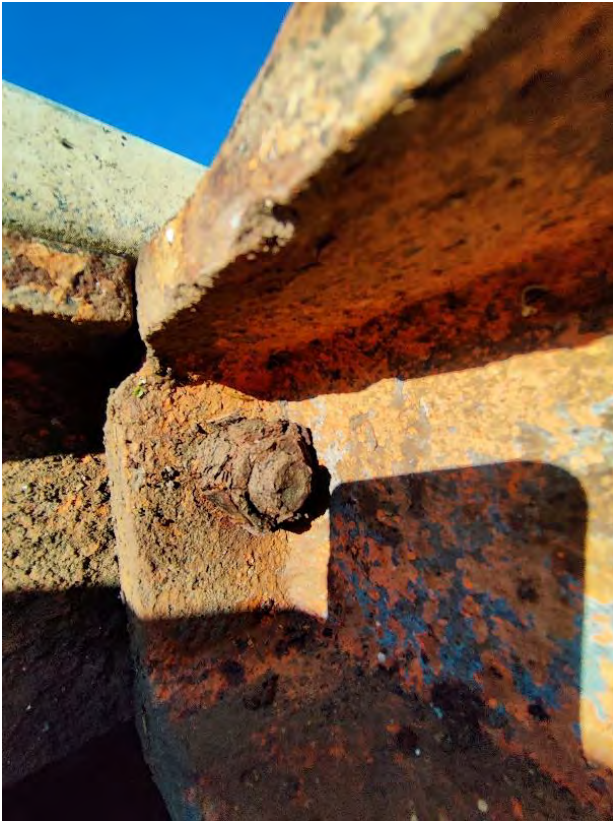
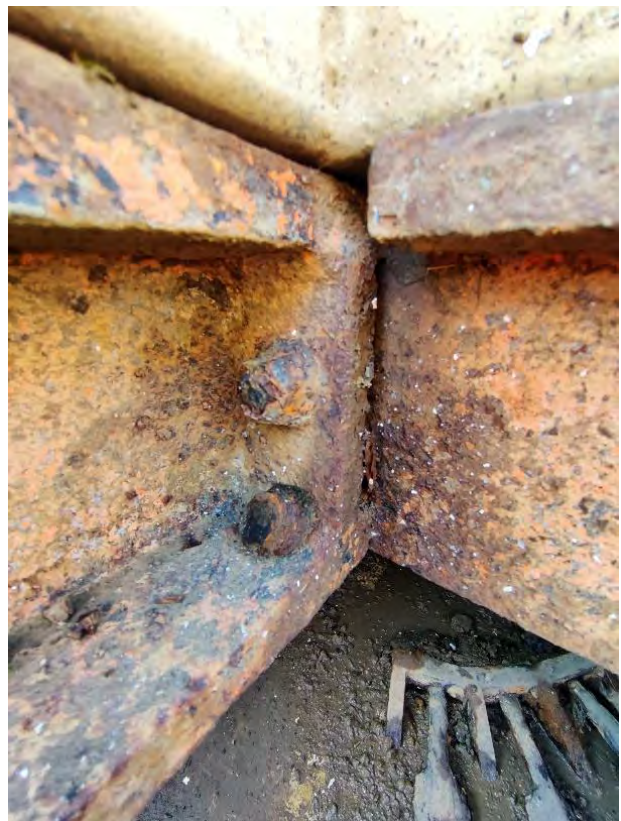
The floor support beams are rusty, but the structure is substantial. However, the connection bolts are heavily rusted and in need of replacing with galvanised bolts. All the beams should also be repainted.

Photo 21 & 22: Typical example of bolts - Upstream Middlesex

3.1.6	Deck support Beams	Repaint
	3.1.5	Deck support bolts	Replace bolts with new galvanised
	3.3	Doubler plate – Upstream Middlesex	Remove and replace with new plates and bolts

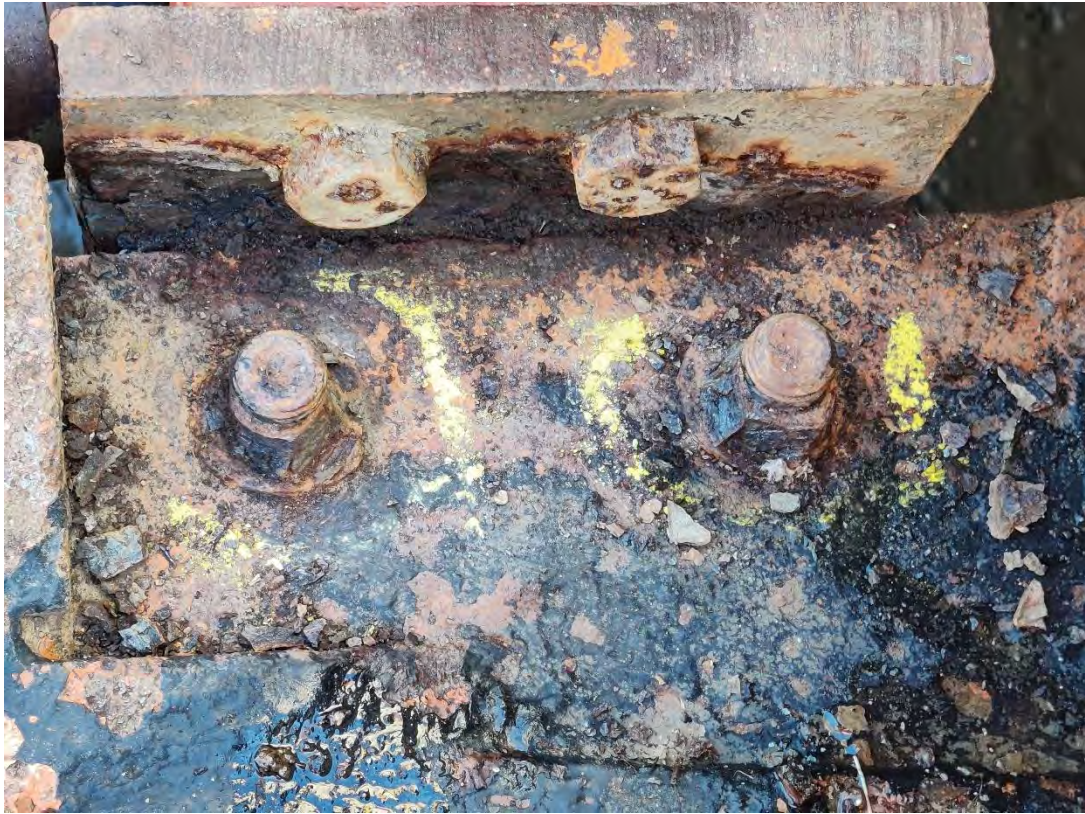
The shock absorber bracket retaining bolt nuts on the underside are badly rusted and need to be replaced.

Photo 23: Underside of brackets – nuts badly corroded

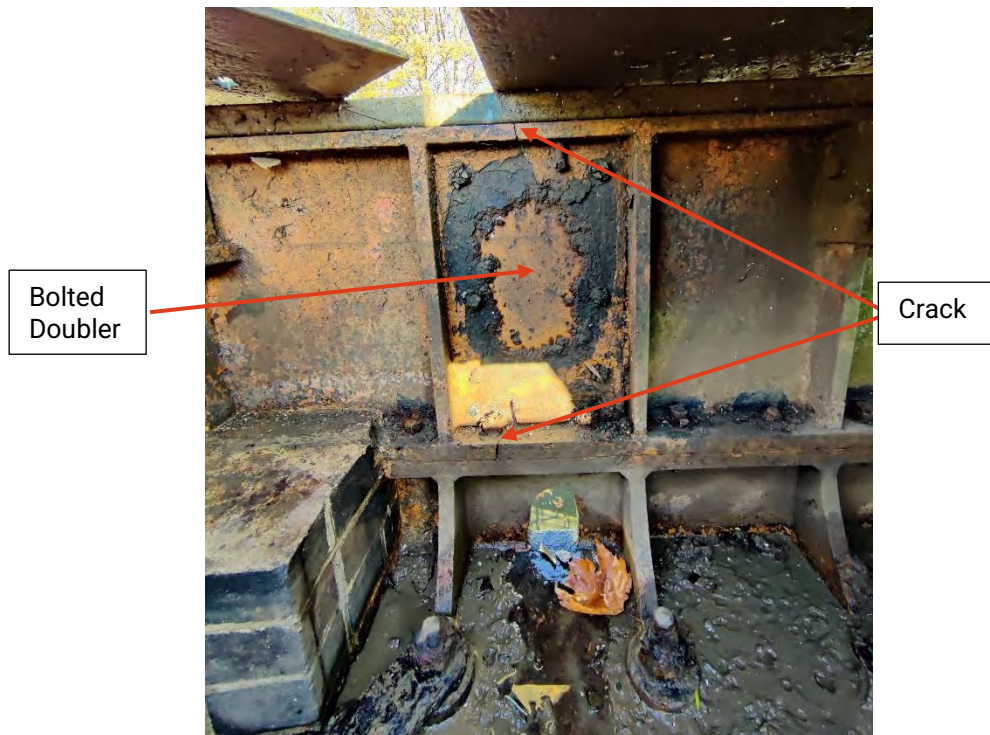
The upper seating is cracked and has been repaired with a bolted patch. However, the bolts and patch are badly rusting and needs replacing

Photo 24: Vertical Crack repaired with Doubler and 6 bolts

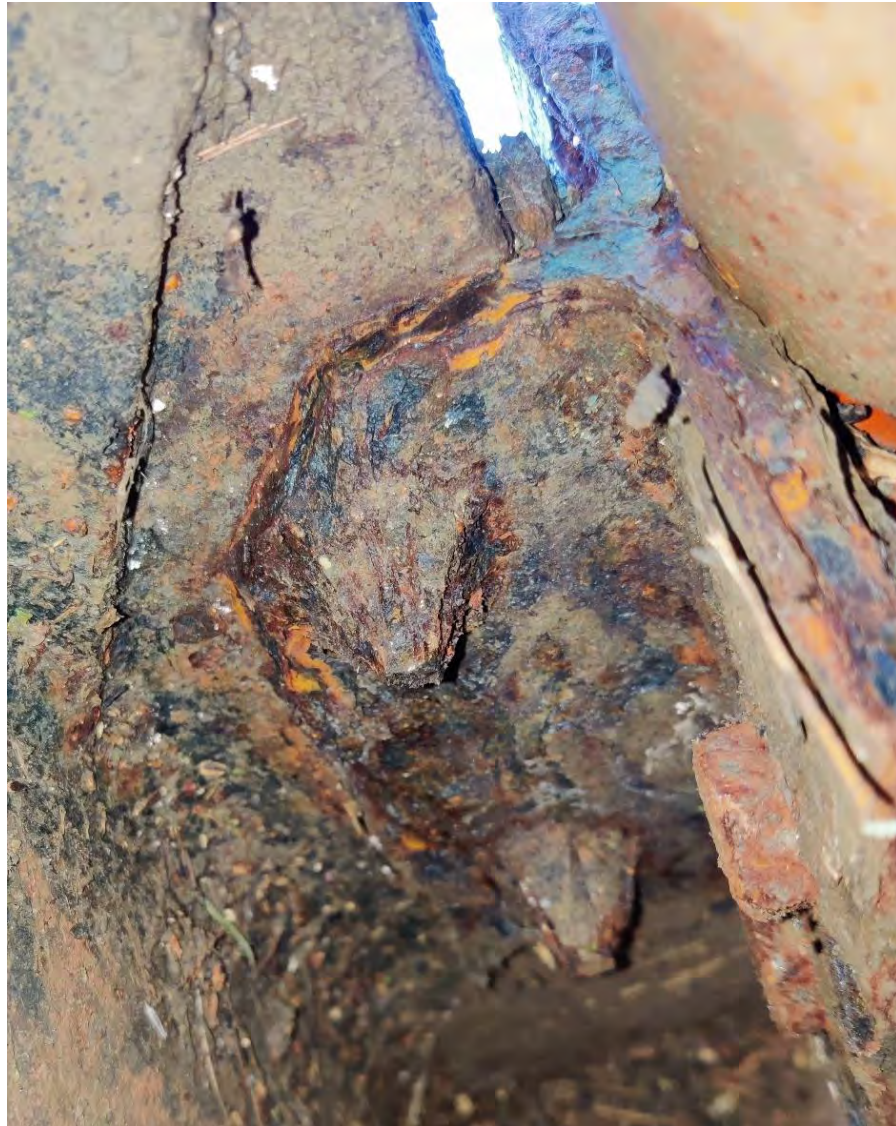
The shock absorber bracket and retaining bolt nuts have disintegrated and need to be replaced.

Photo 25: Nuts have disintegrated

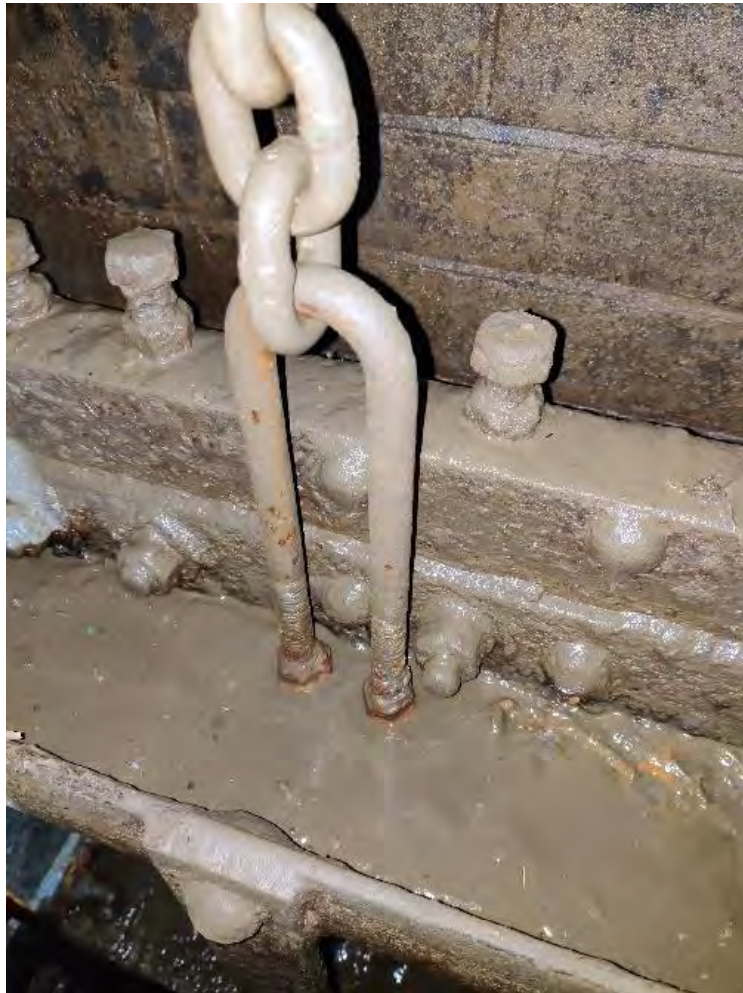
Photo 28: U bolt chain attachment to gate

4.2	U bolt chain attachment to gate	Replace with galvanised U bolts (2 off)
Weir Gates	5.1.3	Deterioration of General paintwork	Repaint entire gates
	5.1.1	Inaccessible areas for painting	Devise a method of blasting and effective repainting in the "voids"

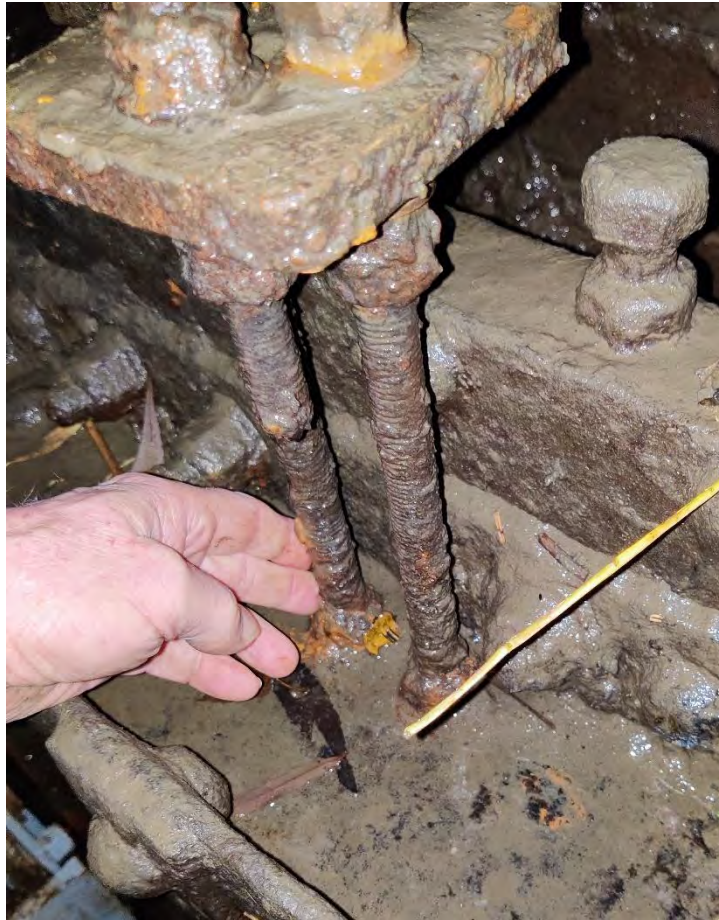
Photo 35: Rusty threaded rod chain attachment to gates

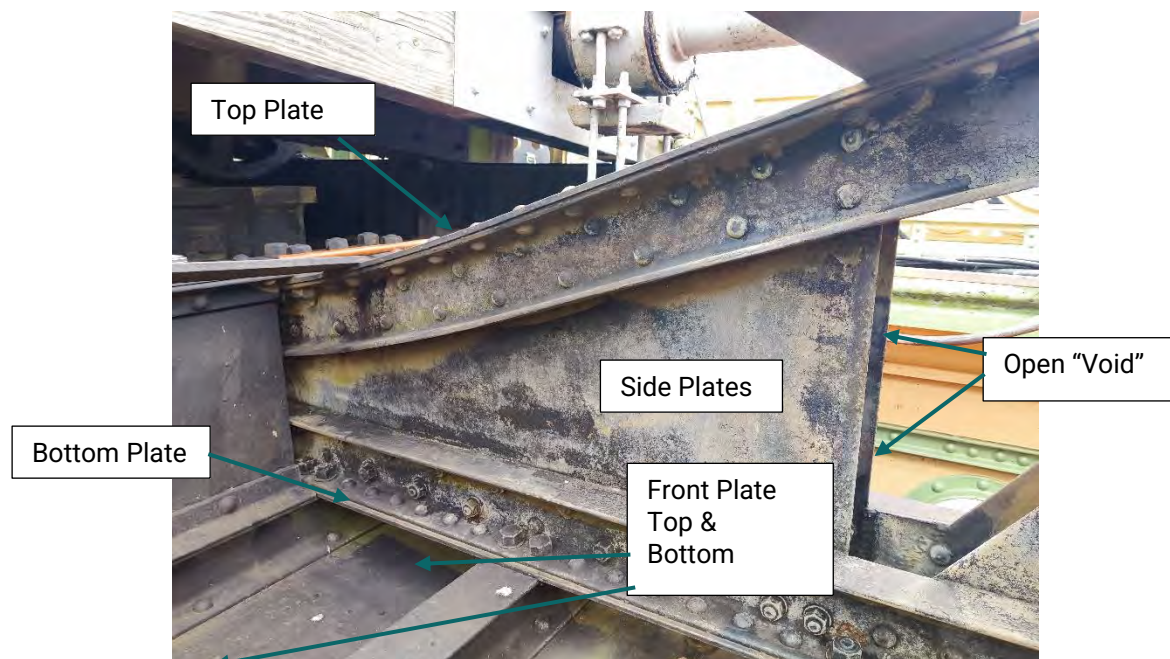
The voids between the end plates are difficult to access and paint and consequently are suffering from corrosion. This is noticeably worse on the upper level than the lower which is more constantly submerged. Despite this, the thickness measurements taken on the end plates and more generally on the gates indicate that significant material remains as shown in the table below.

Photo 36: Top truss plate descriptions

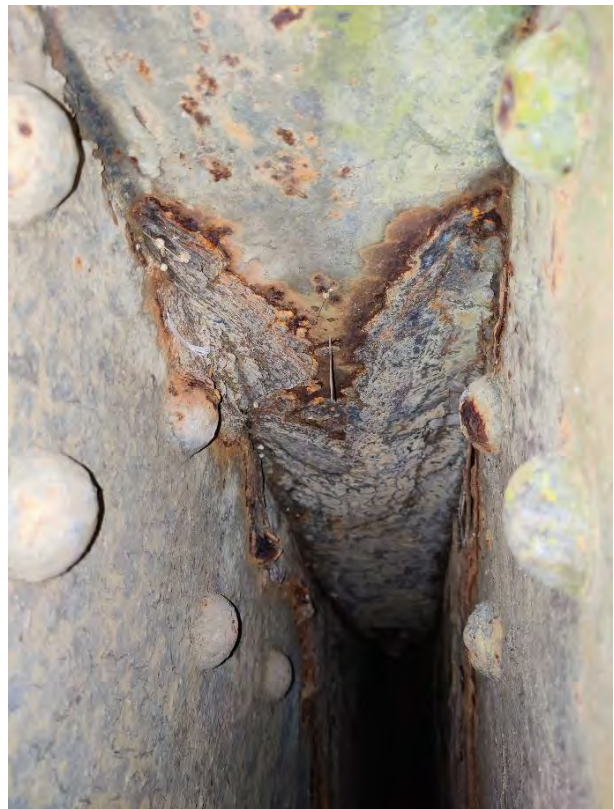
Photo 38: Heavy flaking rust on under side

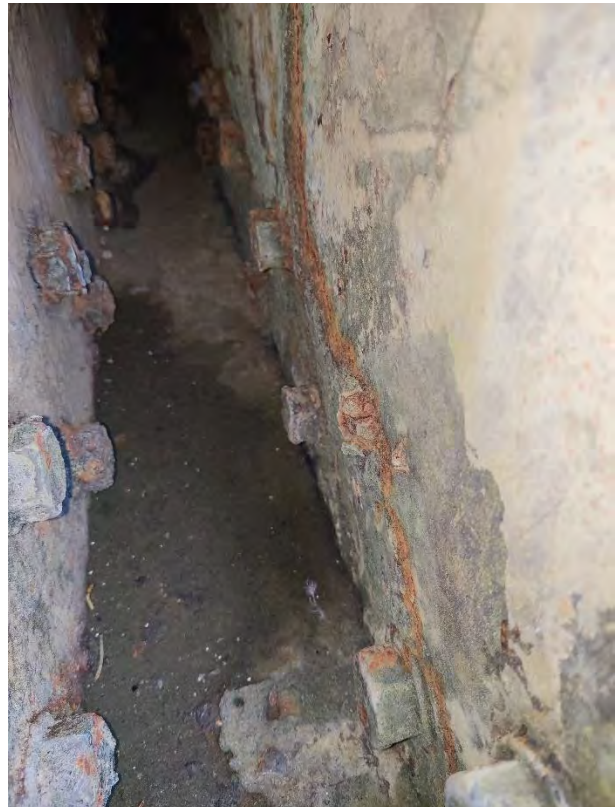
Photos 39 & 40: Typical internal views

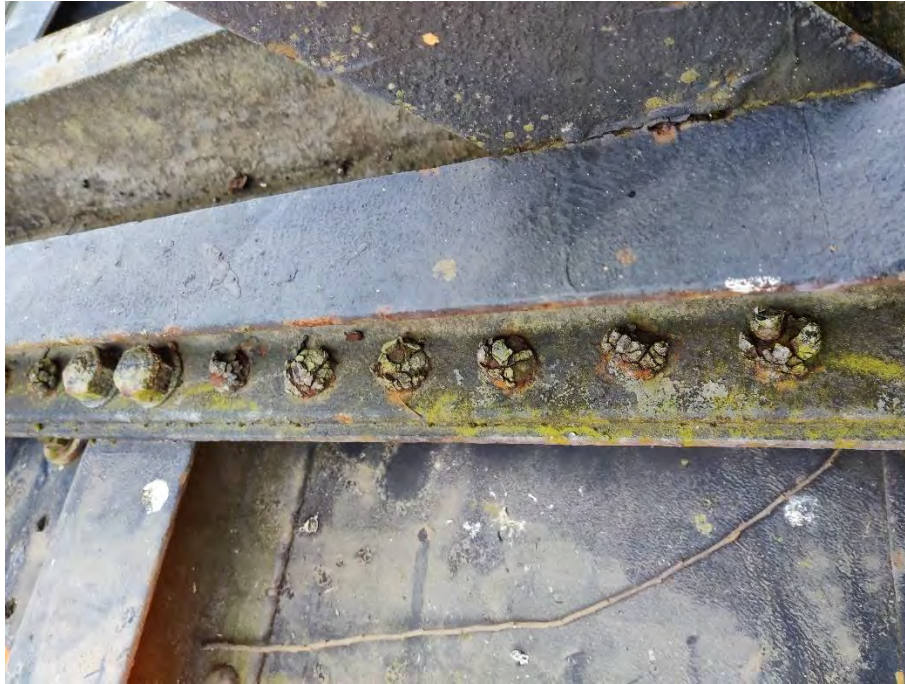
There are numerous rivet heads that are rusty and appear to be “splitting” as shown in the picture below. However, when the rust is hammered off the remaining rivet heads are still effective, see photo 43.

Photo 42: Rusting Rivet Heads

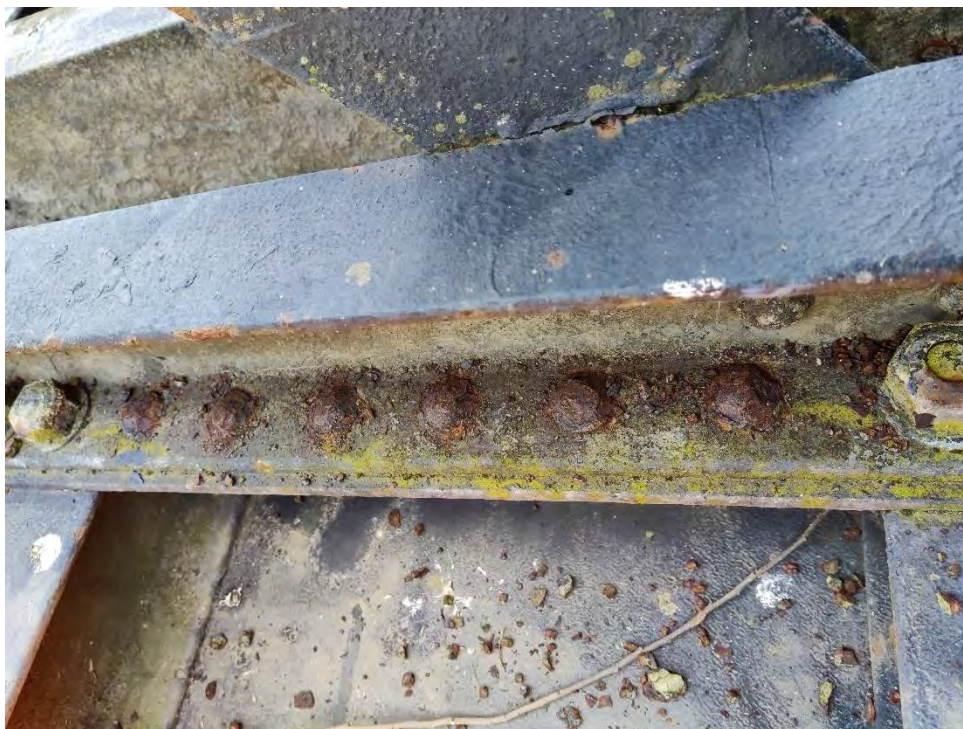
Photo 43: The above rivet heads after removing the loose rust

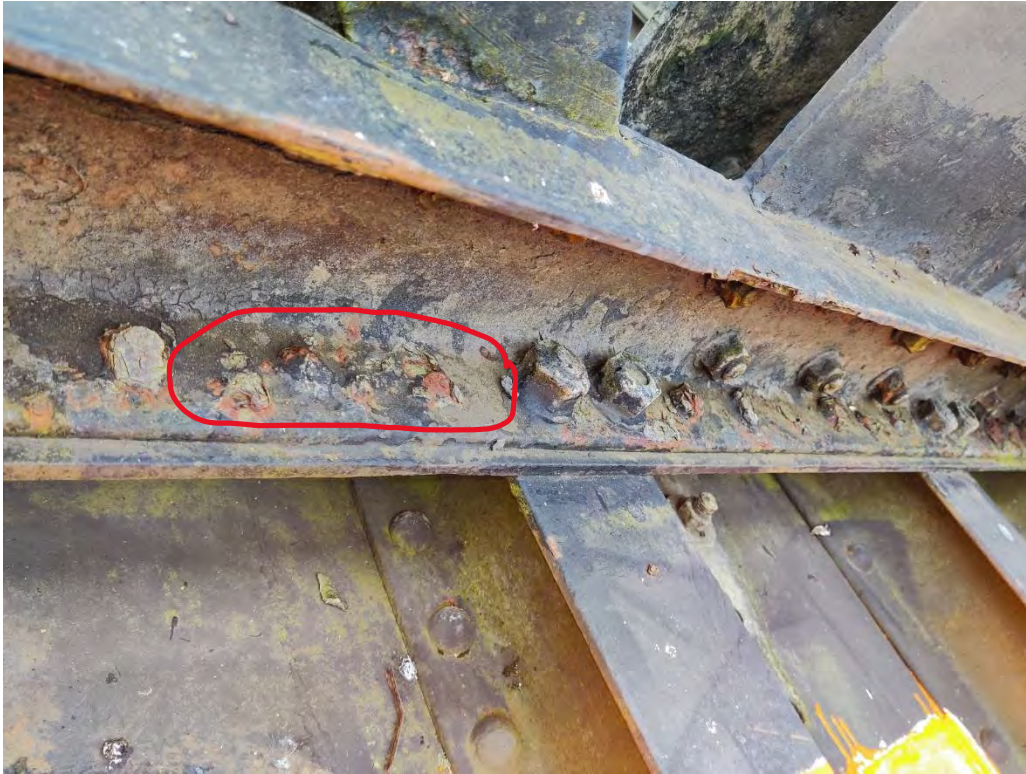
There is evidence that eroded rivet heads in similar condition to those in the previous pictures have previously been painted as shown below.

Photo 44: Corroded rivet heads previously painted

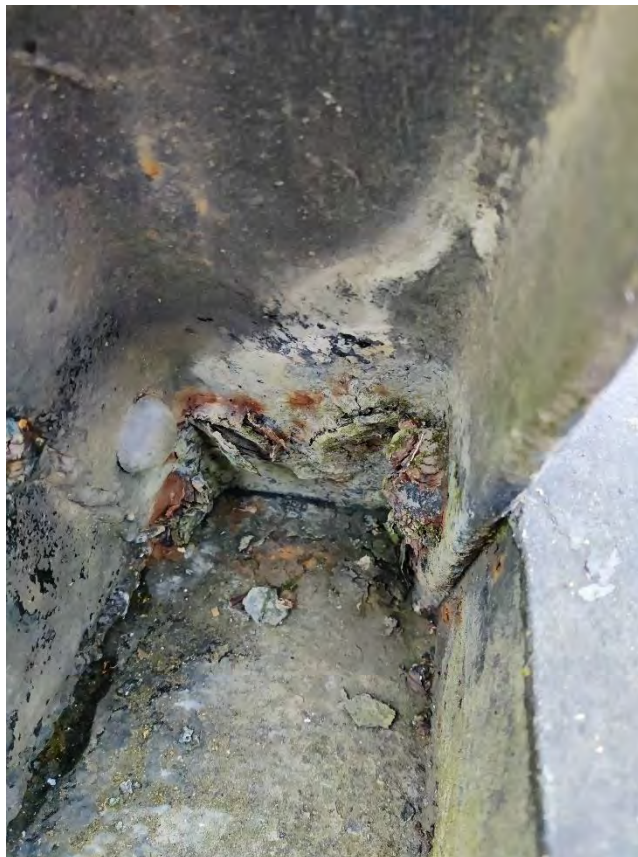
Considering the weirs were last coated in the early 1990s the paint is in reasonable condition on the flat plate areas. However, there are numerous locations where the coatings have failed locally in inaccessible areas, water traps and around bolt and rivet heads. There is also evidence of local paint repairs which are now failing.

Photo 45: Example of local paint failure

In summary all three weir gates need recoating.

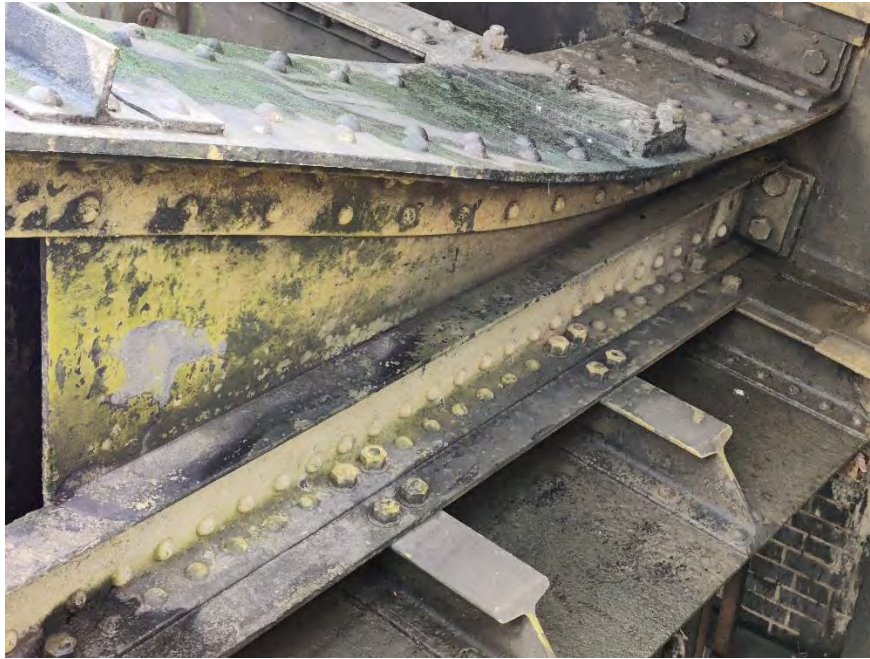
Photo 46: Large areas of the gates are covered in calcium, but the coating is intact beneath

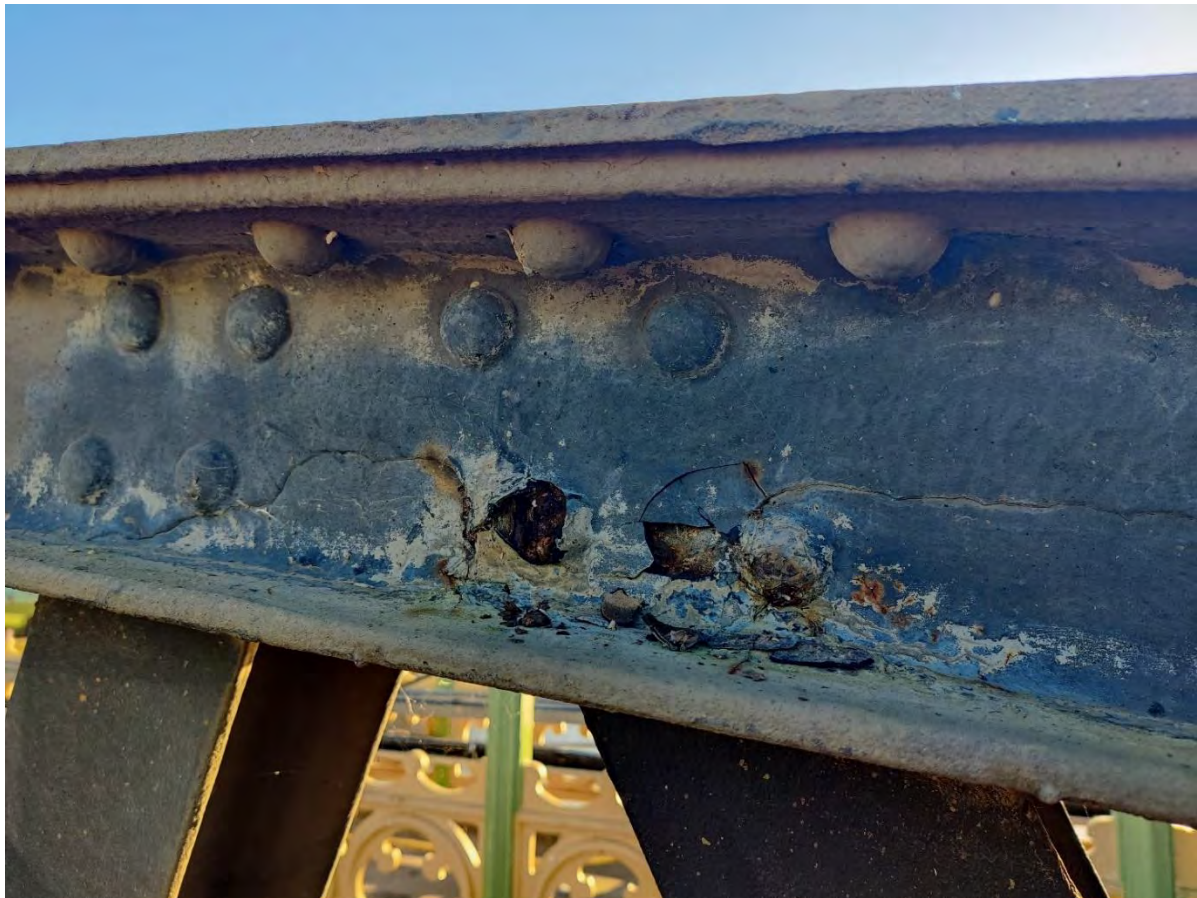
Photo 47: Local paint repairs are failing

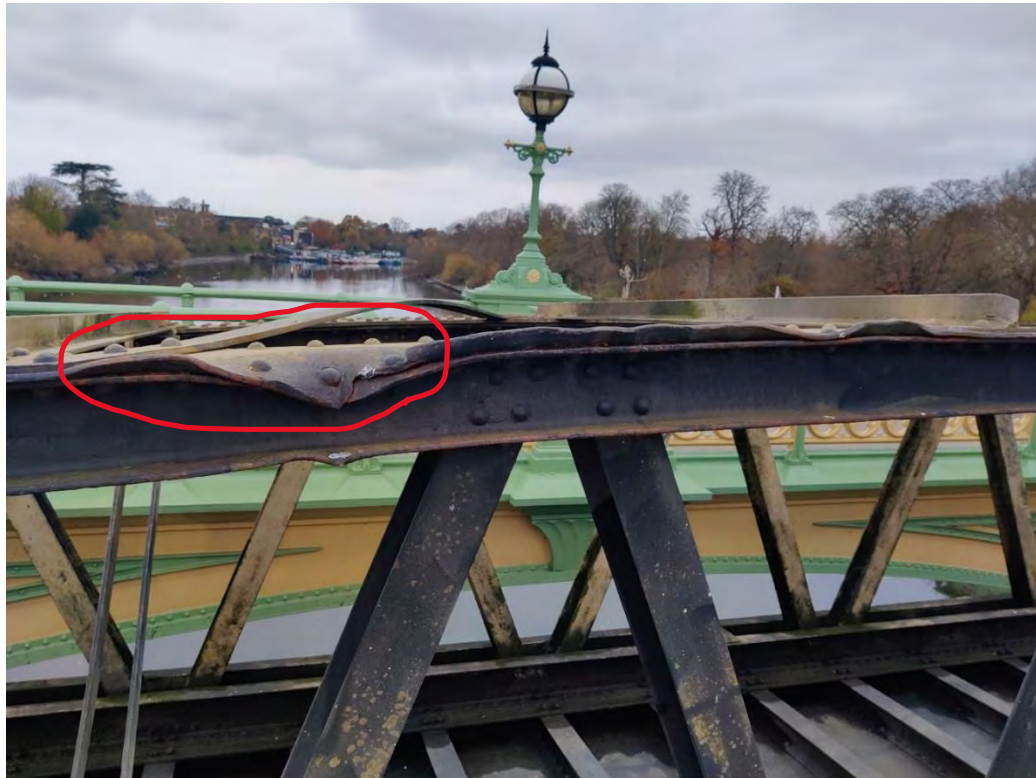
Many years ago, the centre weir gate was hit by a Class V passenger vessel. It rode up onto the gate folding over the top flange and buckling the diagonal below. This has never been repaired.

Photo 48: Impact damage from vessel riding up onto the Weir

5.2	Centre Weir damage	Repair impact damage and buckled diagonal

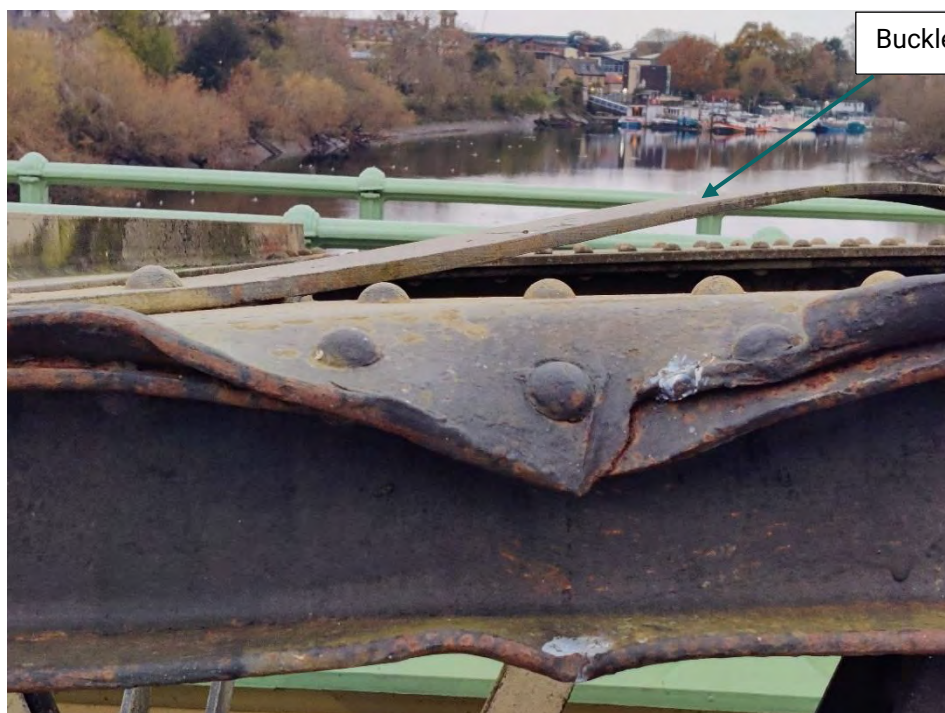
Photo 49: Upper flange rolled over

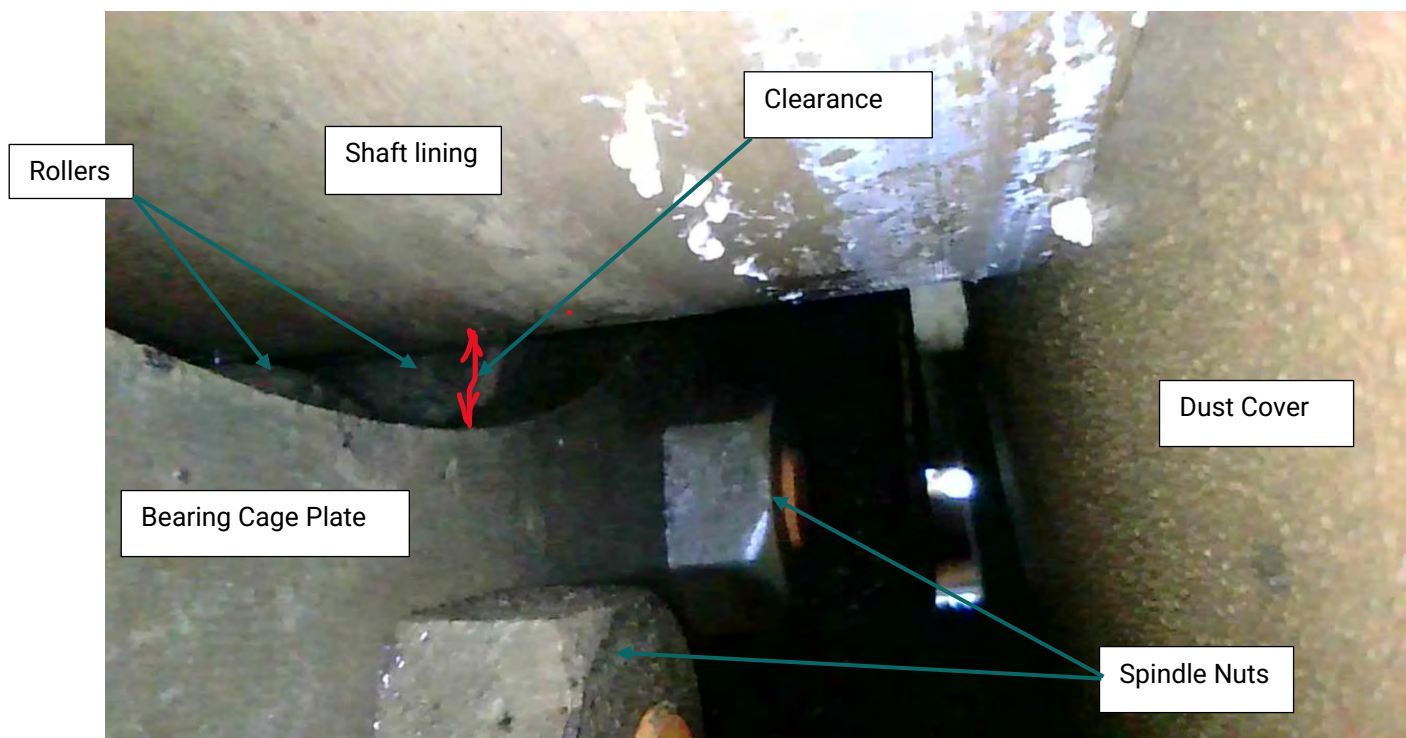
It was therefore raised on Feb 10th and the opportunity taken to look inside the bearing with a borescope. The test raising and lowering was silent without the noises previously heard. Looking inside confirmed the bearing had not catastrophically failed and clearances around the bearing cage more even than indicated by previous photographs. The bearing was also observed to be rotating but metal on metal “crinkling” noises could be heard during the rotation. By comparison the surrey trunnion was silent during rotation. There was however a gap of about ½” between the trunnion and shaft end cap on the surrey end. This indicates that the gate has moved towards the surrey side. On the next raising we will try to close this gap by pushing the trunnion back against the end stop.

Photo 50: Components of the Trunnion bearings – all are bronze

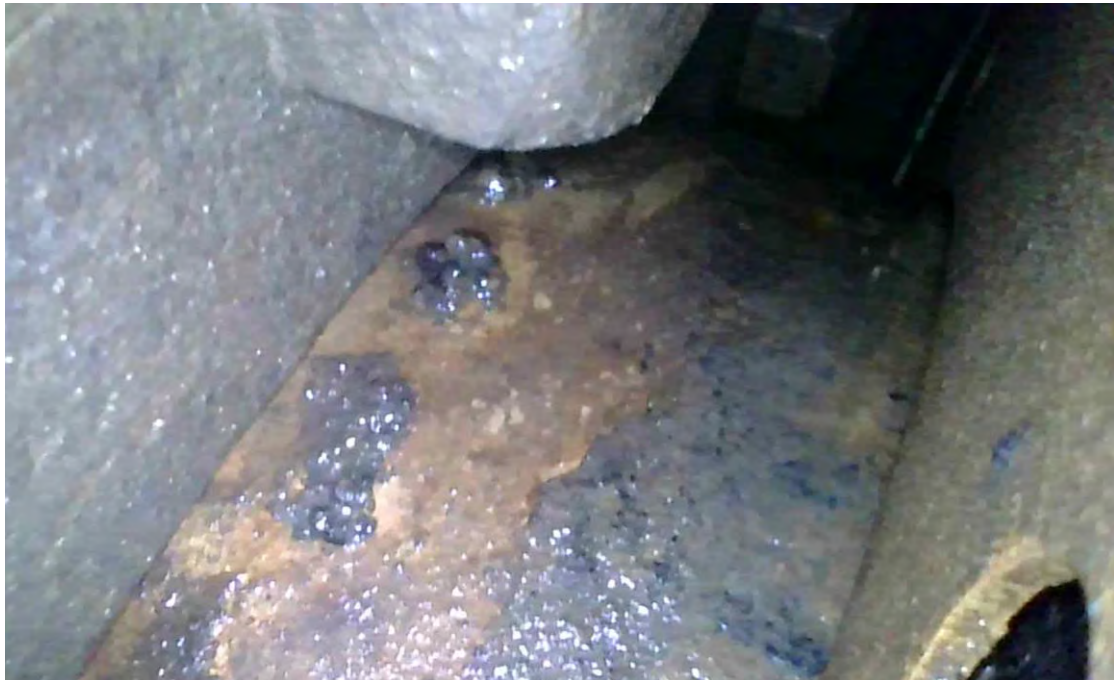
On Jan 21st a Borescope was used to look inside the trunnions as far as possible in the available space when the dust cover was removed. On the surrey end of the surrey gate the dust cover could not be retracted. Typical pictures taken are shown below of the three accessible trunnions. It is recommended that the trunnions should be listened to during their rotation (by riding on the gate as its lowered) to confirm they are silent and not making the same noise as the Centre Middlesex trunnion.

Photo 54: Small clearance between the bearing cage plate and shaft

Trunnion Bearings	6.2	Unknown condition of trunnion bearings	Move centre gate surrey trunnion back against its end cap
			Test raise the centre weir monthly
			Remove and refurbish both Centre gate trunnions at next draw off
	6.3	Middlesex & Surrey	Check noise of trunnions by riding on the Middlesex and Surrey gates during rotation
			Depending on the findings when the centre weir trunnions are removed it may be necessary to refurbish other trunnions in the coming year's draw off works.
Well Boxes	7	No zinc remaining on the anodes	Replacement Anodes to be fitted to all 12 well boxes

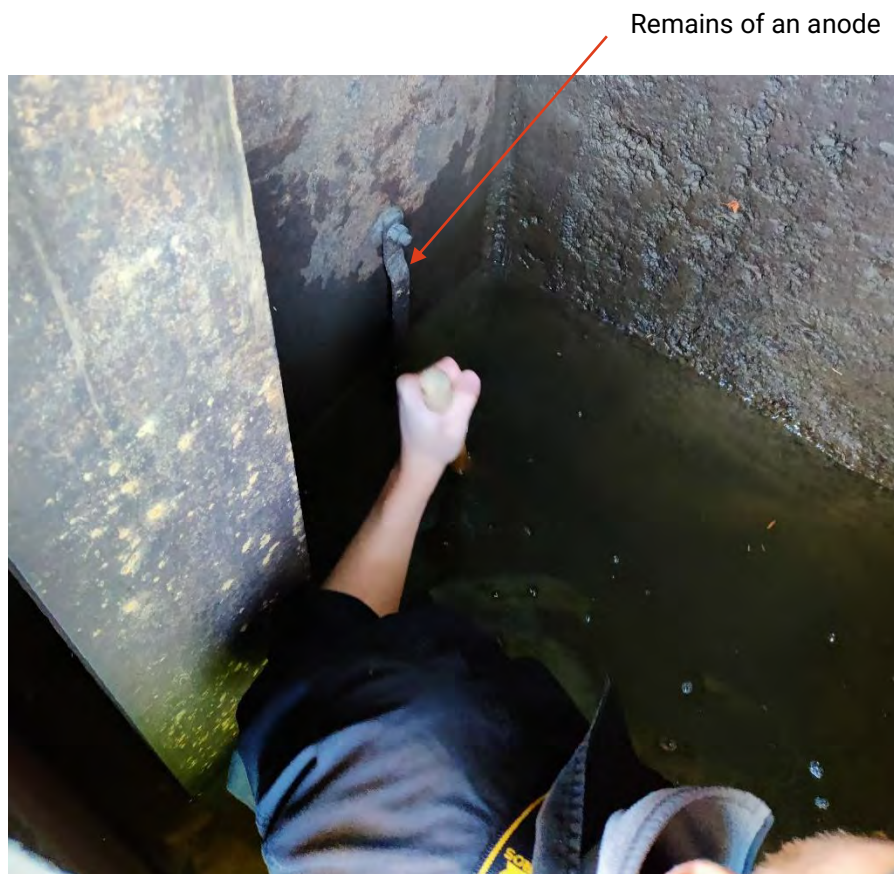
The anodes bolted to the well boxes have totally dissolved leaving only the bolted flat bars, see below. These should all be replaced.

Photo 56 – Dissolved Anode
