Condition Survey Report 2021/2

The PLA has commissioned a condition survey of the mechanical and civil structures at Richmond Lock and Weir. The last full survey was undertaken in the late 1980s prior to the major refurbishments in the early 1990s.

STRUCTURAL SURVEY SUB & SUPERSTRUCTURE CONDITION ASSESSMENT

CLIENT			Houlder Ltd			
PROJECT TITLE			Richmond Lock & Weir			
SUBJECT			Structural Survey			
DOCUMENT TITLE			Sub & Superstructure Condition Assessment			
DOCUMENT REF			2144-BRL-01-XX-RP-C-1000			
REVISION RECORD						
REV	STATUS	DATE	SUMMARY OF CHANGES	PREP	CHK	APP
P01	S2 – Suitable for Information	11/03/22		GG	-	TKHB
P02	S2 – Suitable for Information	25/03/22		GG	MB	TKHB

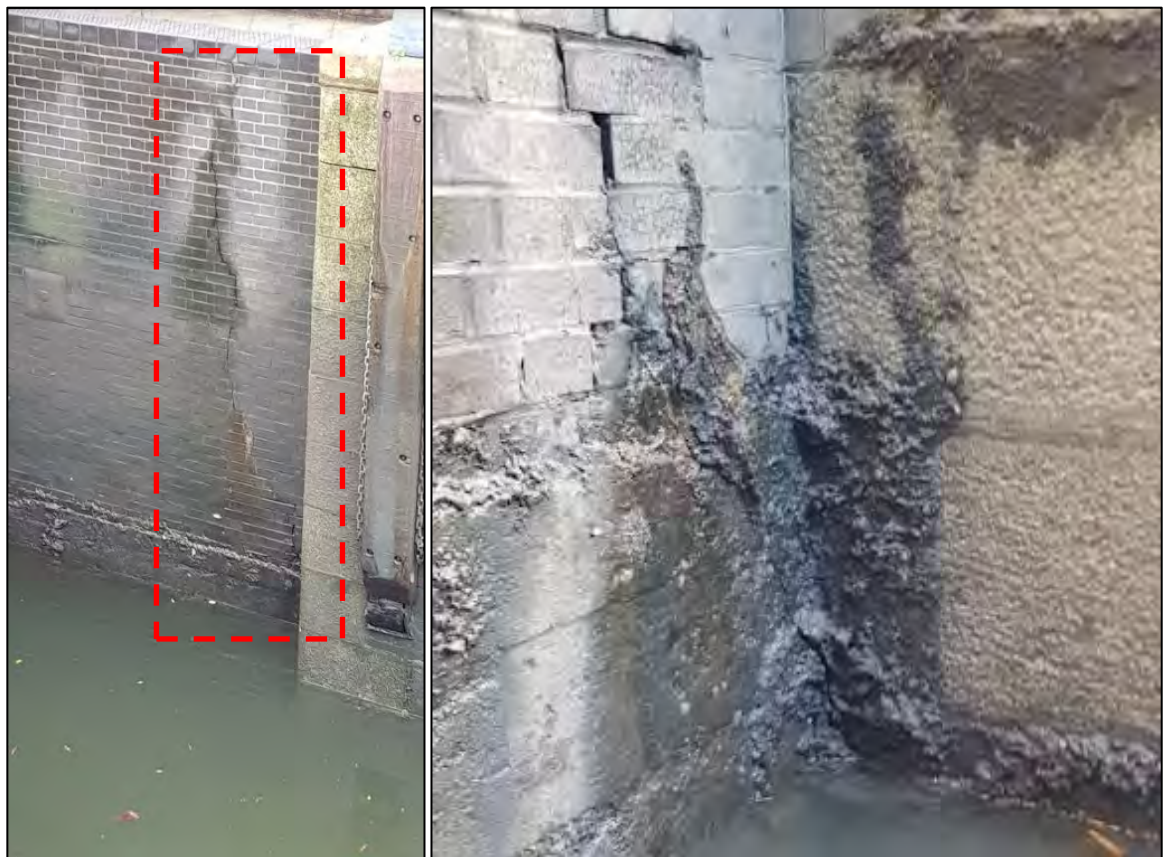
Figure 3.1: LW19 Cracking. Full height (left), low level (right)

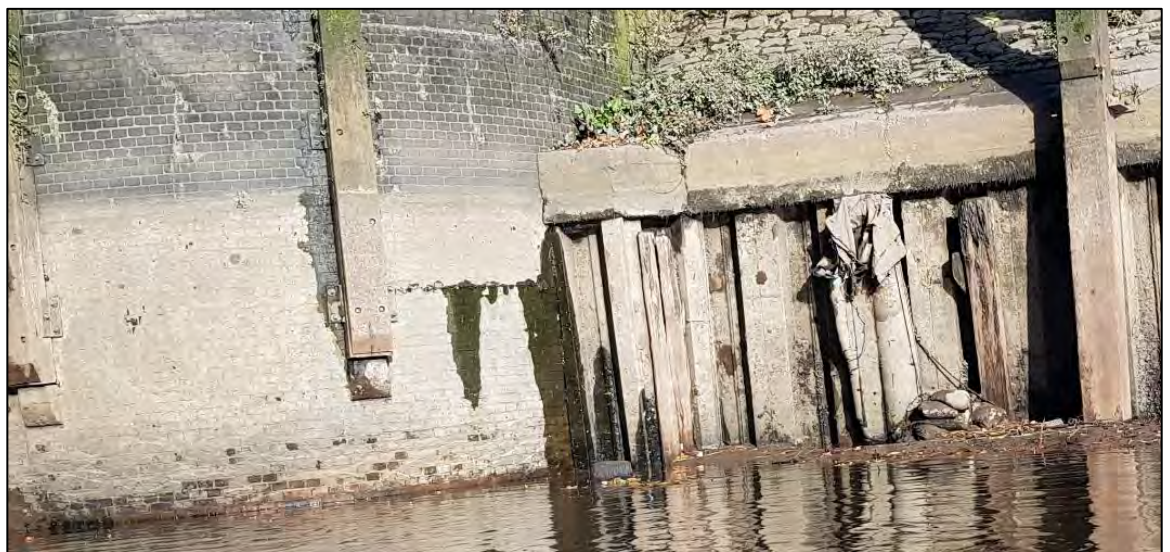
- 3.1.4 Across the wall there are numerous areas of water seepage identified. These locations correlate with crack locations and rubbing timber connections. While some areas of water seepage are very minor, a notable flow of water was observed from behind the rubbing timber at the LW7/8. During the survey, there was a significant flow of water at the interface between the lock wall, and the adjacent sheet pile wall at the upstream extent of LW1 (Figure 3.2).

Figure 3.2: LW1 - Interface Leak

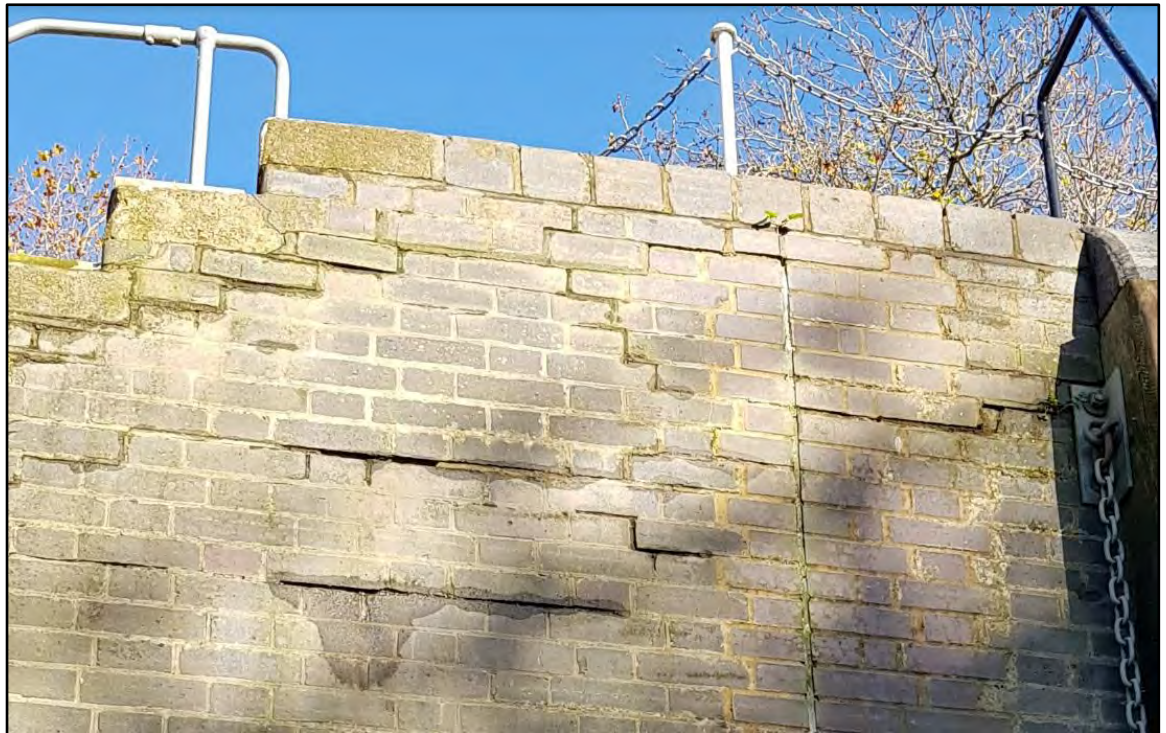
- 3.1.5 Mortar loss is evident in multiple locations across the wall. While this mortar loss varies in location it is most often seen directly beneath the coping and around the rubbing timbers (see Figure 3.3).

Figure 3.3: Typical mortar loss around rubbing timbers

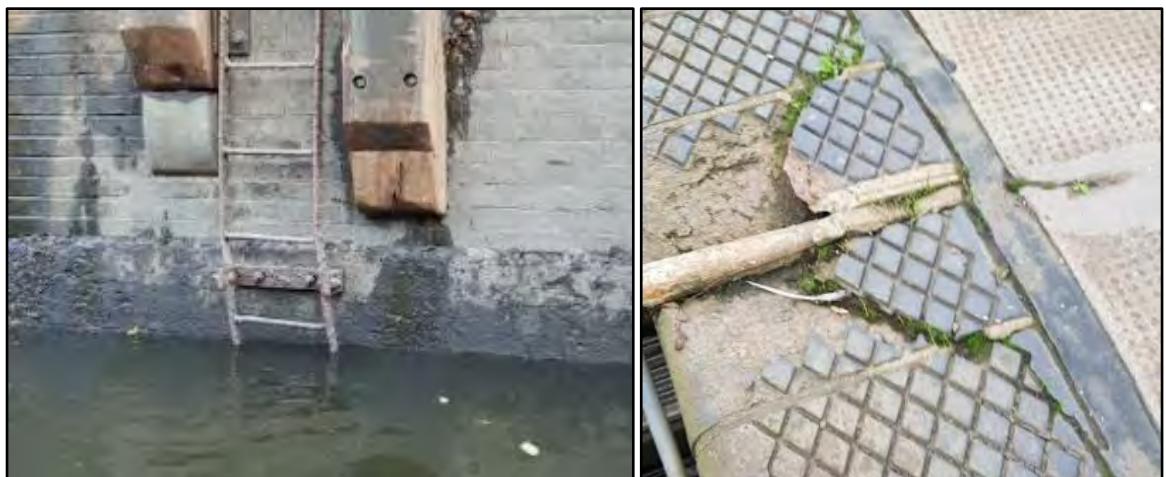
- 3.1.6 It was noted as part of the survey that the escape ladders are deformed at their lower extents (Figure 3.3) where they extend below the protecting fenders. This damage is assumed to be the result of vessel impact.

Figure 3.4: Ladder deformation (left), surfacing damage (right)

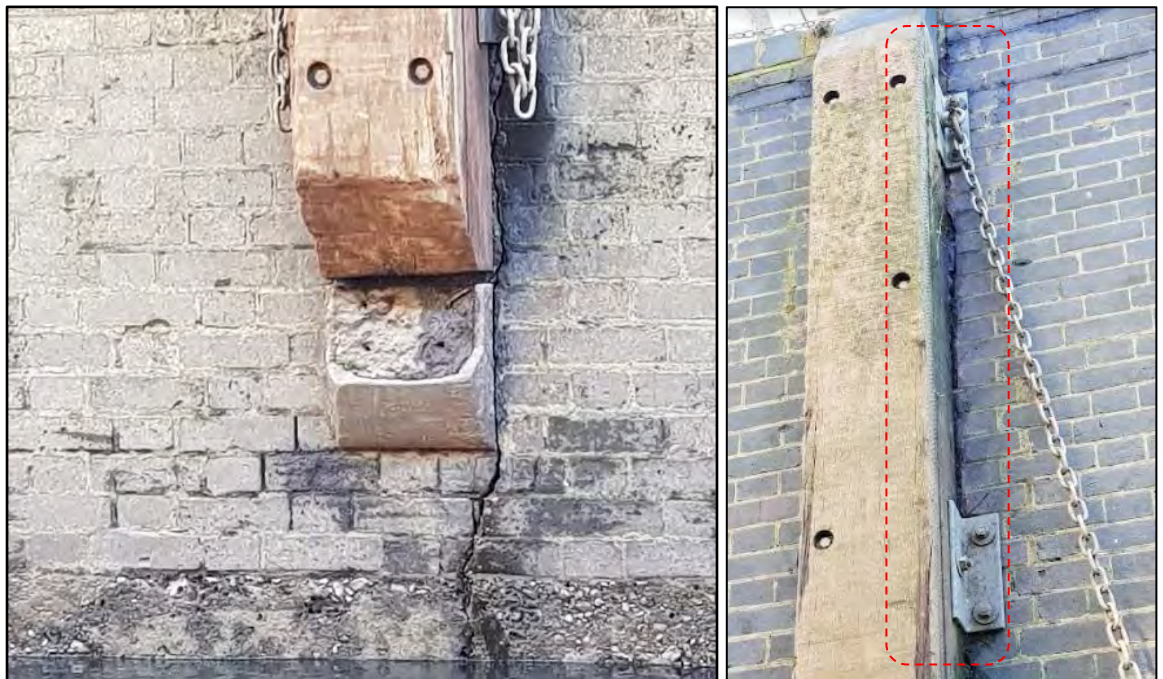
Figure 3.5: Crack alongside rubbing timber (LIS27/28)

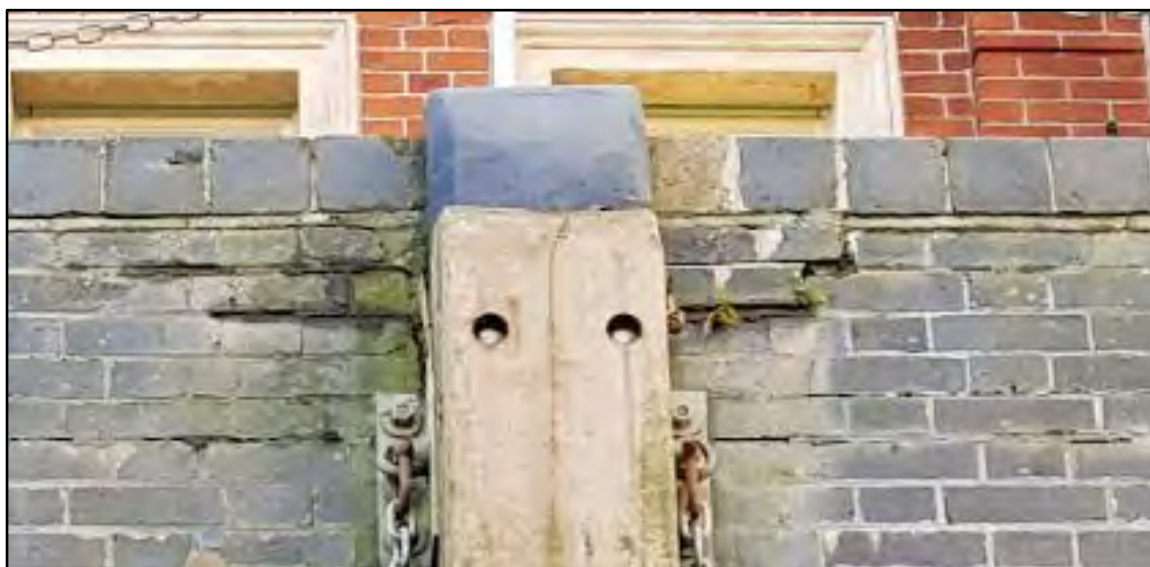
- 3.2.4 There are several cases of damage to the brickwork capping. These are usually located adjacent to the rubbing timbers (Figure 3.6).

Figure 3.6: Brickwork mortar loss and damage

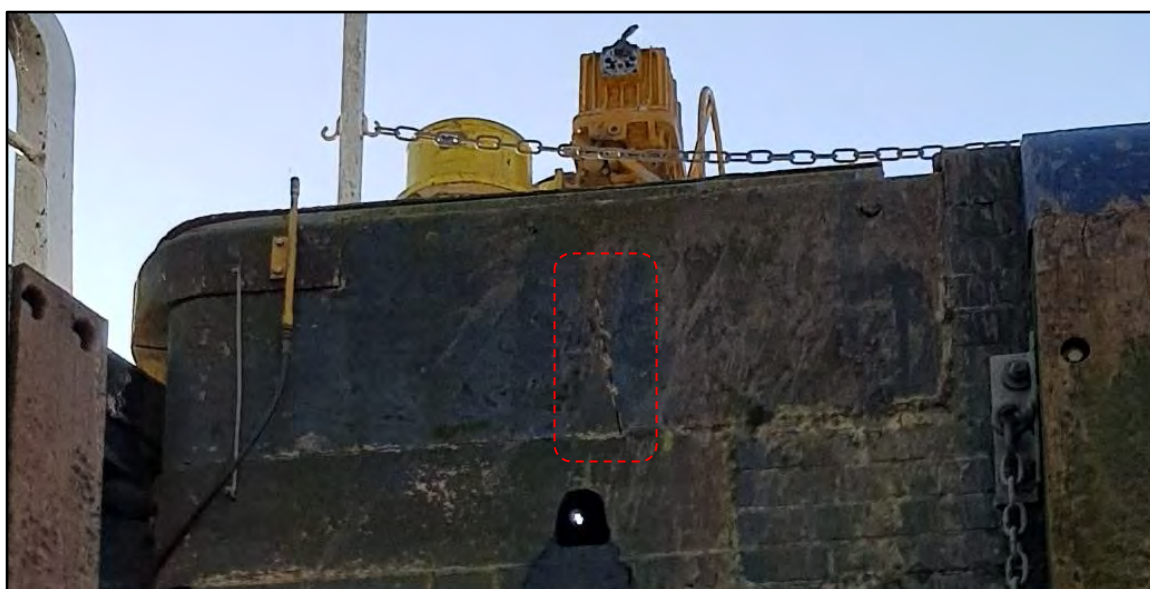
- 3.2.5 The steel plate which covers the lock gate mechanism at the upstream extent is cracked (Figure 3.7). This is covered in the Houlder Limit Report, refer to Section 3.3.

Figure 3.7: Cracked steel plate

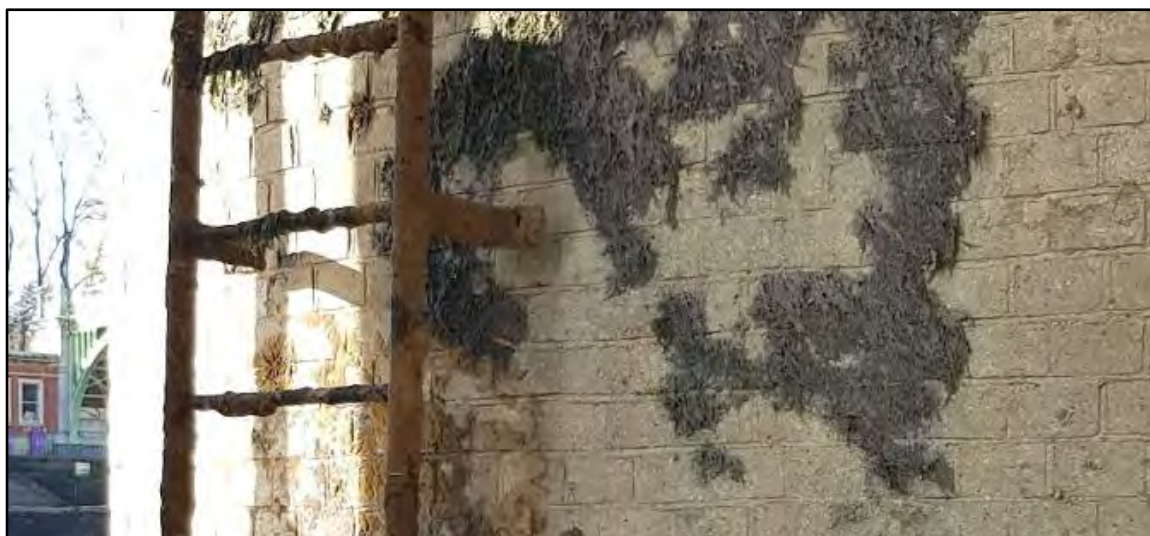
- 3.2.6 The ladder in wall section LIS43 has a failed fixing such that it is not connected to the wall at its lower level. This would usually be obscured by the maintained water level.

Figure 3.8: Failed Ladder connection

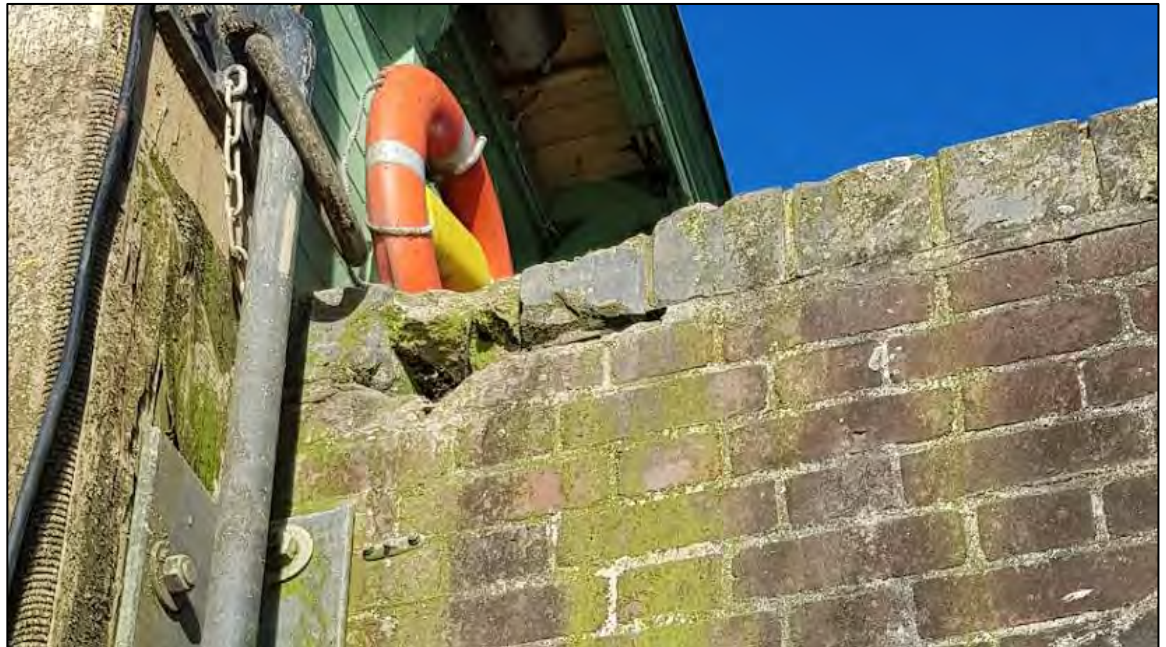
where there are existing irregularities in the wall (e.g., drainpipes, chain connections, rubbing timbers). In one instance, at LIM16, a hole is present just below the capping, it is assumed a drainpipe or similar was once installed here (Figure 3.10)

Figure 3.10: Hole in Capping

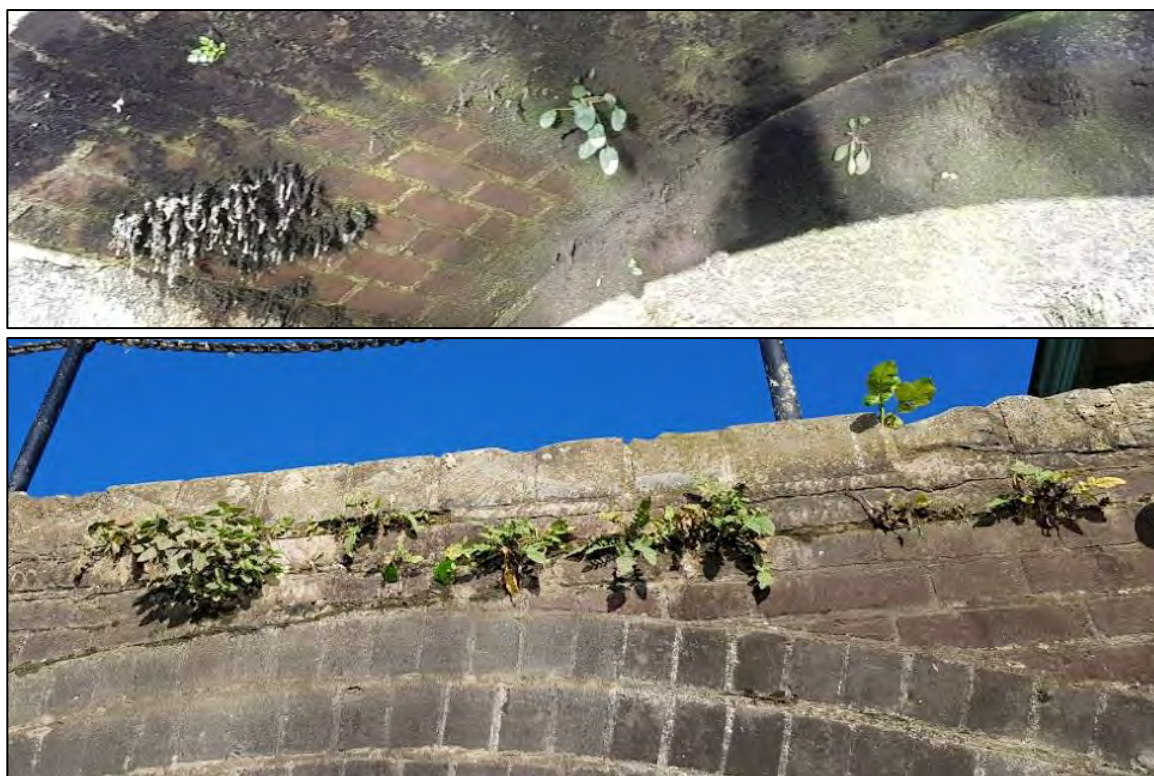
- 3.2.9 There are multiple areas of vegetation growth also located beneath the capping, examples are shown in Figure 3.11, which represent some of the more vegetated areas observed.

Figure 3.11: Typical vegetation growth

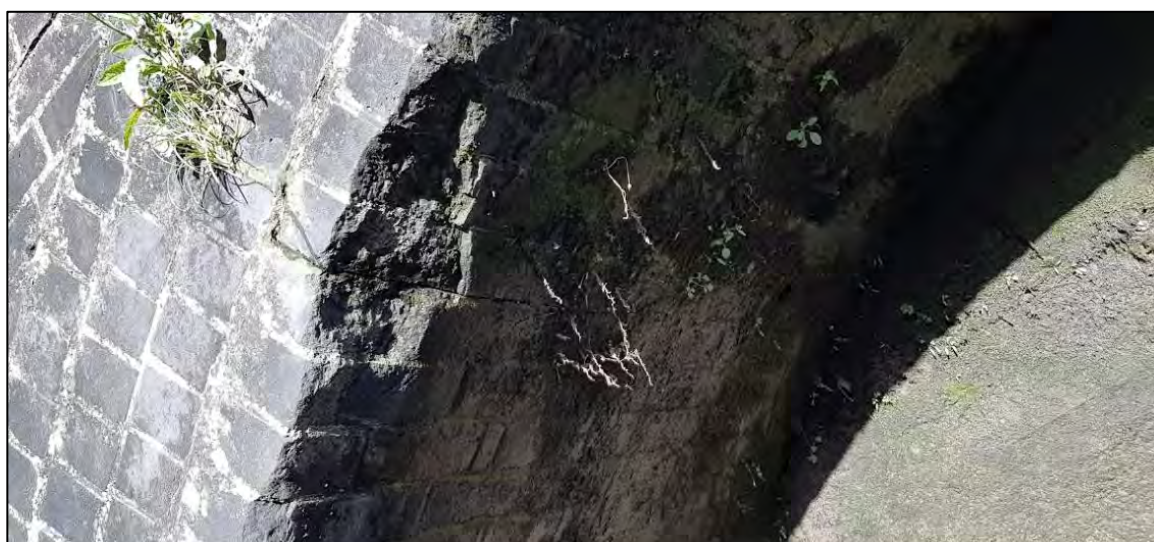
- 3.2.10 There are areas, such as that shown in Figure 3.12, where the brickwork is damaged. These areas are usually on the corner of the arch supports.

Figure 3.12: Arch Support Brickwork Damage

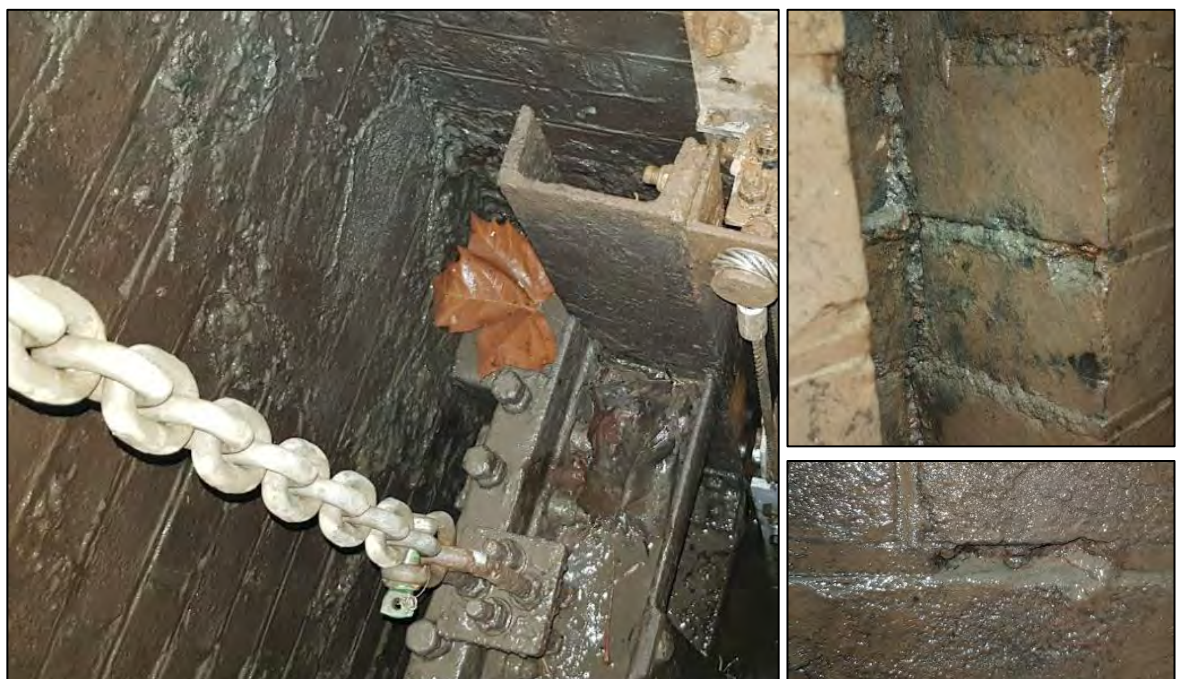
- 3.2.14 The downstream sluice pit is in **good** condition.
- 3.2.15 The sluice pit has two platforms, once at a low level (directly above the sluice gate), and one beneath the counterweight. Both of these platforms were found to be secure and accessed as part of the survey.

Figure 3.13: Downstream sluice pit - minor grout loss

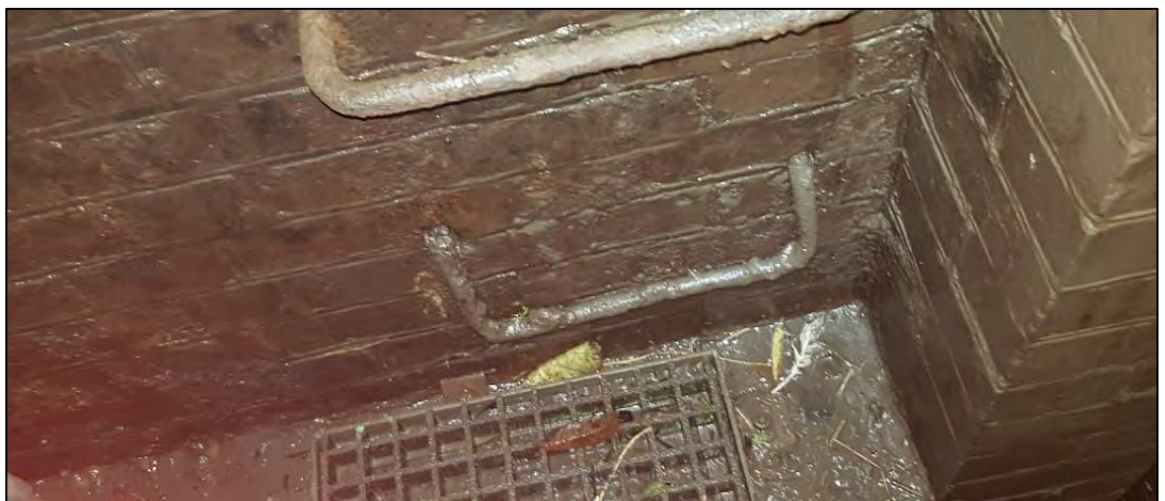
- 3.2.16 The brickwork is generally in a **very good** condition, although grimy in places. The soffit of the arch is obscured by marine growth and could not be closely inspected. There is very minor loss of grout in some localised locations (Figure 3.13) behind the upstream-most sluice chain and alongside the channels built into the brickwork on the riverside face. These channels are assumed to be used for a stoplog support during any sluice gate works.
- 3.2.17 The lowest rung of the access ladder is no longer perpendicular to the wall and is thus not fit for purpose. (Figure 3.14). The rung could not be moved by hand.

Figure 3.14: Access ladder rung

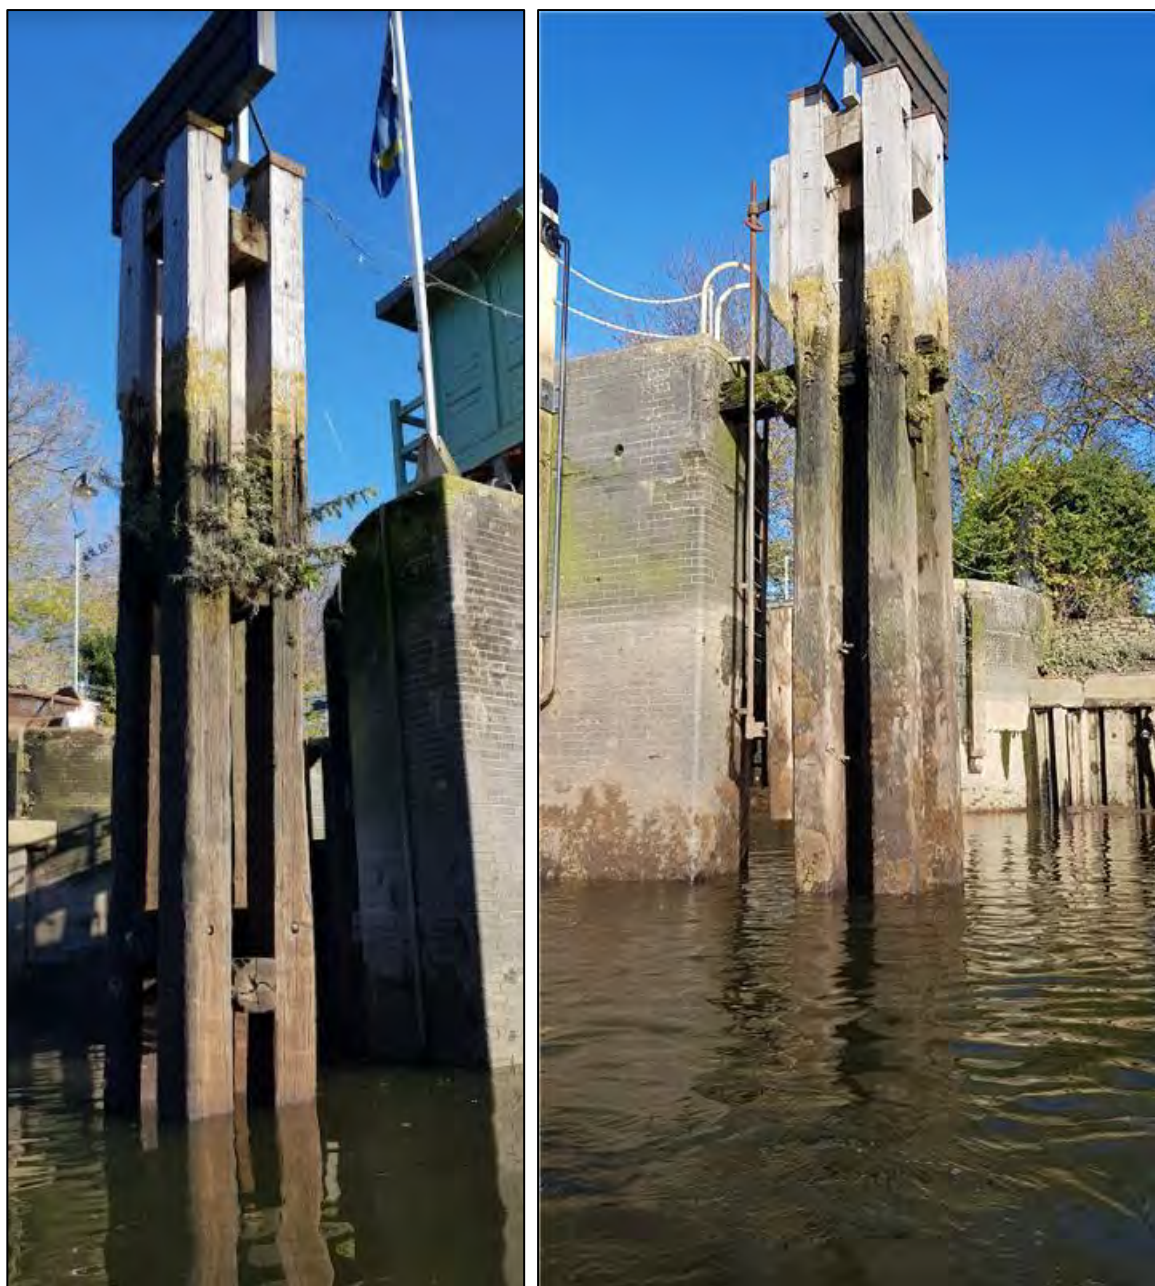
- 3.3.2 Of these, the upstream dolphin is in **very poor** condition. The timber members are decaying and there is significant section loss within the intertidal range. The dolphin structure has lost its verticality and has developed a twist..
- 3.3.3 The downstream dolphin is in a **fair** condition, while the timber demonstrates similar decay and section loss, the structure retains its verticality and positioning.
- 3.3.4 Neither timber could be accessed for knife penetration testing as part of the survey.
- 3.3.5 It is noted these timber dolphins are independent from the main Richmond Lock structure and do not therefore contribute significantly to its operation, thus their condition is perhaps of lesser importance. However, the dolphins do provide impact protection as well as supporting PLA notice boards advising river uses of local conditions.

Figure 3.15: Timber Dolphins, Upstream (right), Downstream (left)

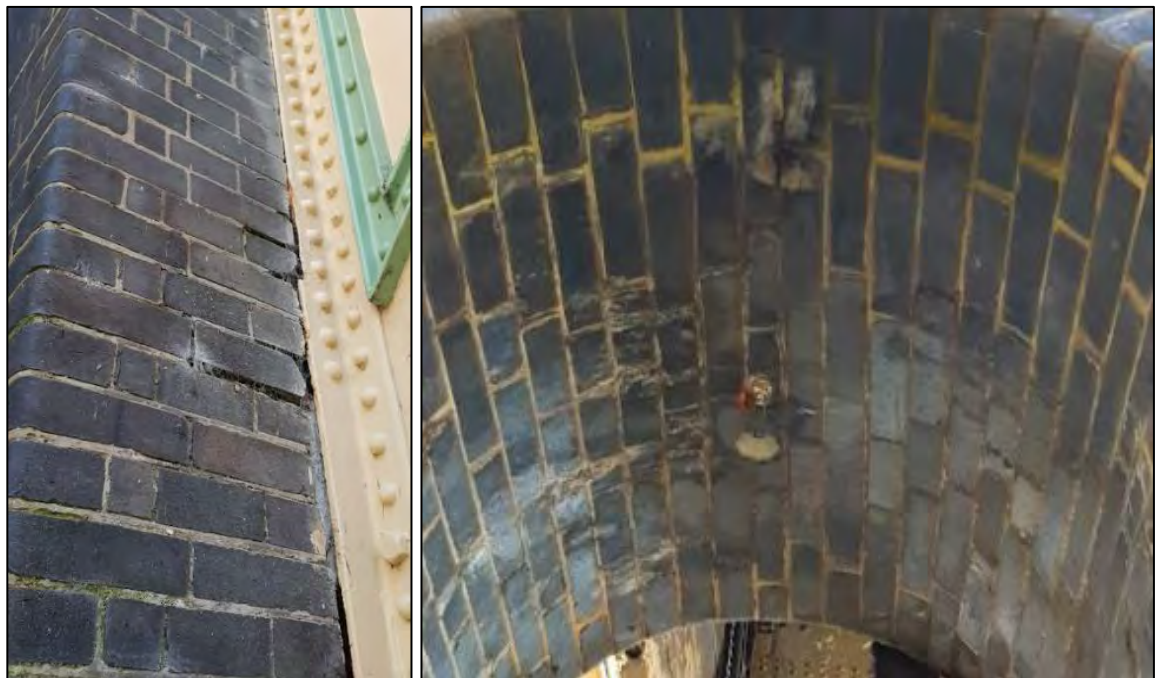
- 3.4.3 The brickwork of Pier 0 is in a **good** condition. The north face of the pier could be accessed from the lock island, as such the pier could be inspection more closely that the south face, and the following piers within this section.
- 3.4.4 The north face exhibits calcium staining in places, particularly on the soffits of the window arches built into the pier (Figure 3.16).

Figure 3.16: Pier 0, Mortar loss (left), arch soffit staining (right)

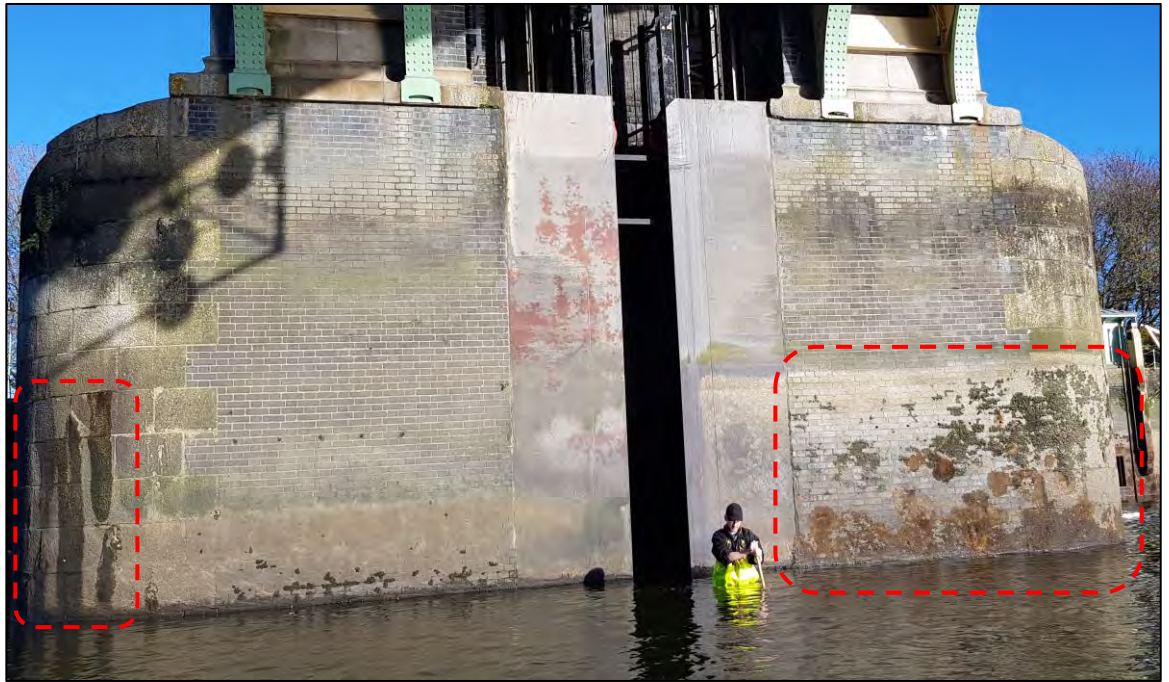
- 3.4.7 The brickwork of Pier 1 is in **good** condition. Marine growth is evident around the high-water line. Further staining is present on the upstream side of the pier, at heights which would usually be covered were the survey not carried out during draw off (see Figure 3.17).

Figure 3.17 Pier 1. Water seepage (left), vegetation staining (right)

- 3.4.8 Water seepage was observed between the blockwork at the downstream end of the pier (Figure 3.17). While not a key defect, it suggests there may be a void or similar failing of the mortar in this location.

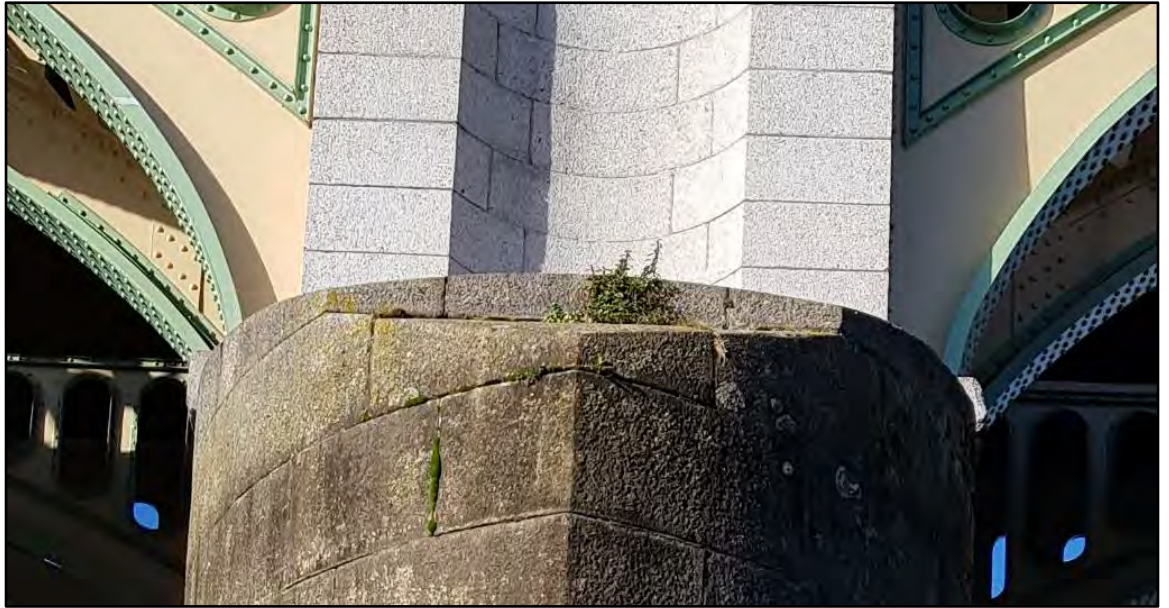
Figure 3.18: Pier 1. Upper level vegetation

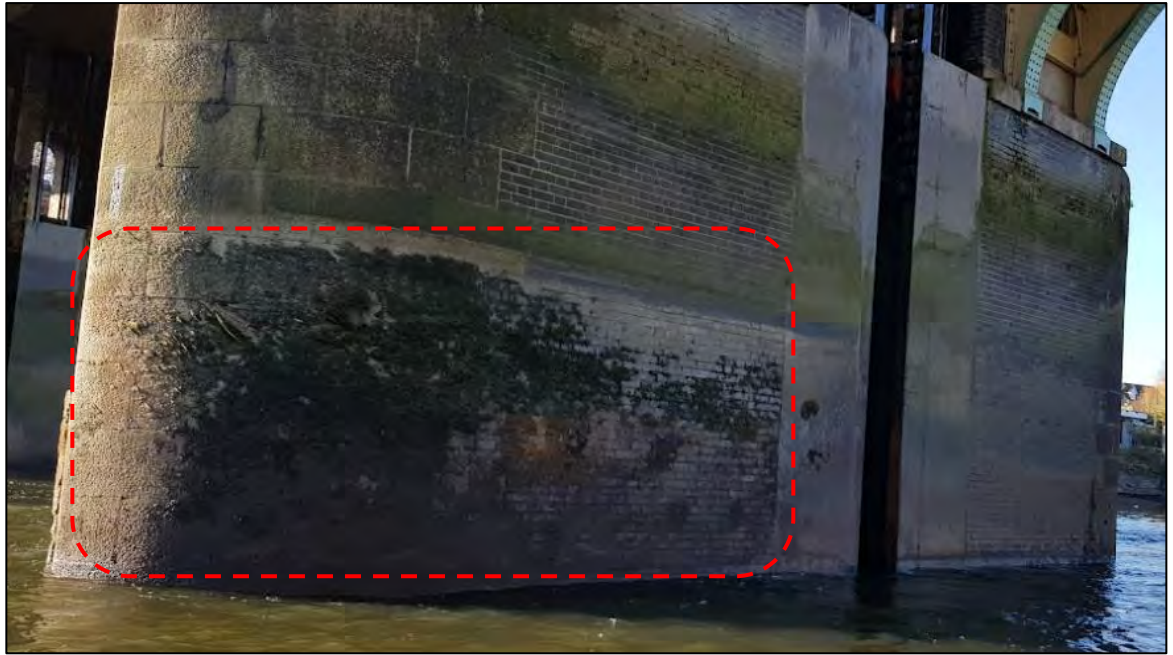
- 3.4.10 Pier 2 is in good condition as per Pier 1 and shares the same typical defects as identified previously. Marine growth obscures the brickwork around the high-water level. A larger patch of marine growth is present on the upstream blockwork which would usually be below water level (Figure 3.19).

Figure 3.19: Pier 2 - Marine Growth

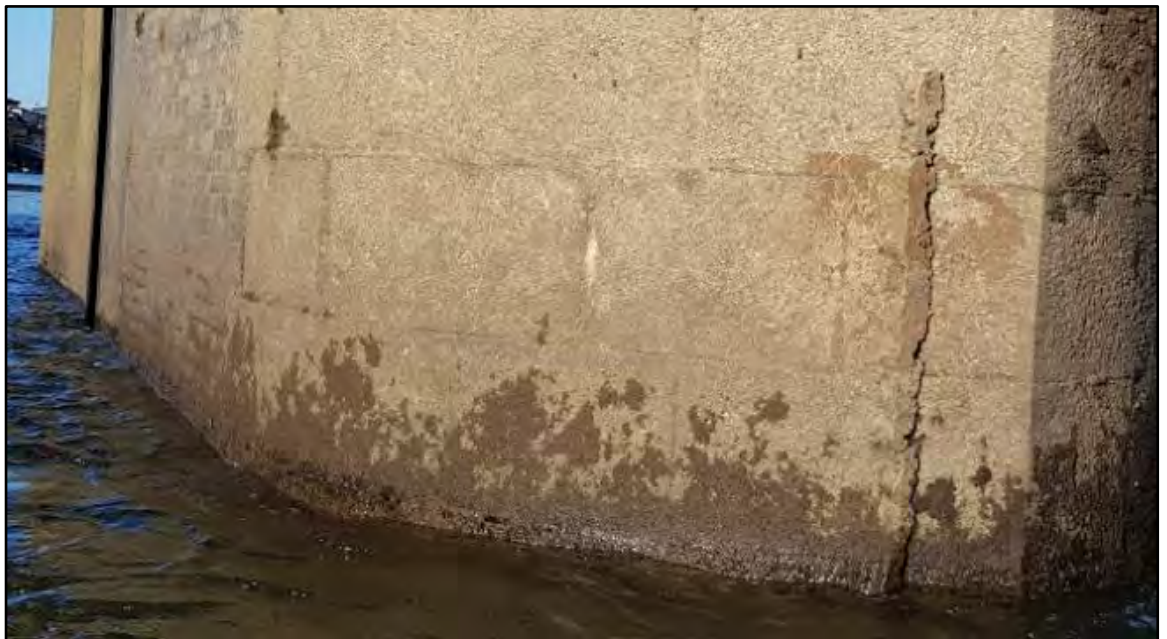
Figure 3.20: Pier 2 - previous repair

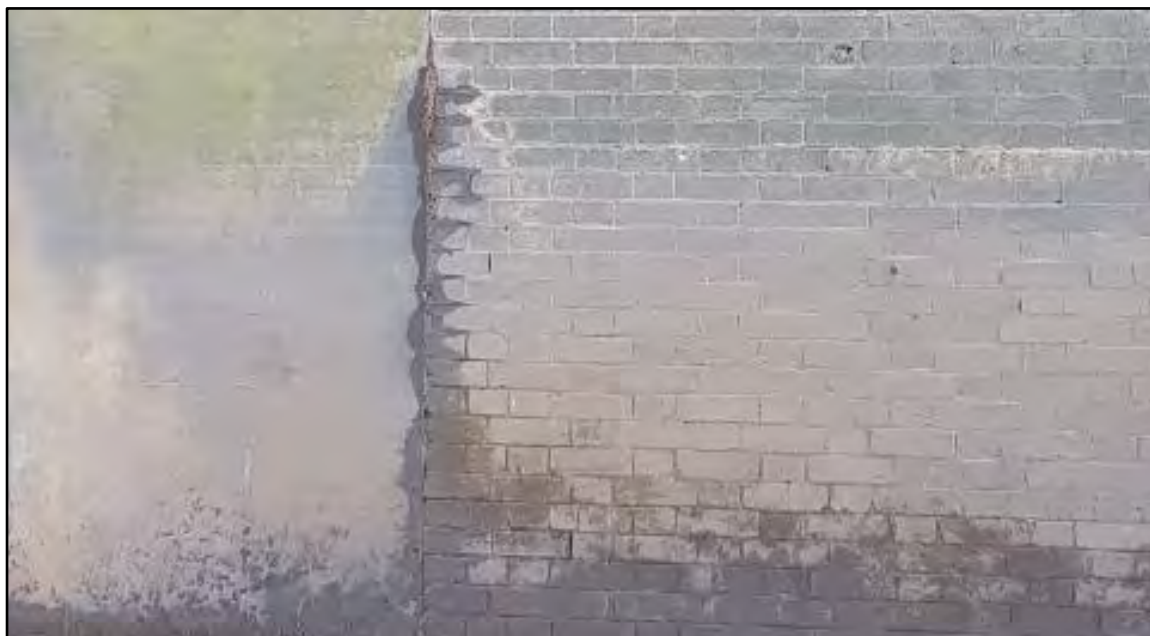
Figure 3.21: Pier 3 - Water seepage

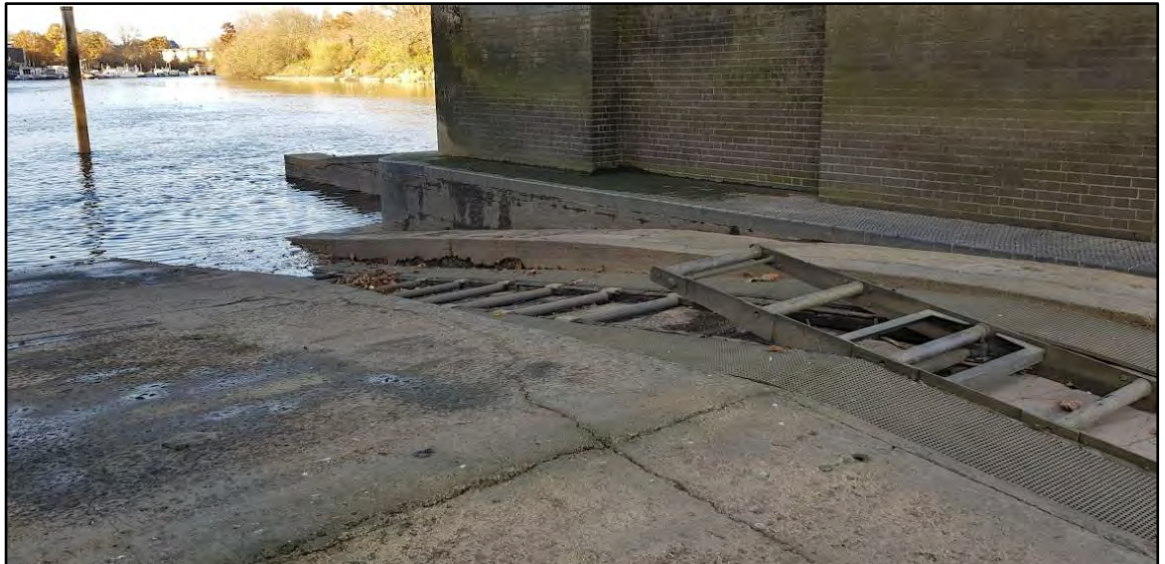
- 3.5.3 The concrete apron upper slab is in a **good** condition. There is a construction joint between the two concrete pours where the gradient of the ramp changes. Several cracks are present across the surface of the concrete but they do not compromise its function.

Figure 3.22: Concrete Apron

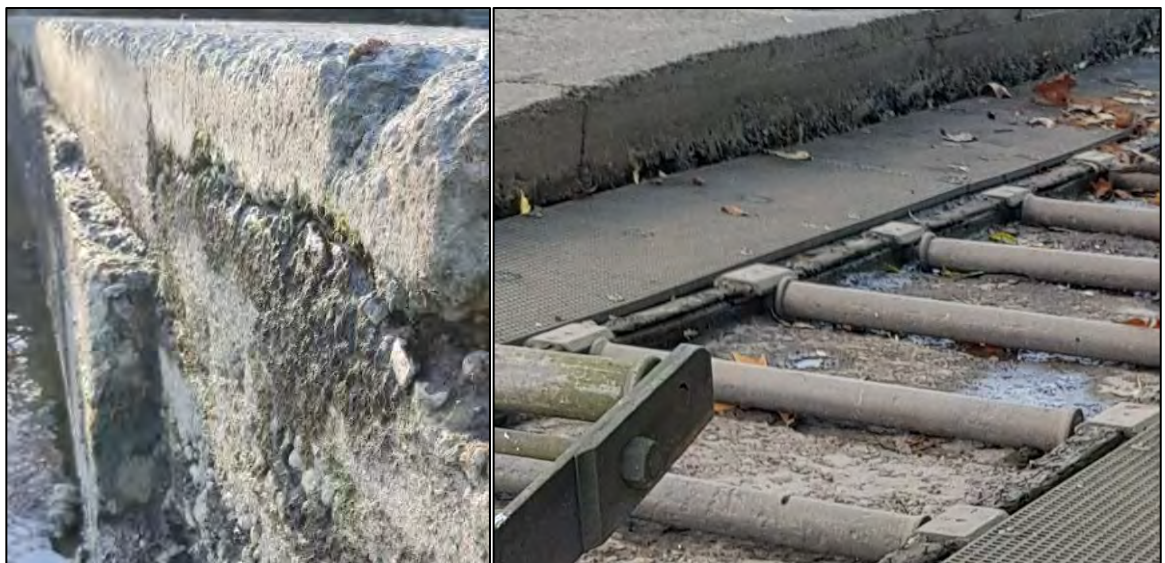
- 3.5.4 The lower concrete slab can only be seen beneath the tracked rollers, and at the end of the structure on the upstream side, where the ramp does not extend down to the foreshore level. The slab is in a **fair** condition, although the top surface is aged and abraded.

Figure 3.23: Concrete Slipway - Low Level Concrete

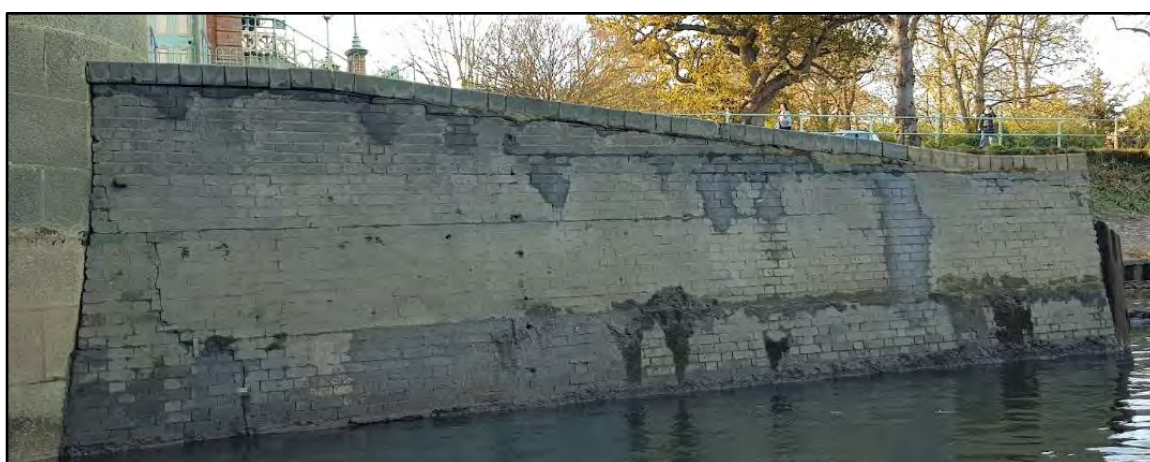
- 3.5.5 The retaining wall is formed from brickwork masonry and in a varied condition across its length.
- 3.5.6 Downstream of Pier 3, the wall is in a **fair** condition. The wall is cracked in numerous places; these cracks are often the full height of the wall. Water seepage is also noted along several of the mortar joints. The walkway along the top of the wall can be felt to be settling towards one side suggesting some movement, but this was not observed on the front face of the wall.

Figure 3.24: Pier 3 - Downstream retaining wall

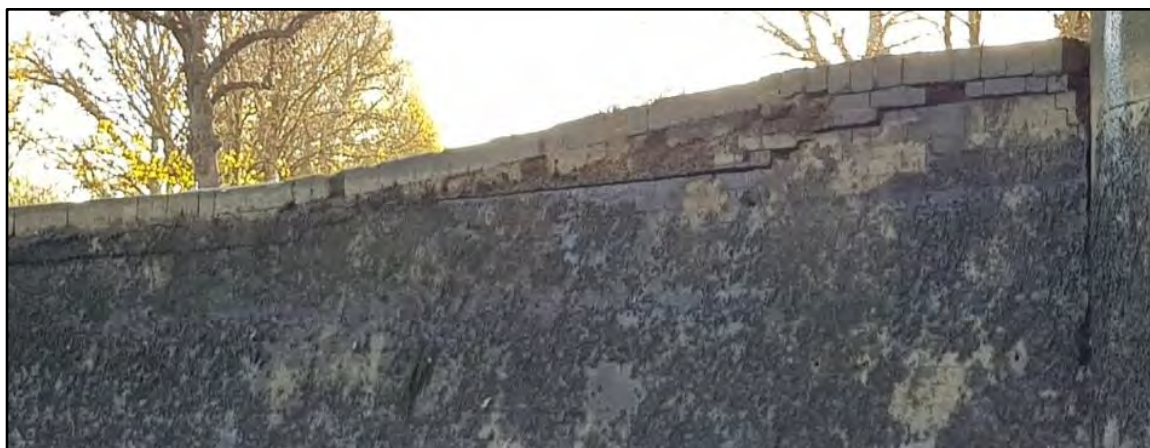
Figure 3.25: Upstream Slipway wall - missing mortar and brick

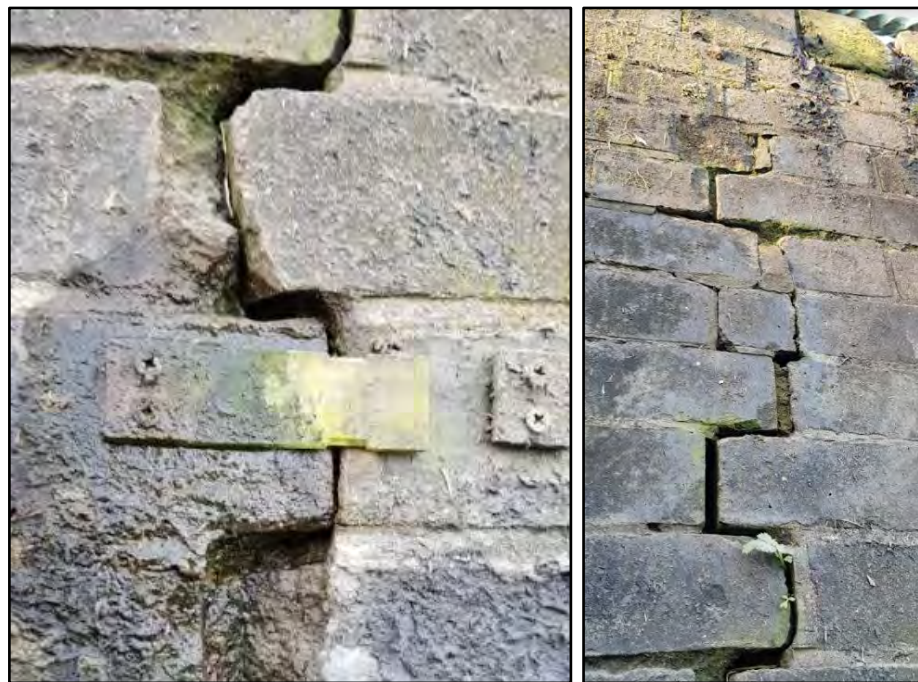
Figure 3.26: Slipway Wall - Typical Cracks

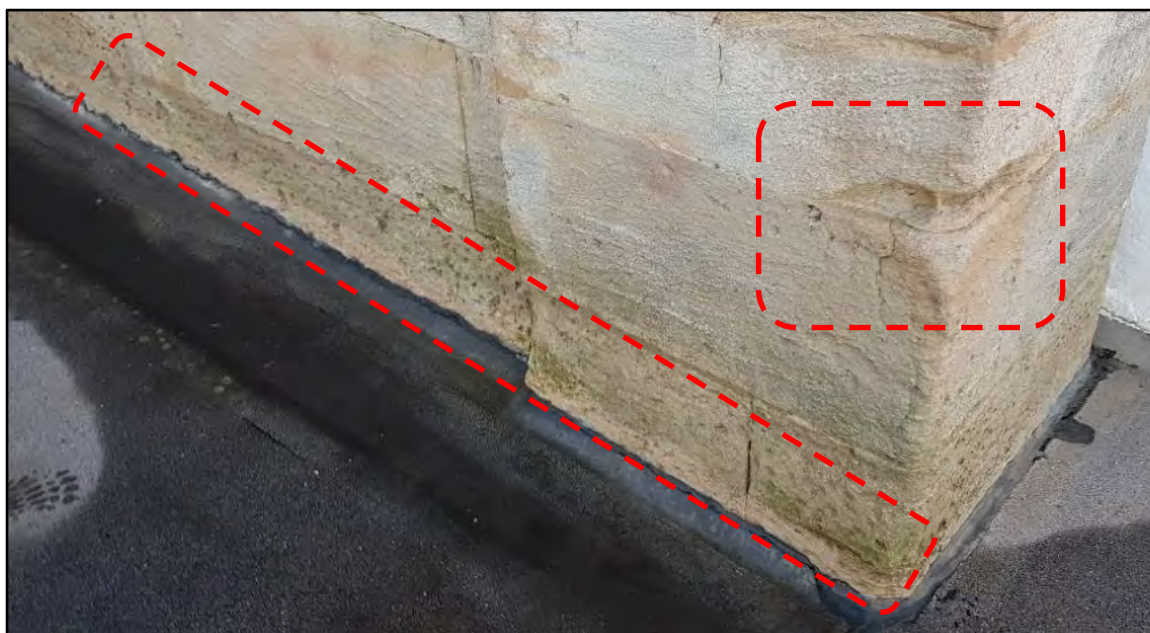
Figure 3.27: Tollhouse - low level erosion, and blockwork damage (red)

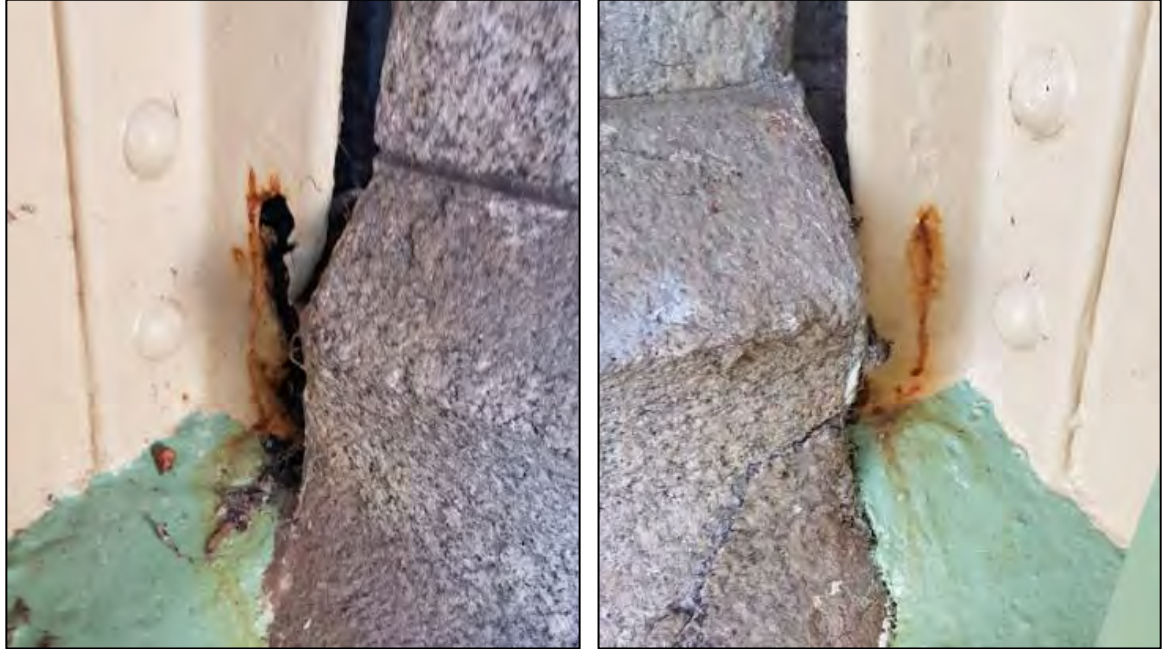
Figure 3.29: Corrosion at base of pedestrian support flange (typical)

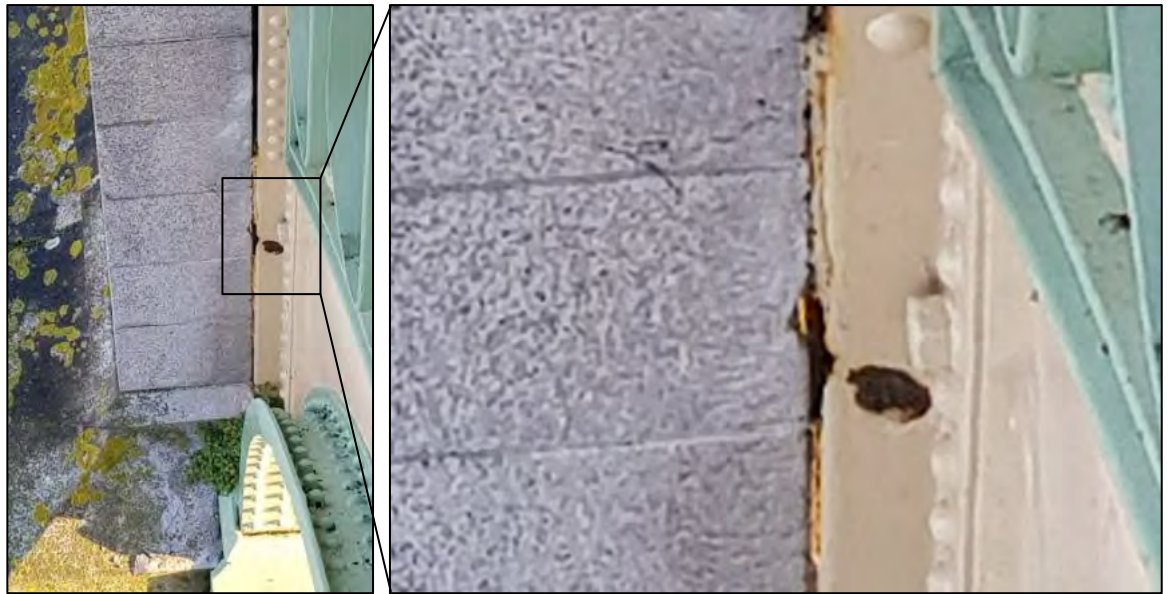
Figure 3.30: Pier Landing - Typical corrosion locations - Pier 1, 2, 3
