SAFETY BULLETIN No.3 of 2013

FAILURE TO KEEP A PROPER LOOKOUT

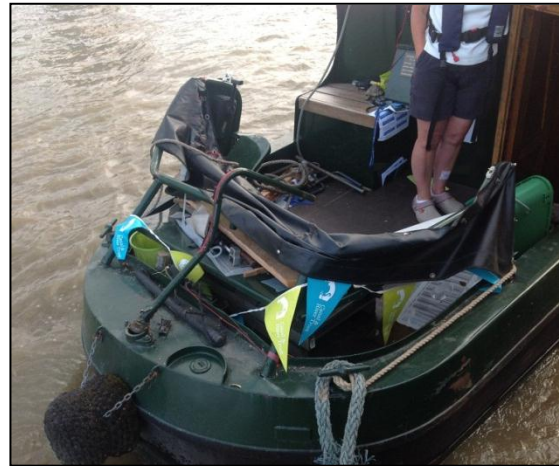
In a recent incident, a vessel collided with a narrow boat after re-entering the navigational channel at the Coin Street Moorings. The impact damaged the narrow boat's stern and disabled her steering. The Master admitted not seeing the narrow boat at all. **Where visibility is restricted or small craft maybe encountered, Masters should consider whether they require someone else to assist to maintain a proper lookout.**

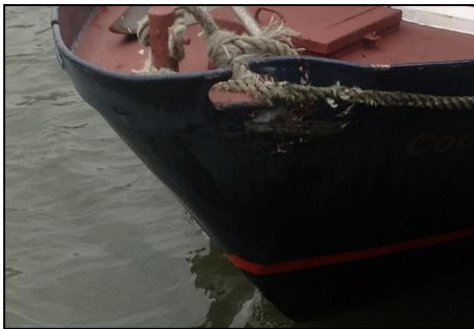
In another incident, a vessel collided with a mooring buoy in clear visibility while the Master had been distracted re-booting navigational equipment. **Masters should avoid distraction by delegating tasks to crew to ensure that a proper lookout is maintained at all times.**
