Condition Survey Report 2021/2

The PLA has commissioned a condition survey of the mechanical and civil structures at Richmond Lock and Weir. The last full survey was undertaken in the late 1980s prior to the major refurbishments in the early 1990s.

STRUCTURAL SURVEY SUB & SUPERSTRUCTURE CONDITION ASSESSMENT

CLIENT			Houlder Ltd			
PROJECT TITLE			Richmond Lock & Weir			
SUBJECT			Structural Survey			
DOCUMENT TITLE			Sub & Superstructure Condition Assessment			
DOCUMENT REF			2144-BRL-01-XX-RP-C-1000			
REVISION RECORD						
REV	STATUS	DATE	SUMMARY OF CHANGES	PREP	CHK	APP
P01	S2 – Suitable for Information	11/03/22		GG	-	TKHB
P02	S2 – Suitable for Information	25/03/22		GG	MB	TKHB

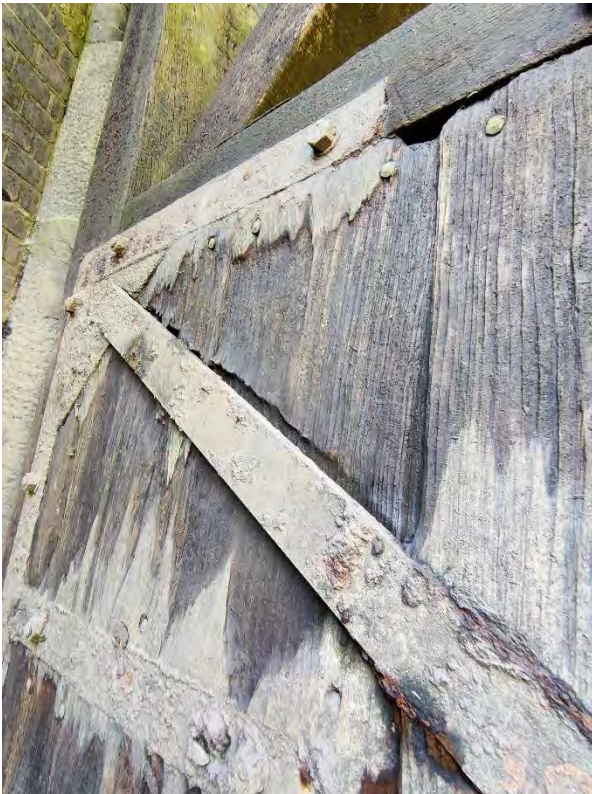
Timber of gates is eroded as shown below but the wood remains hard and resistant to penetration from a bradawl.

Photo 1: The steel straps have minimal wastage

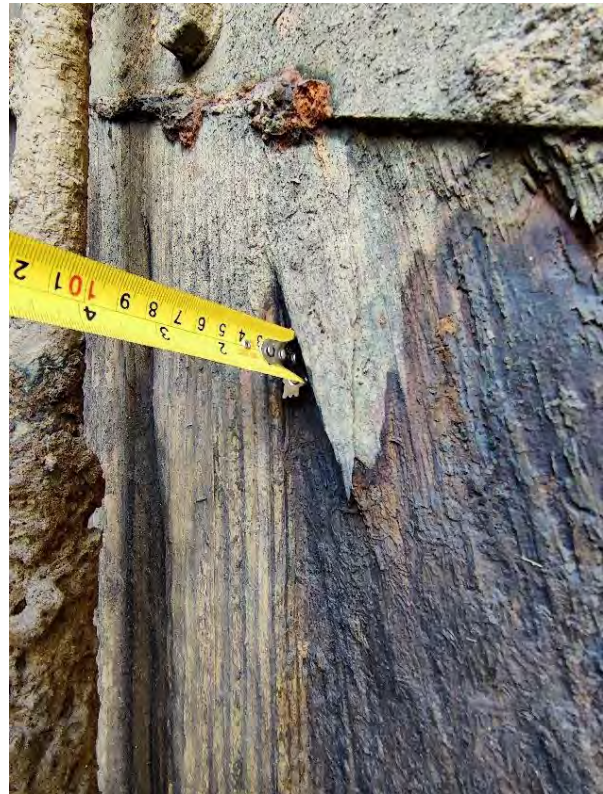
Photo 2: Typical 10-12mm of eroded timber

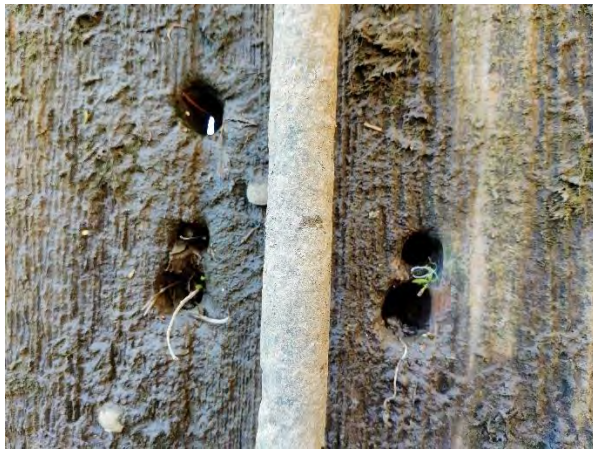
There are some isolated holes going deep into the timber and in one case all the way through. These should be plugged to prevent further loss.

Photo 5: Downstream Gate holes

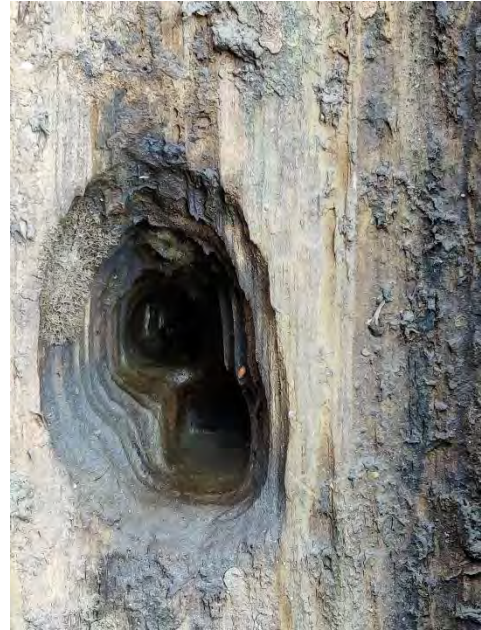
Photo 6: Upstream holes

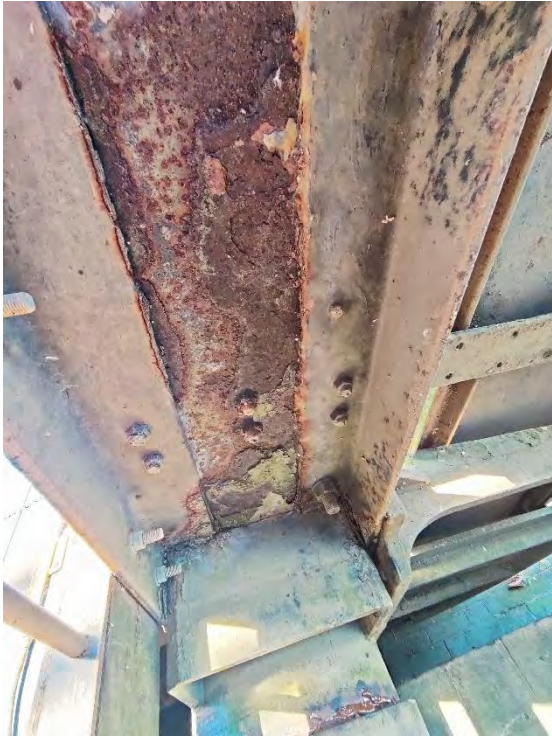
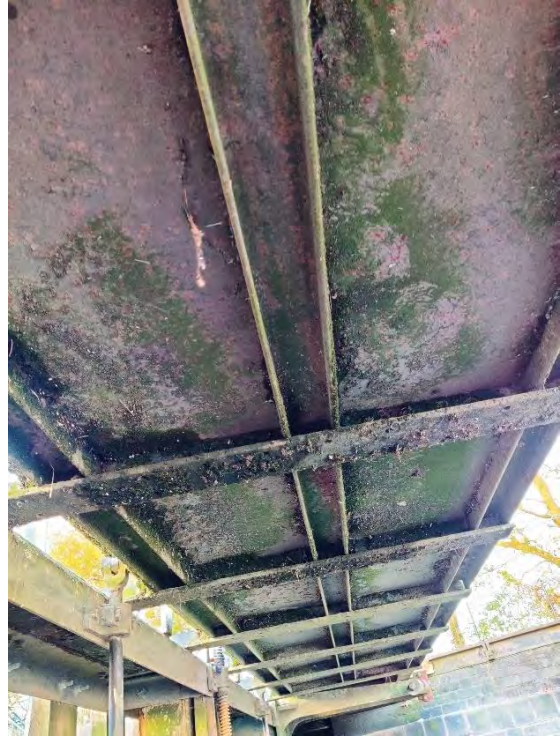
Underside of walkway deck is rusty with minimal paint coating remaining.

Photos 7 & 8: Underside of Upstream Walkway

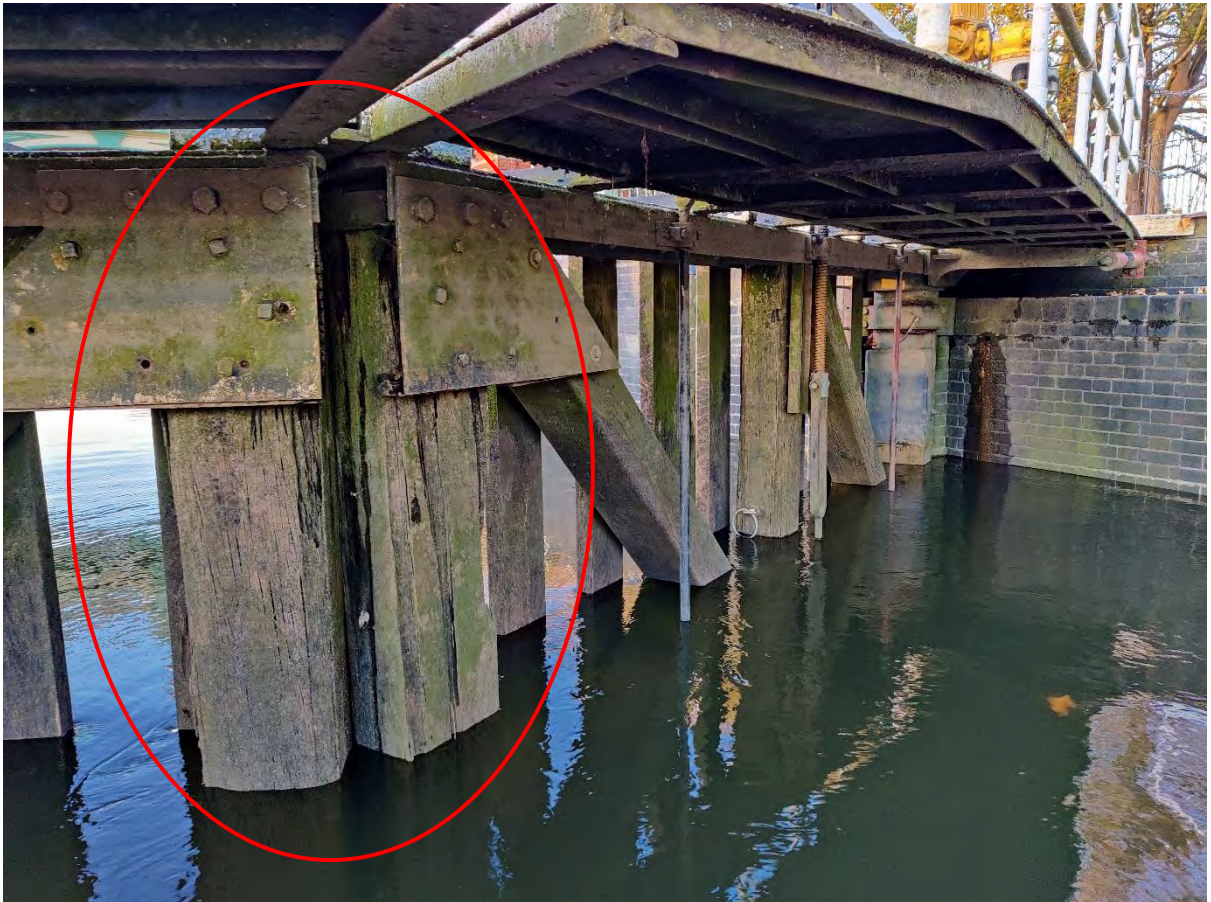
The tops of both main central verticals are badly rotten together with lapped packer pieces behind the steel plates as shown below.

Photo 10: Area of concern highlighted

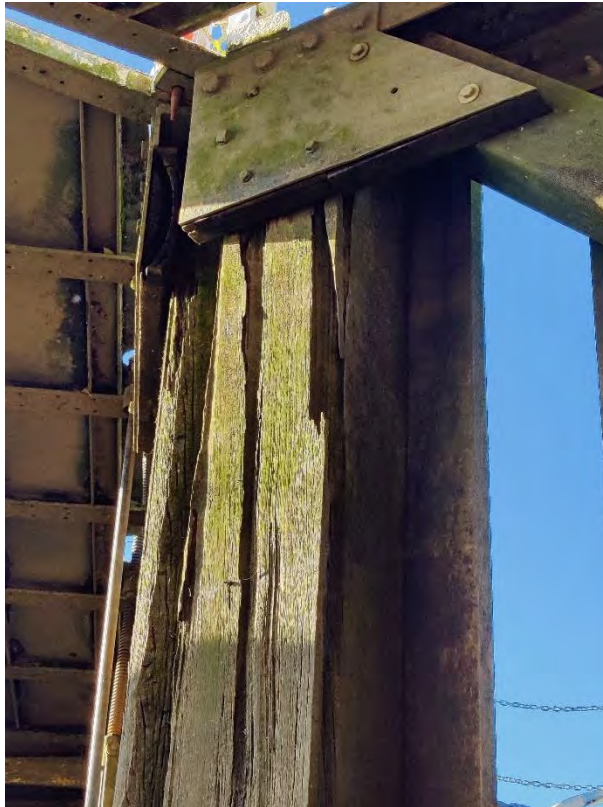
Photo 11: Surrey gate

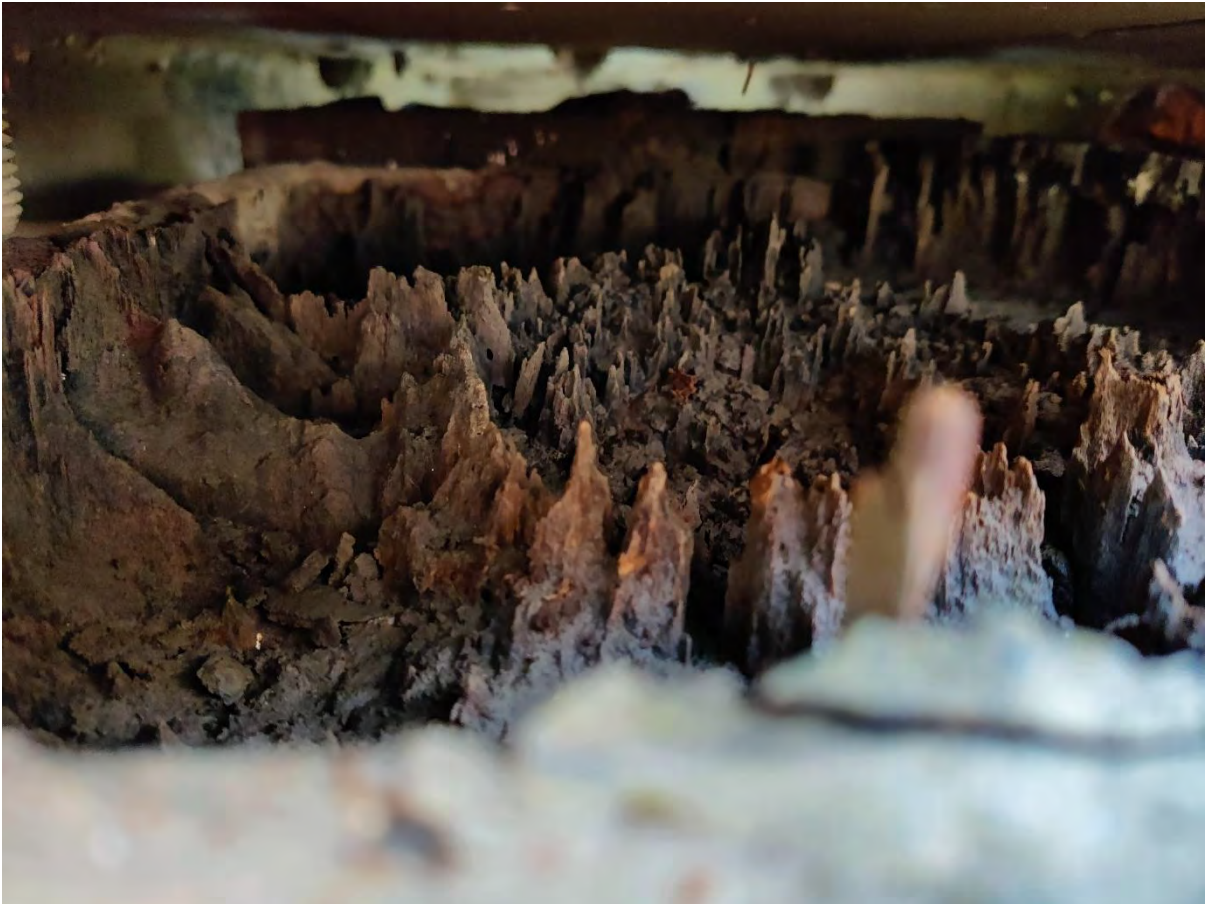
Photo 15: Top of the vertical timber Upstream Middlesex Gate

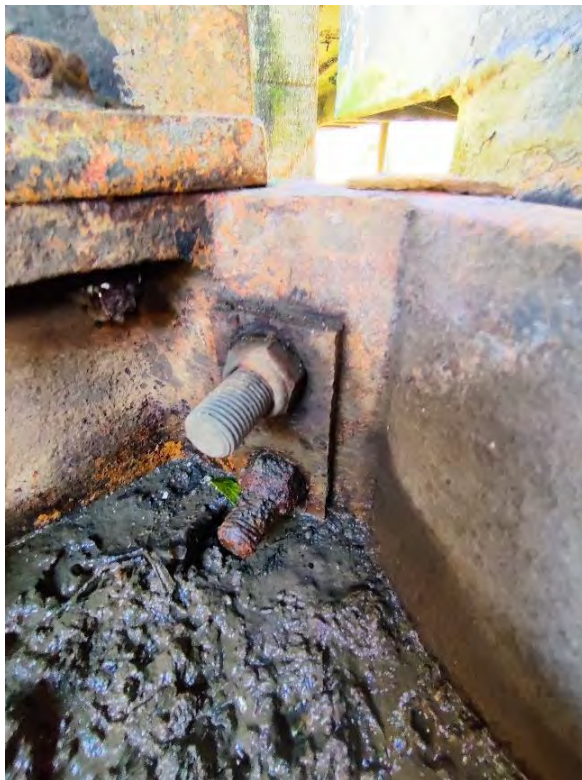
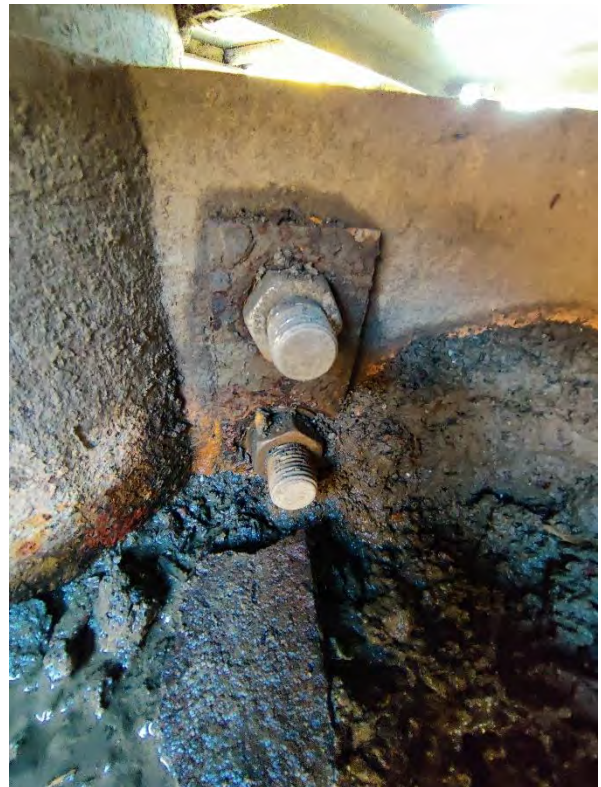
Photo 16: Upstream Middlesex Gate

The bolts retaining the top bearing bands are not all galvanised and some not fitted with nylock nuts. Typical examples are shown below. These should be removed and replaced.

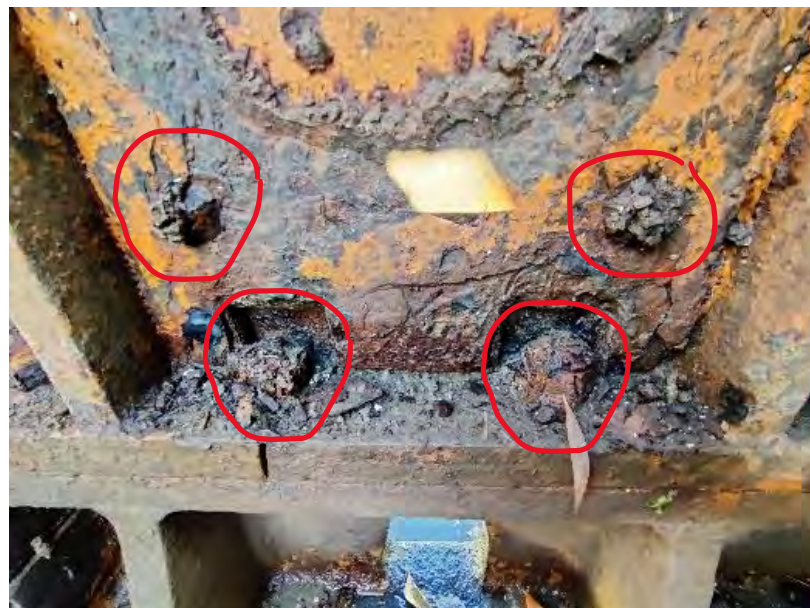
The upper seating is cracked and has been repaired with a bolted patch. However, the bolts and patch are badly rusting and needs replacing

Photo 25: Close up showing the poor condition of the bolts

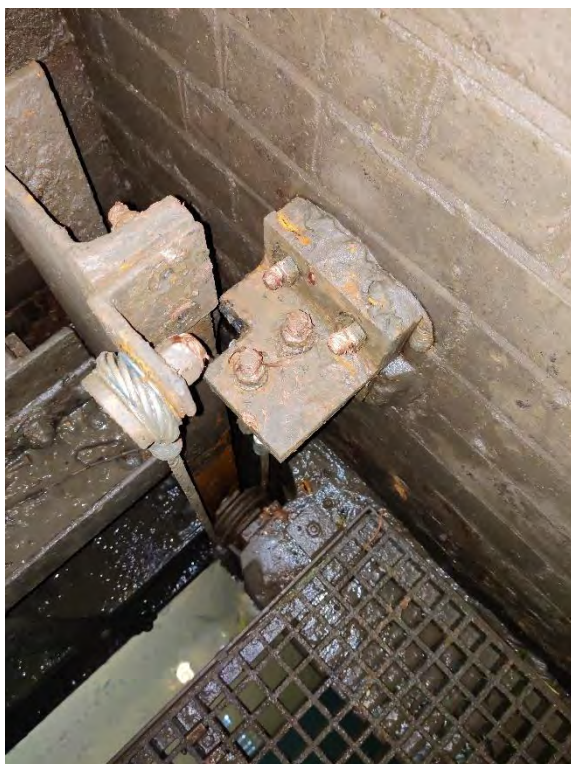
Photo 26: Wire attachment to gates and wall

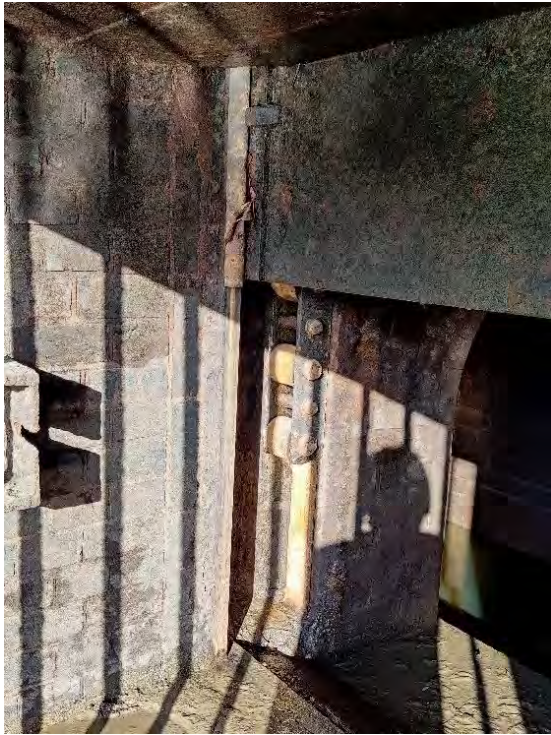
Photo 29: Sluice pit viewed through the grating

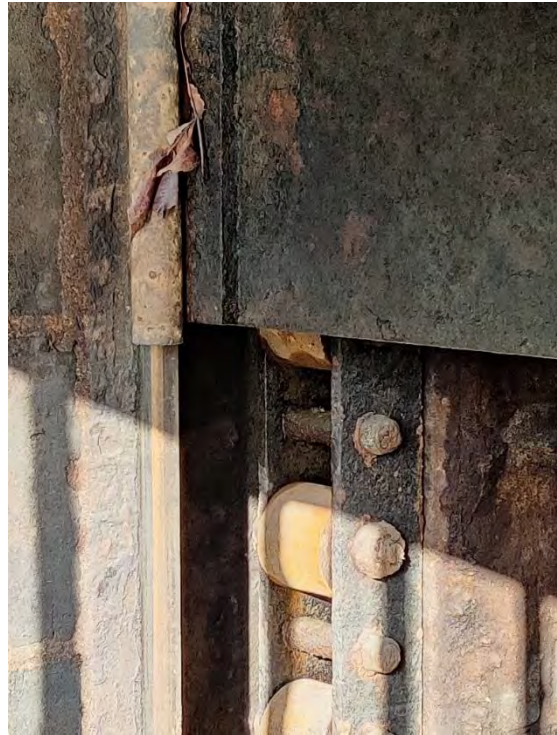
Photo 30: Roller cradle

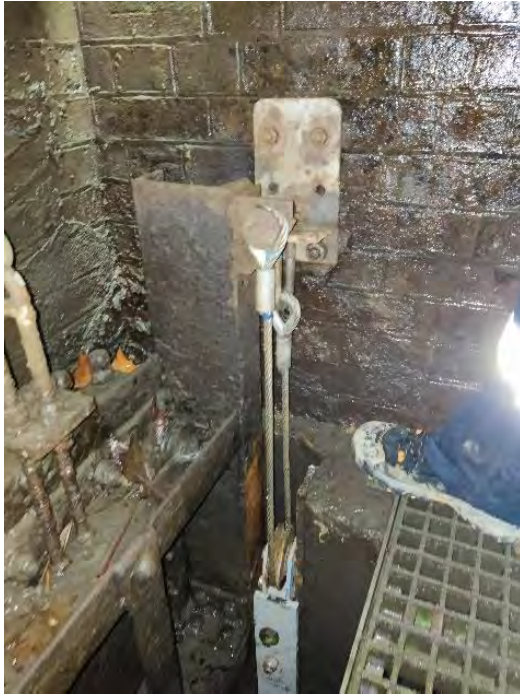
Photo 31: New Roller Cradle wires

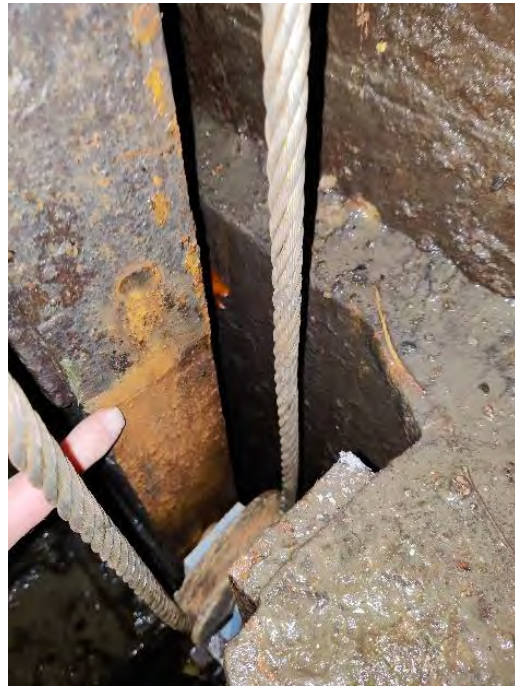
Photo 32: Wear on gate structure

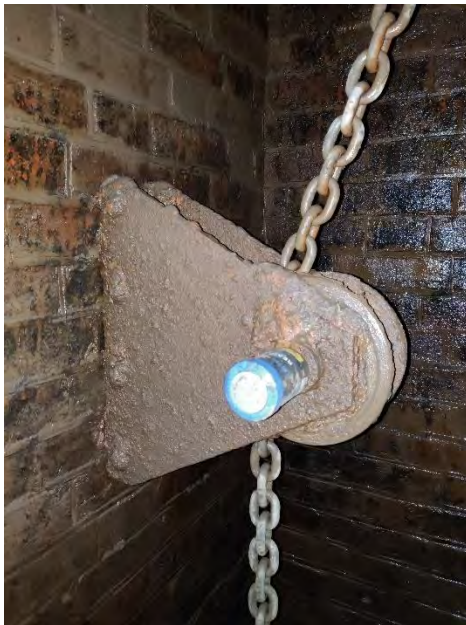
Photo 33: Chain sheave

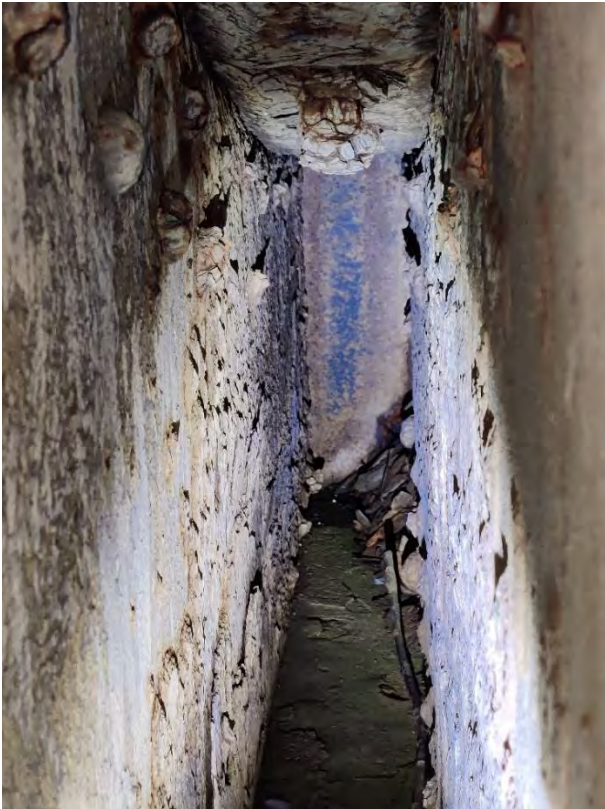
The voids between the end plates are difficult to access and paint and consequently are suffering from corrosion. This is noticeably worse on the upper level than the lower which is more constantly submerged. Despite this, the thickness measurements taken on the end plates and more generally on the gates indicate that significant material remains as shown in the table below.

Photo 37: Paint remaining on the end face

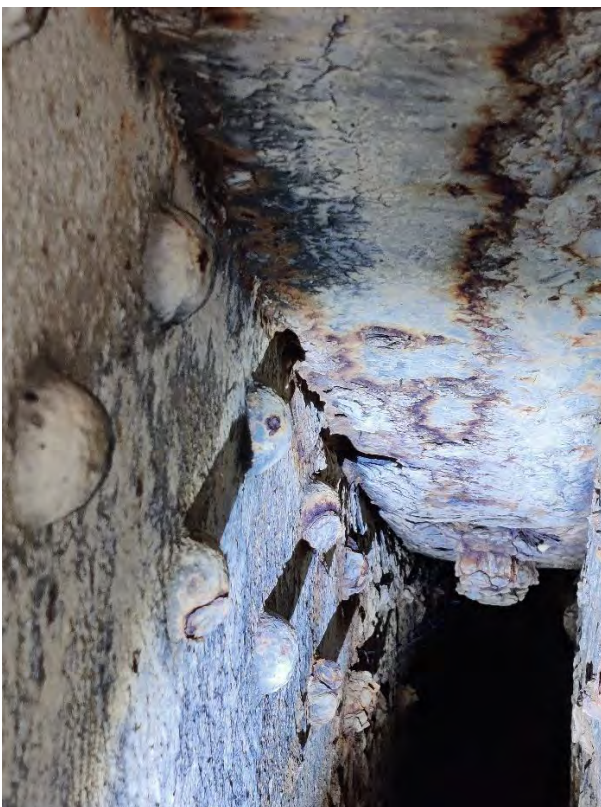
Photos 39 & 40: Typical internal views

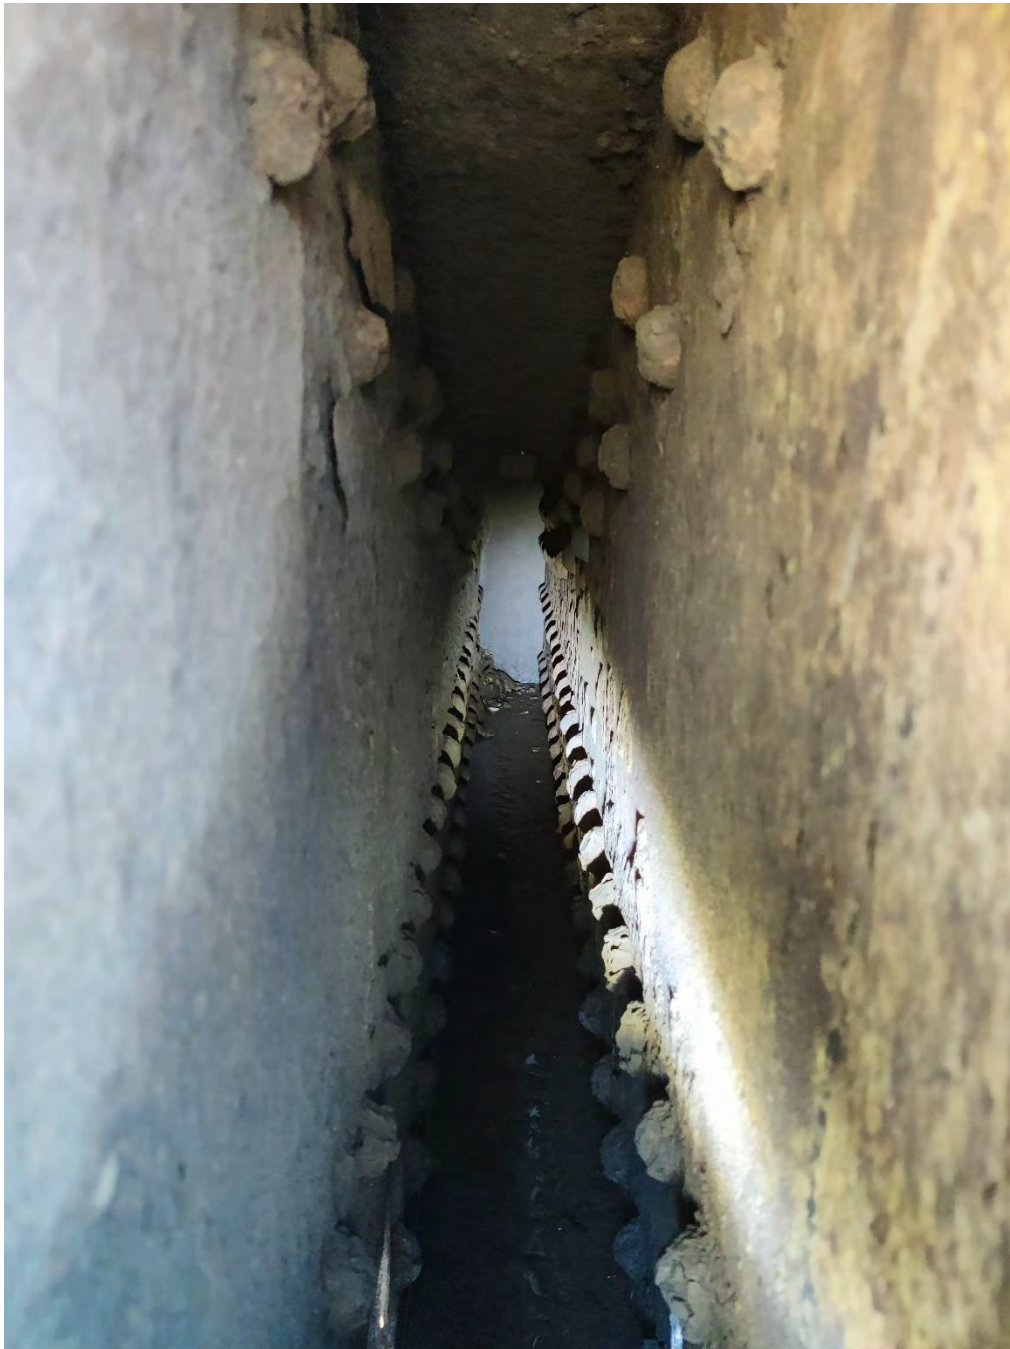
Photo 41: The spaces are about 1.5m deep

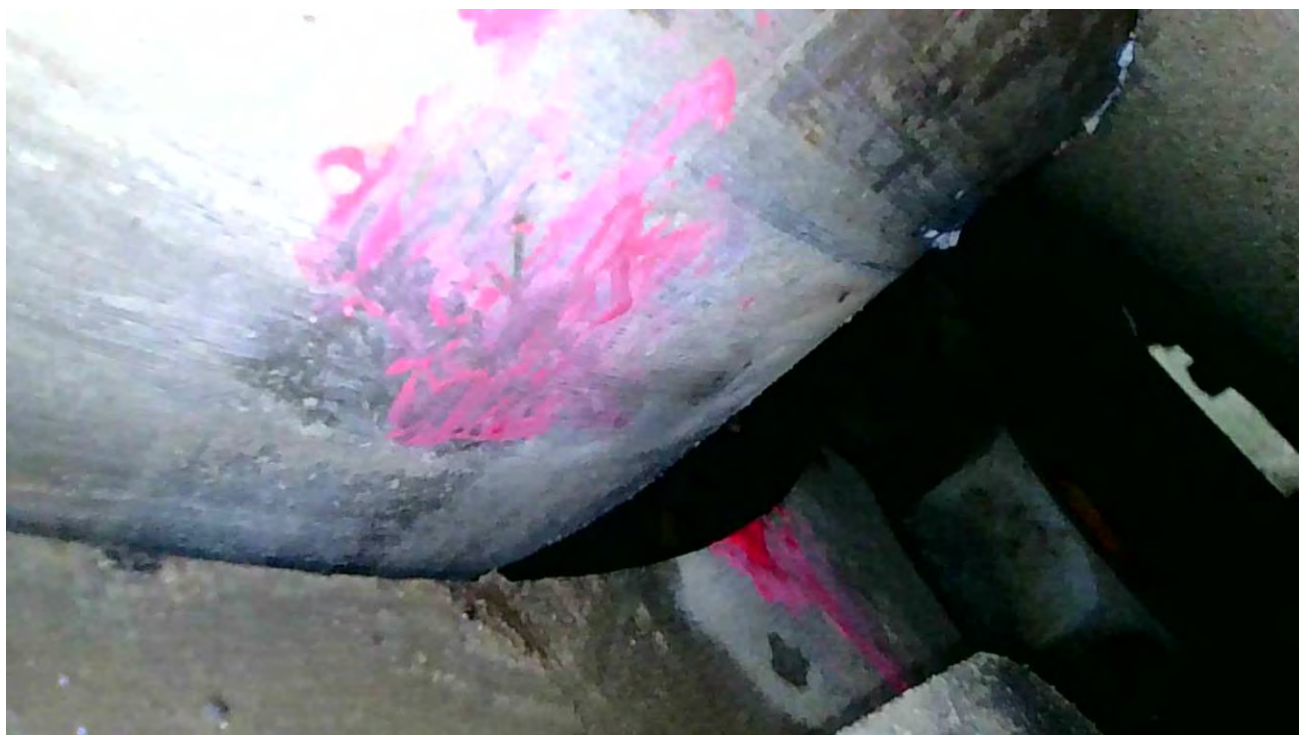
Photo 51: Separation of the paint marks indicates the bearing is rotating

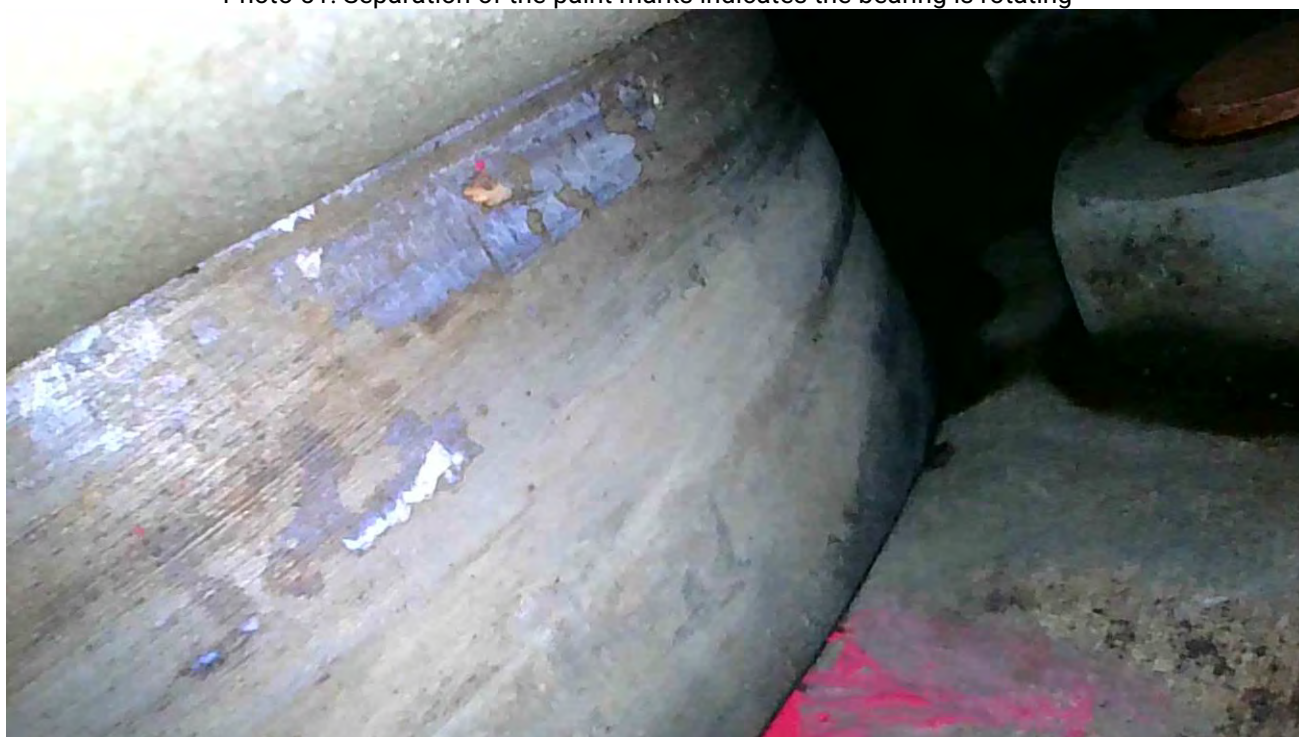
Photo 52: The clearance between the paint mark and shaft is small (top picture indicates otherwise)

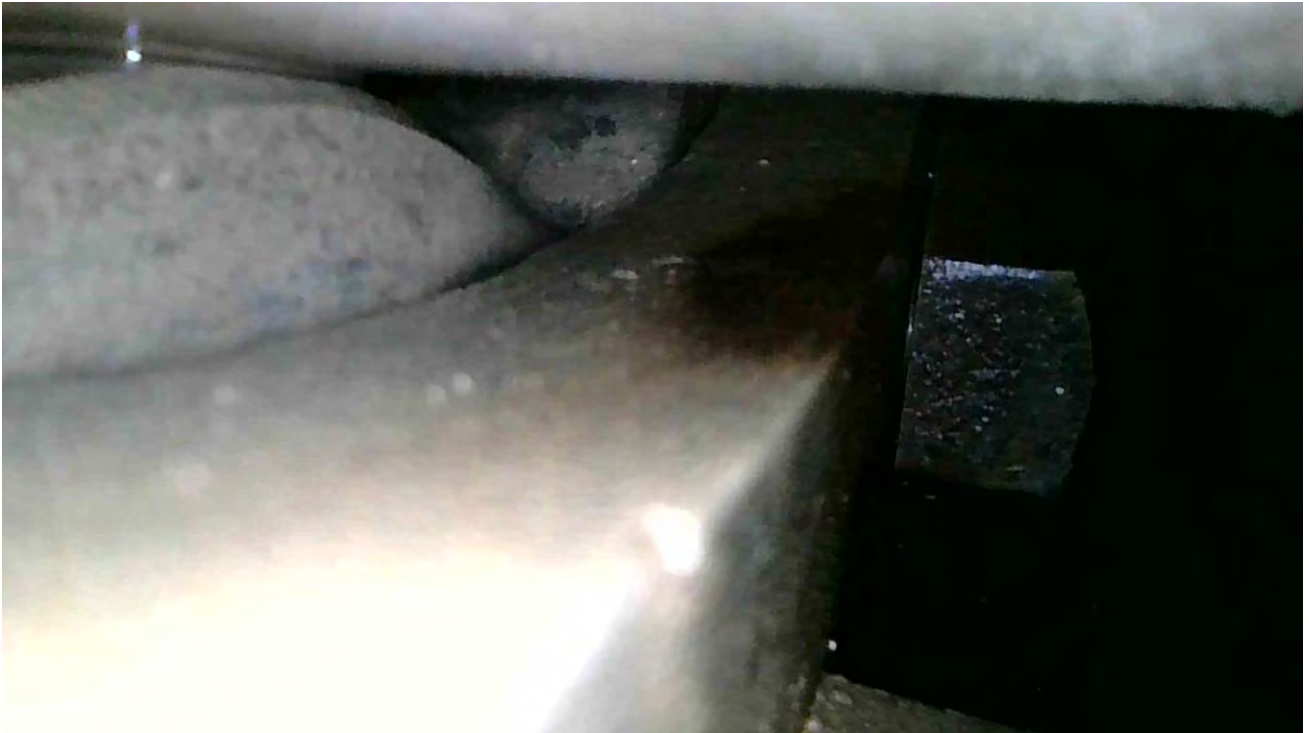
Photo 53: Roller bearings visible inside the bearing cage

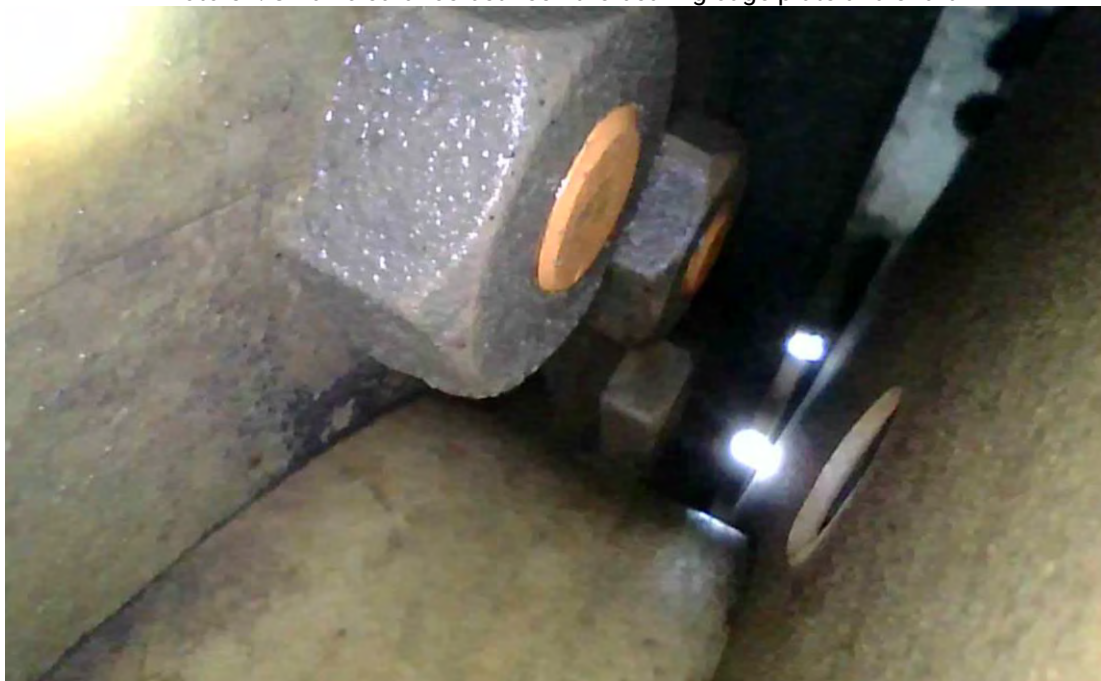
Photo 55: Bronze Spindle Nuts

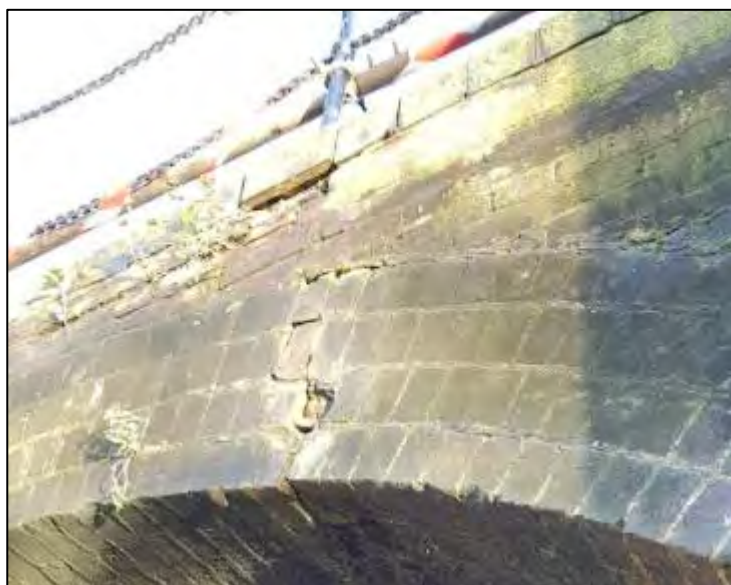
- 3.2.7 The structure is in a visually **good** condition and there are minor defects across its length. The wall is in a **poor** condition at LIM15 due to a long standing defect, where a crack spans the arch soffit and full-frontal height of the wall toward a handrail stanchion (see Figure 3.9). The handrail in this location is largely unsupported and is able to move laterally, representing a safety concern. At the time of the visit the handrail was braced with scaffold members but repair of the damaged brickwork is required.

Figure 3.9: LIM15 Cracking and handrail support

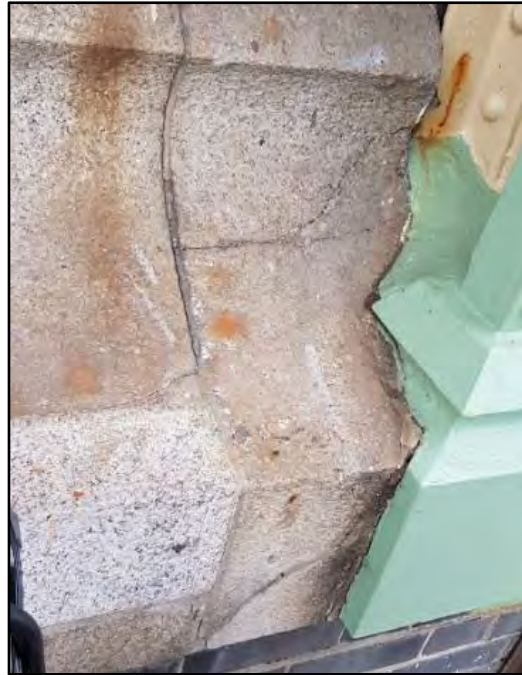
Figure 3.28: Pedestrian bridge - foundation cracks

- 3.7.5 There is cracking within the foundation which supports the Pedestrian Bridge at the North Tollhouse (Figure 3.27). There are signs this has been repaired previously, but the underlying cause does not seem to have been resolved. A similar defect is present at the south building but to a more minor extent.

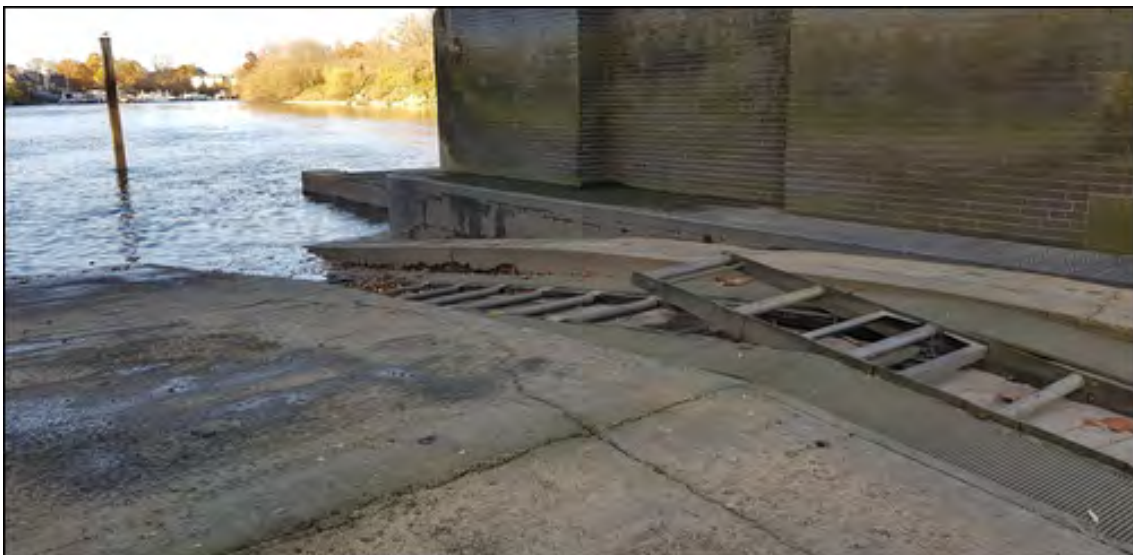
Photo 17: Downstream Middlesex

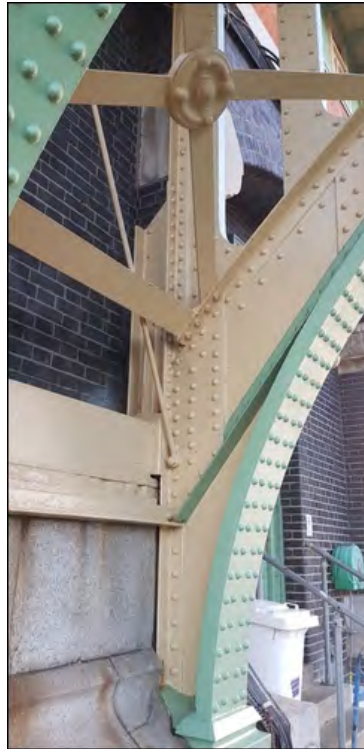
Photo 18: Typical Ground Anchor and top bearing restraint straps

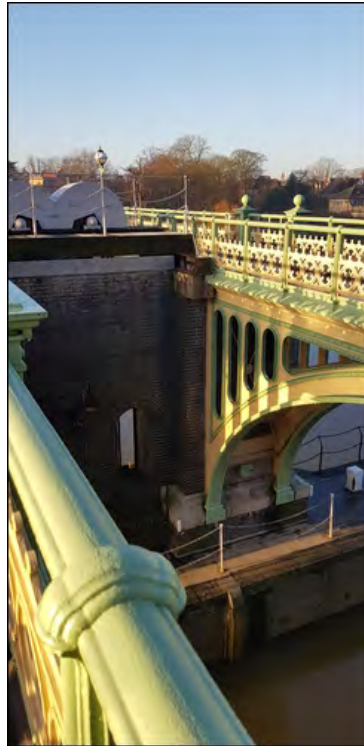
Photo 20: Typical example - Downstream Middlesex

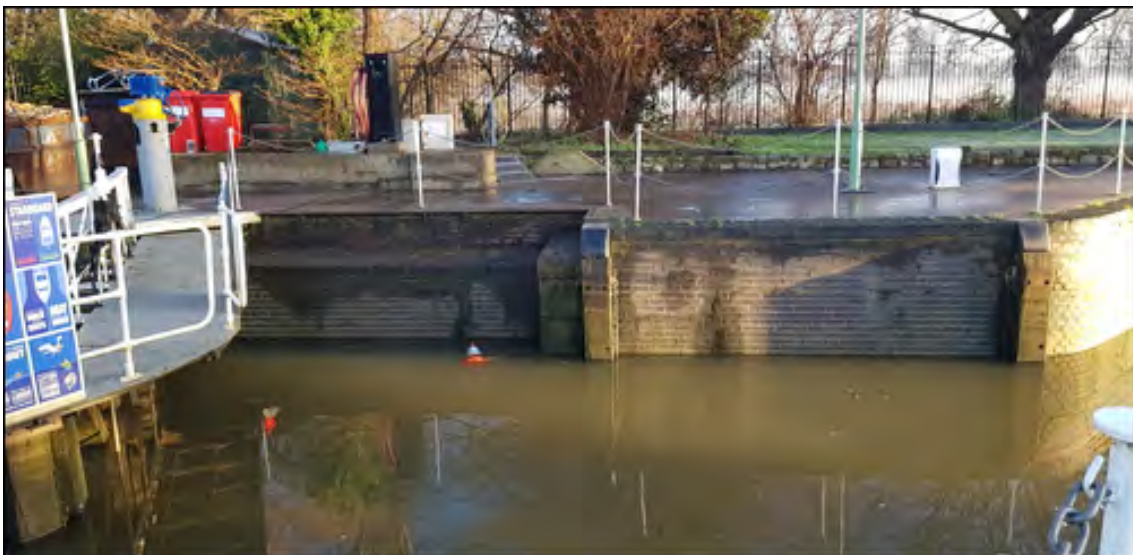
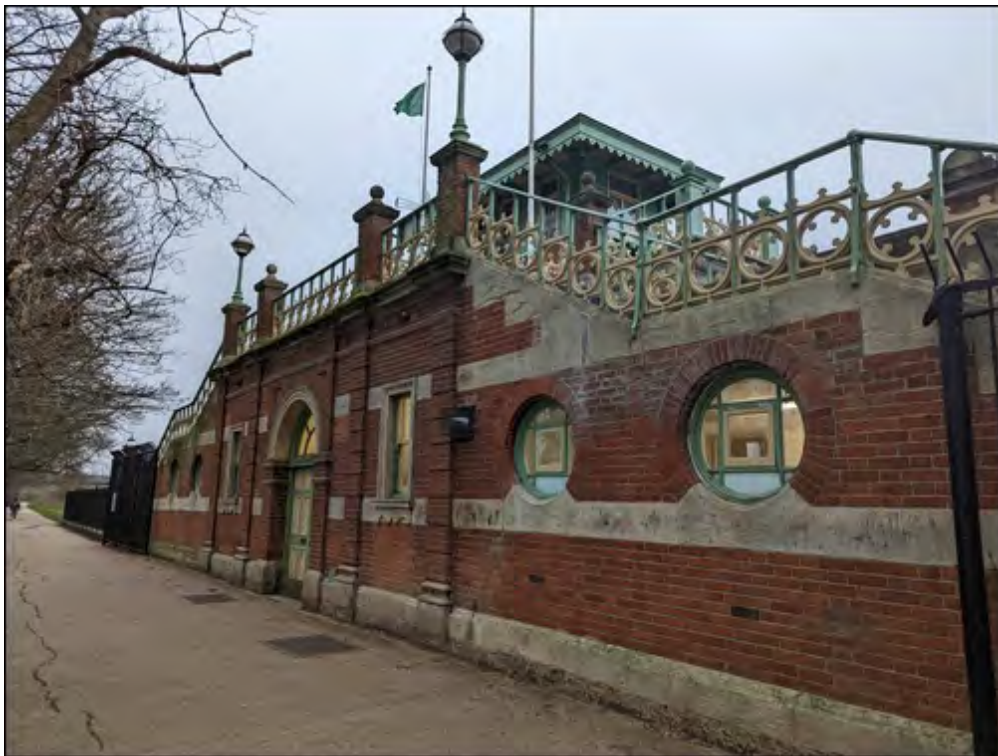
Photo 21:

Photo 21 & 22: Typical example of bolts - Upstream Middlesex

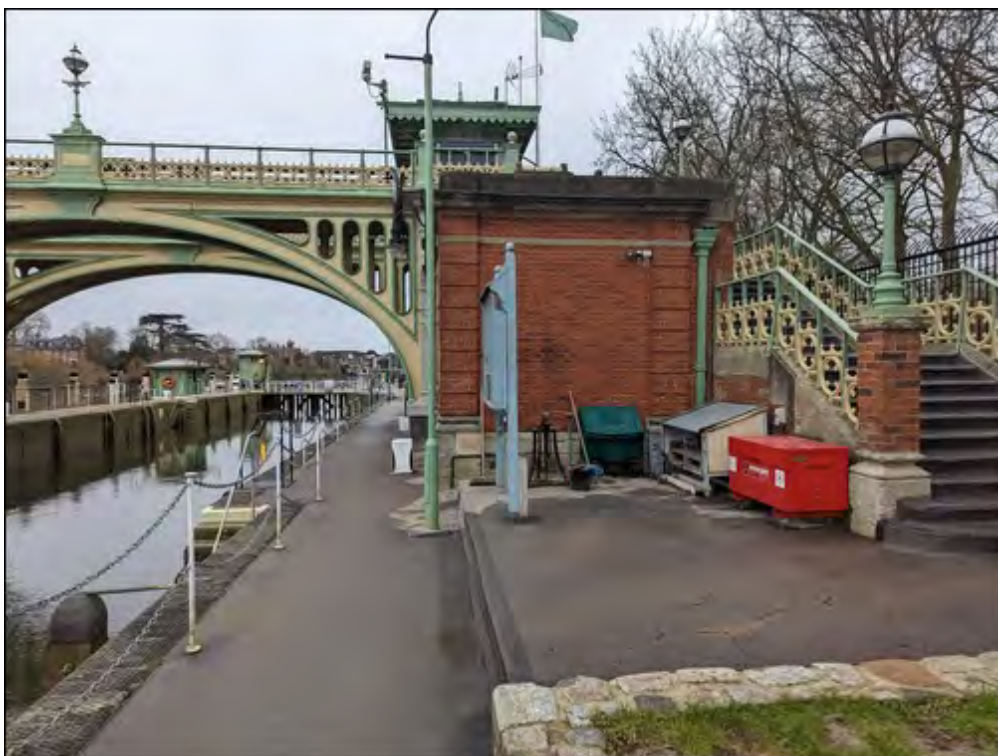
Photo 23: Underside of brackets – nuts badly corroded

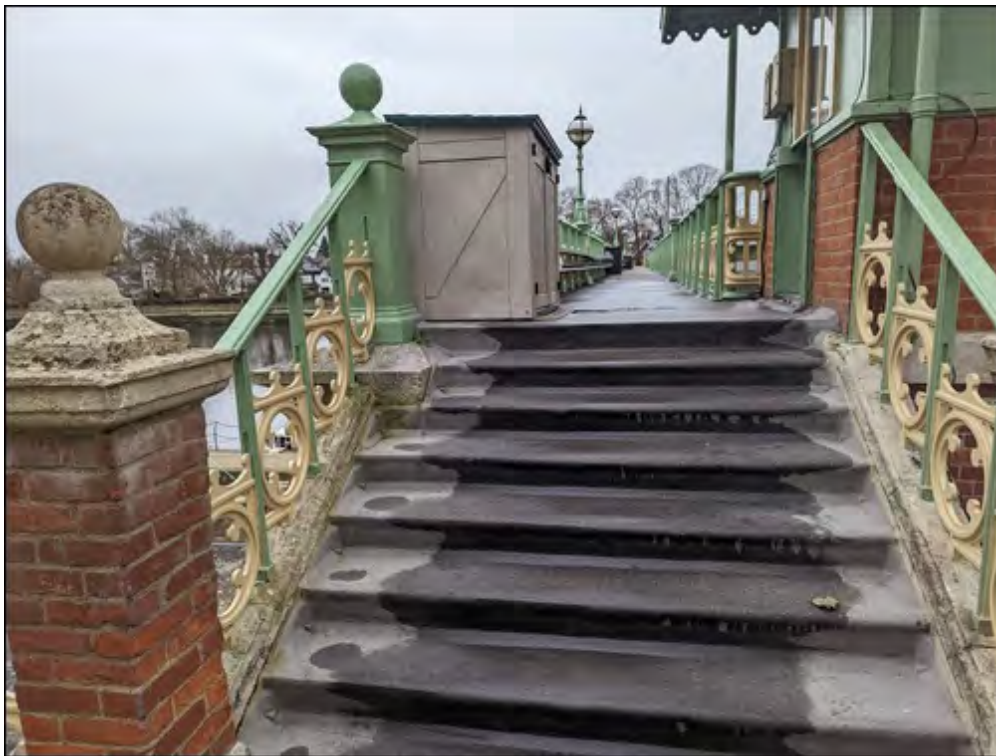
Photo 24: Vertical Crack repaired with Doubler and 6 bolts

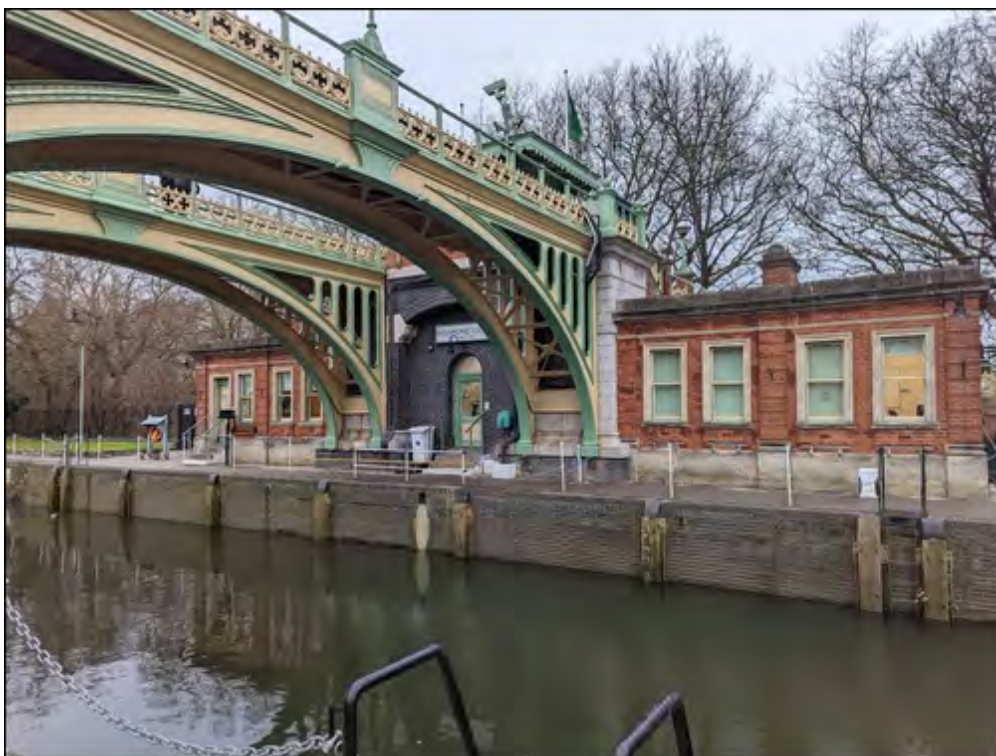
Photo 25: Nuts have disintegrated

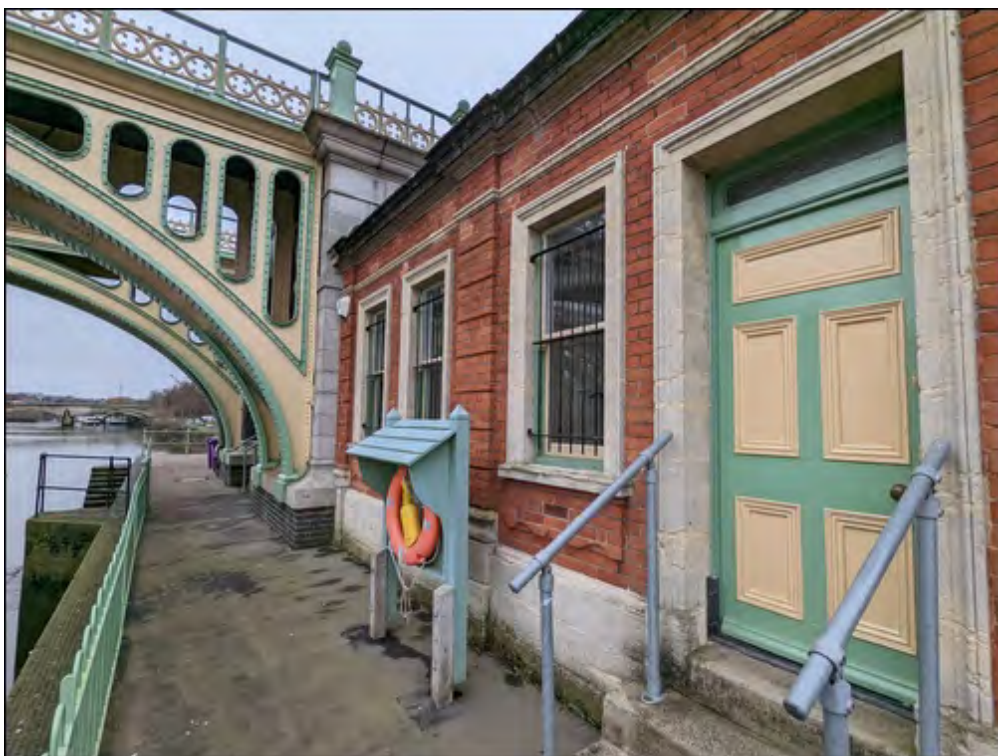
Photo 27: Wear of gate from cradle rollers ~ 3mm

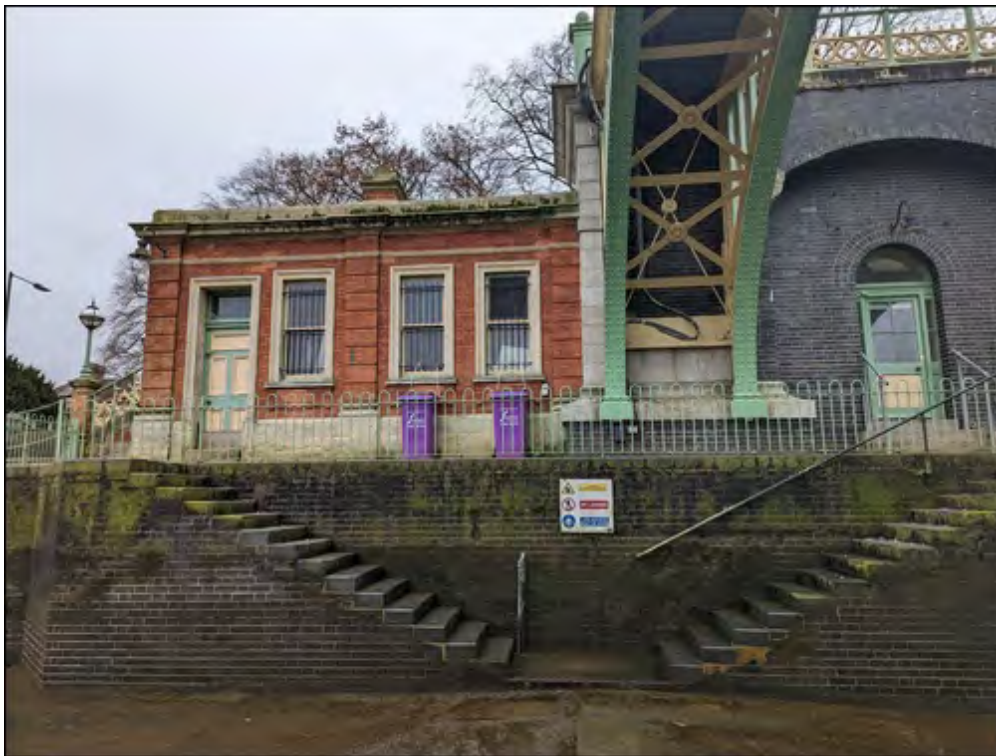
Photo 28: U bolt chain attachment to gate
