Condition Survey Report 2021/2

The PLA has commissioned a condition survey of the mechanical and civil structures at Richmond Lock and Weir. The last full survey was undertaken in the late 1980s prior to the major refurbishments in the early 1990s.

STRUCTURAL SURVEY SUB & SUPERSTRUCTURE CONDITION ASSESSMENT

CLIENT			Houlder Ltd			
PROJECT TITLE			Richmond Lock & Weir			
SUBJECT			Structural Survey			
DOCUMENT TITLE			Sub & Superstructure Condition Assessment			
DOCUMENT REF			2144-BRL-01-XX-RP-C-1000			
REVISION RECORD						
REV	STATUS	DATE	SUMMARY OF CHANGES	PREP	CHK	APP
P01	S2 – Suitable for Information	11/03/22		GG	-	TKHB
P02	S2 – Suitable for Information	25/03/22		GG	MB	TKHB

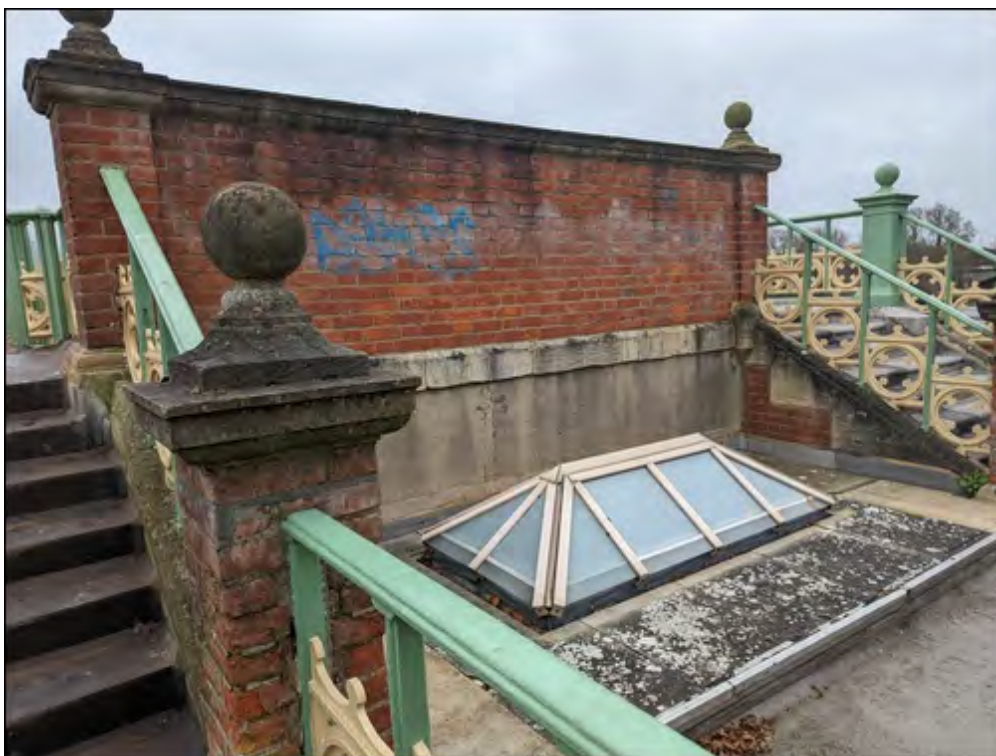
Photo 29: Sluice pit viewed through the grating

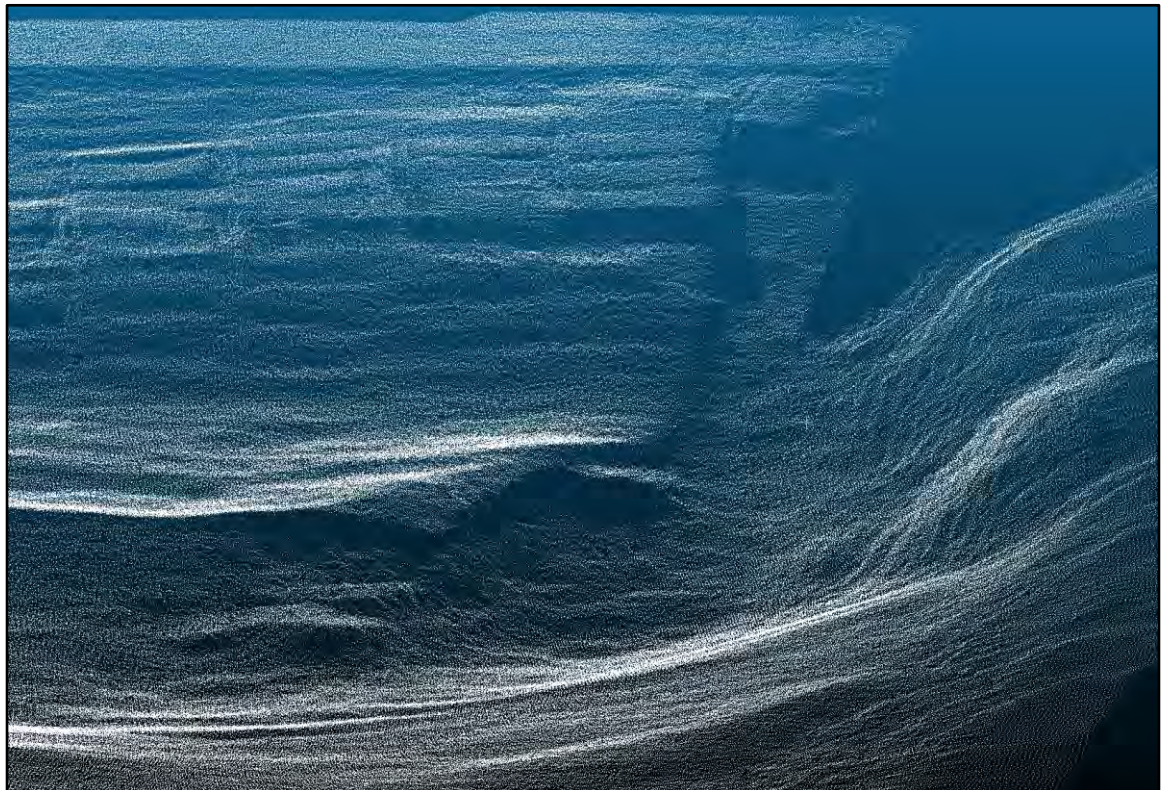
Figure 3.1 - Second scour to the riverbank side of the scour protection

- 3.1.5 A secondary scour hole up to 1.7m deep at the riverbank edge of the scour protection in front of the Middlesex weir was also identified. This was not dived due to tidal constraints.
